**Report of the Board of Inquiry into the Collision  
between *Sun Paradise* and *Pride of Airlie***

Report of the  
Board of Inquiry  
Into the collision  
Between *Sun Paradise*  
and *Pride of Airlie*  
Whitsunday Passage  
on 18 November 2001

**REPORT/ ANNEXES**

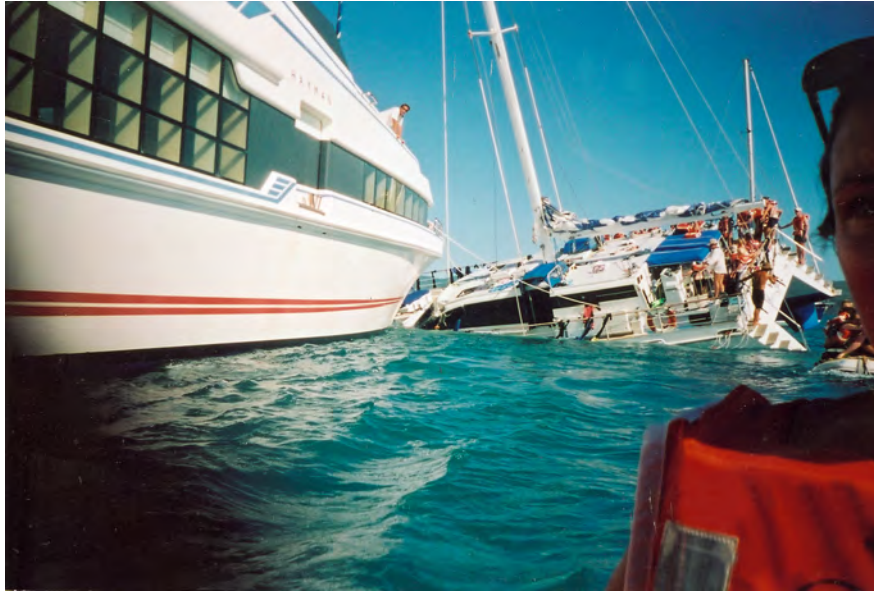
Photo 1 - The Pride of Airlie under the bows of Sun Paradise shortly after the collision.

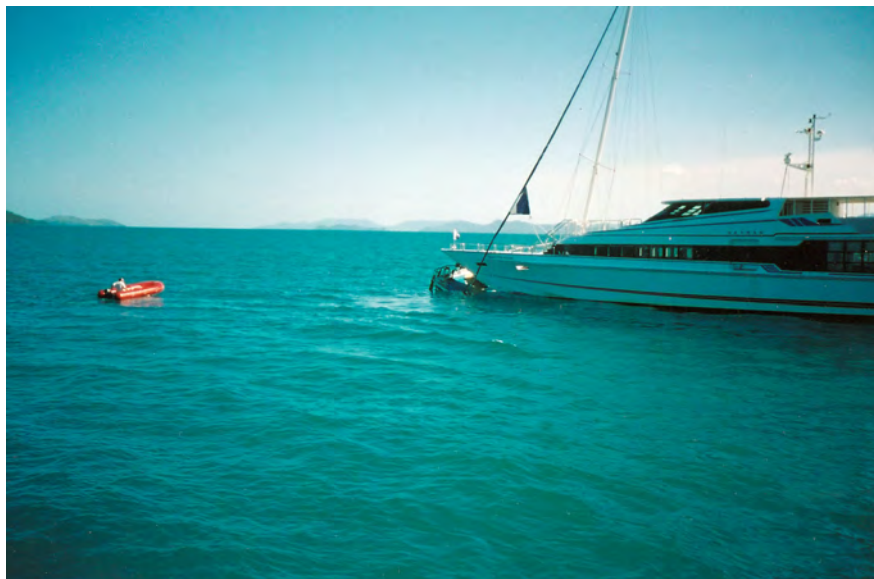
**2.4.1 Environmental Conditions.** The weather conditions of 18 November 2001 in the Whitsunday Passage were fine, visibility was unimpeded by weather or sea, the sky was blue, there was no rain and only a light breeze. The visibility was described in evidence submitted to the Board variously as being “...just perfect” with 5-10 knots of wind (AJ Neilson answer to Q35-36) and “very favourable conditions for the day” (Liddell answer to Q38).

Photo 2 - Conditions on the day were benign.

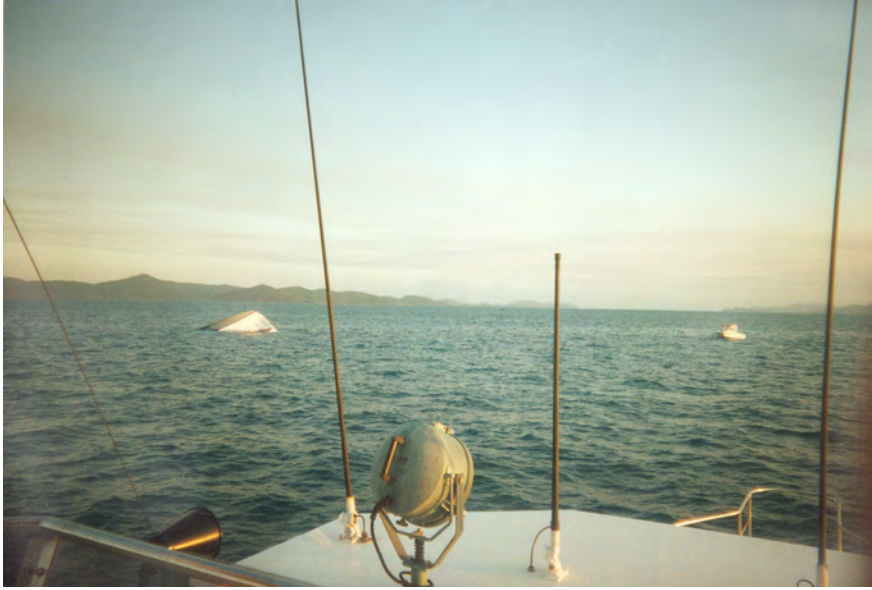
Photo 3 - The Pride of Airlie shortly before sinking

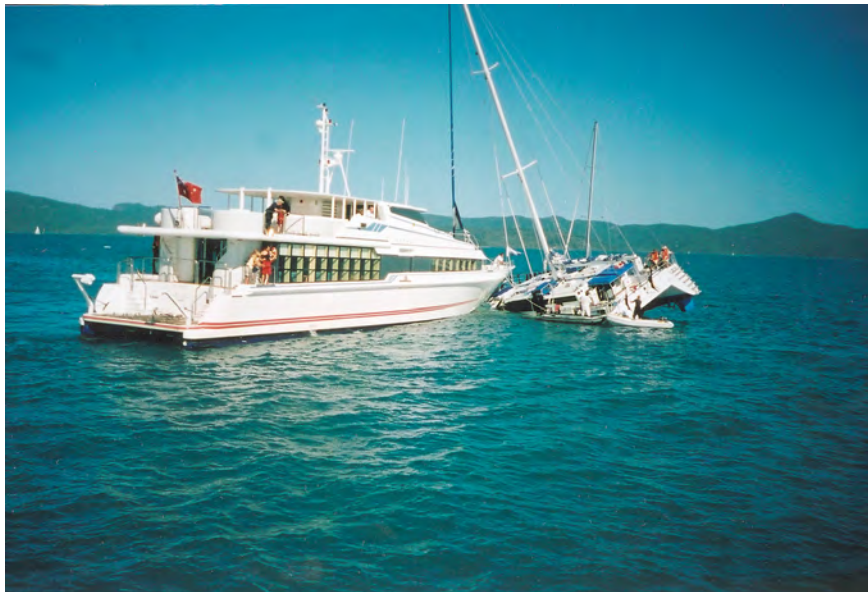
Photo 4 - The Pride of Airlie under the bows of Sun Paradise shortly after the collision.

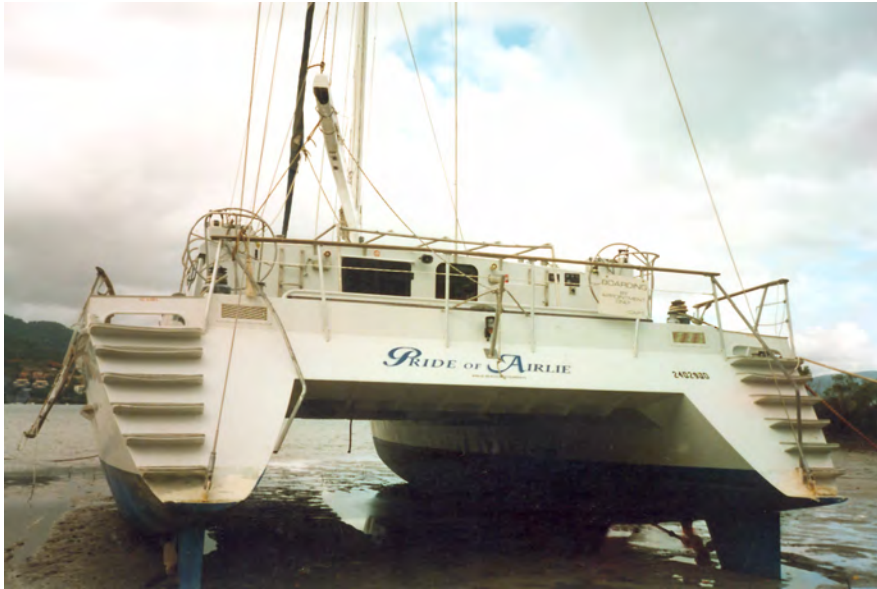
Photo 5 - The dual conning arrangements in the Pride of Airlie

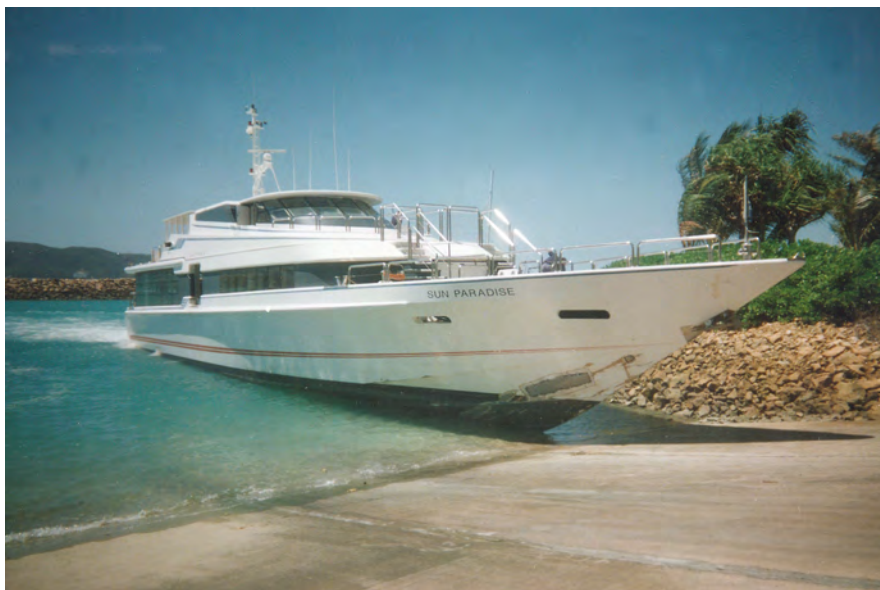
Photo 6 - The under-hull damage to Sun Paradise after temporary repairs.

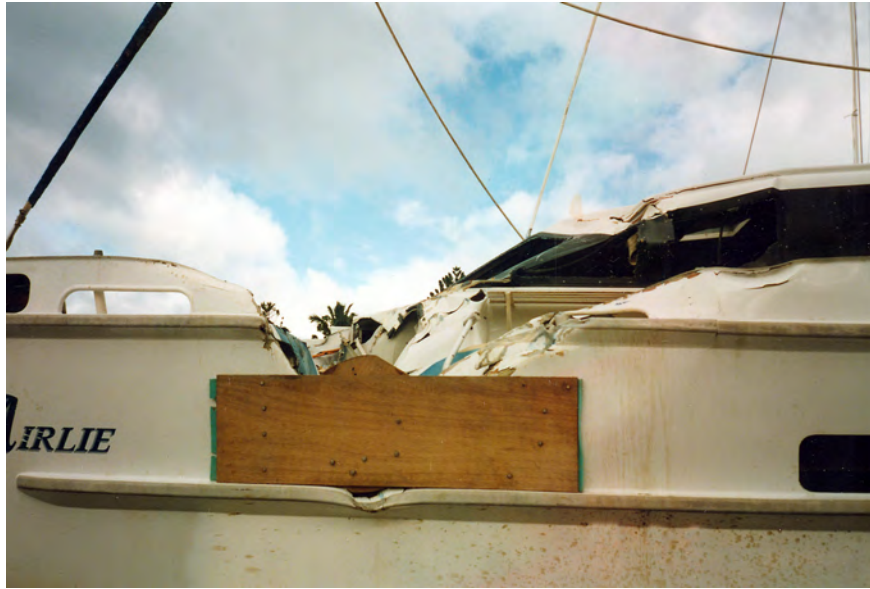
Photo 7 - The point of impact showing damage to the Pride of Airlie.

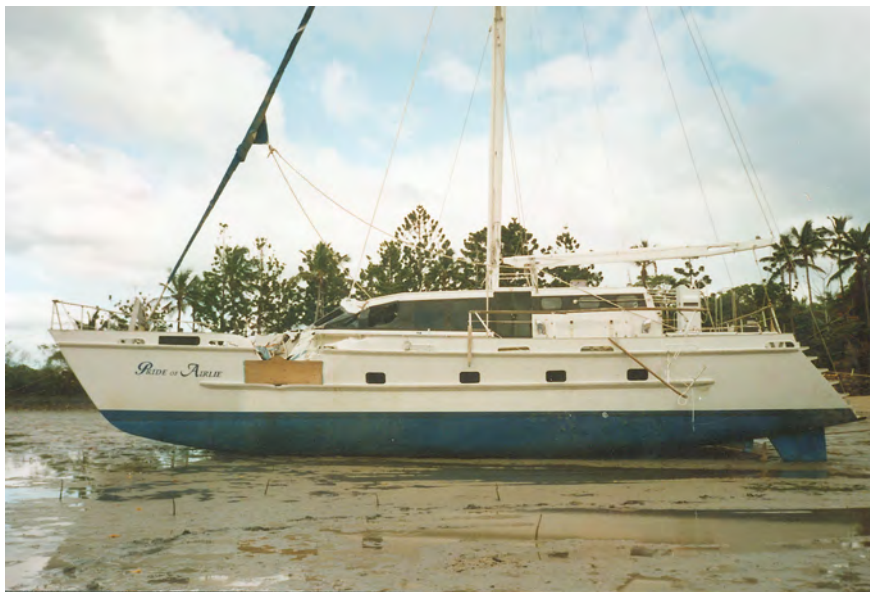
Photo 8 - The point of impact showing damage to the Pride of Airlie.

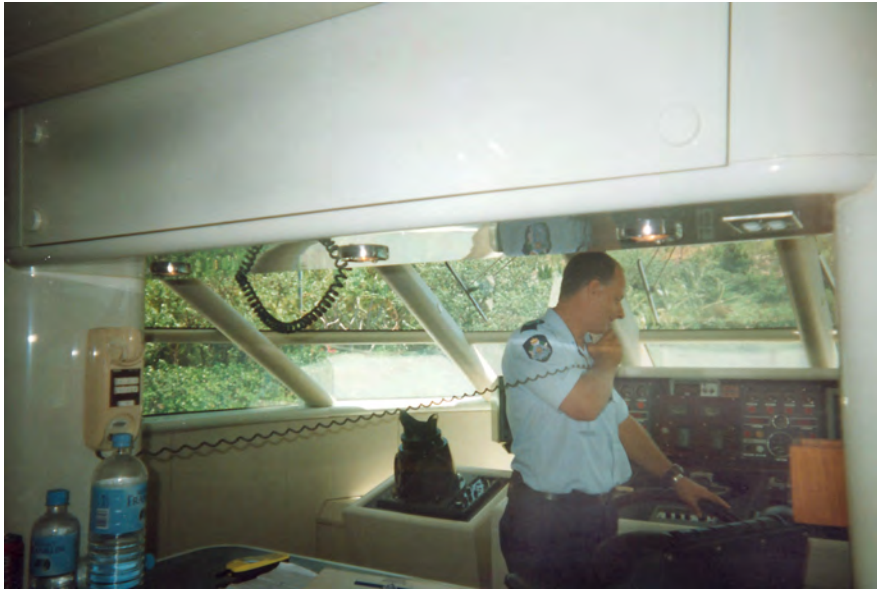
**3.1.5 Master Sights “Pride of Airlie”.** Mr Daniel then replaced the intercom and upon looking forward, for the first time saw the “Pride of Airlie” off his starboard bow at a stage when the collision was imminent.

Photo 9 - The bridge of the Sun Paradise showing the intercom and access to the conning position.

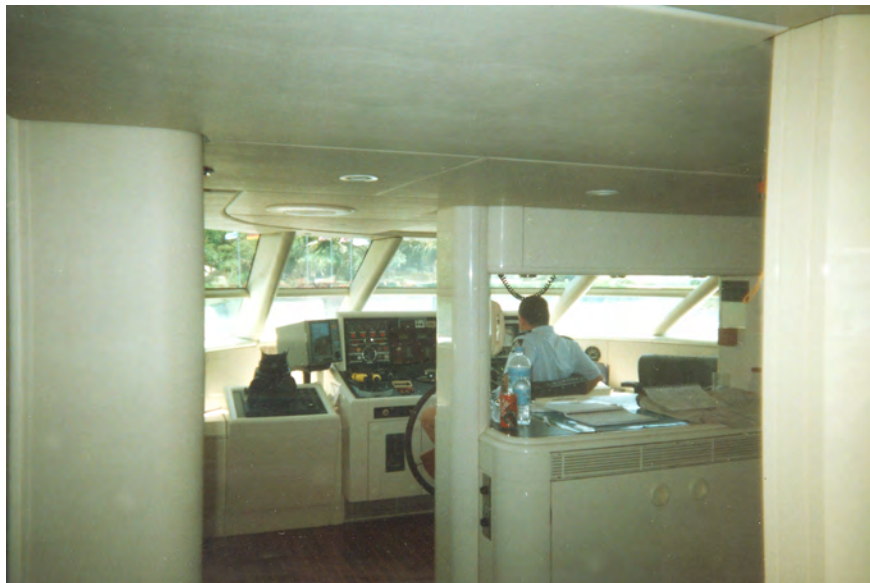
Photo 10 - The view from the entrance to the bridge of the Sun Paradise showing mullion and pillar design of the bridge windows.

3.3.19 During the repair of the “Sun Paradise”, the horizontal mullions and vertical pillars were reduced in size, at a cost of approximately \$20,000 (see the evidence from Mr Peter Stowe, Marine Operations Manager, Hayman Island, Day 3, pp. 223). This has no doubt improved visibility.

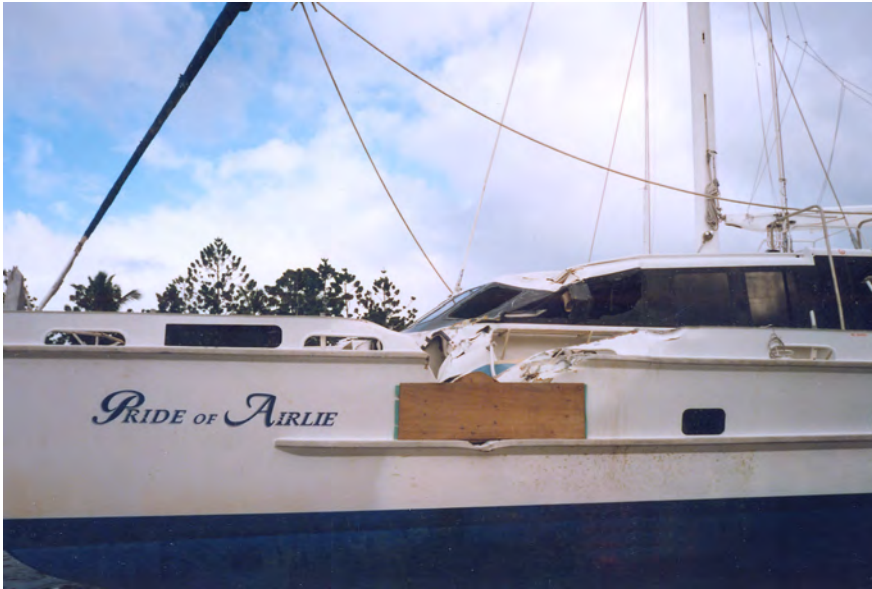
Photo 11 - External damage to the Pride of Airlie.
