**REPORT OF THE BOARD OF INQUIRY
INTO THE MARINE INCIDENT
INVOLVING THE SHIP *WUNMA* IN THE
WATERS OF THE GULF OF
CARPENTARIA ON 6 AND 7 FEBRUARY
2007**

WUNMA BOARD OF INQUIRY

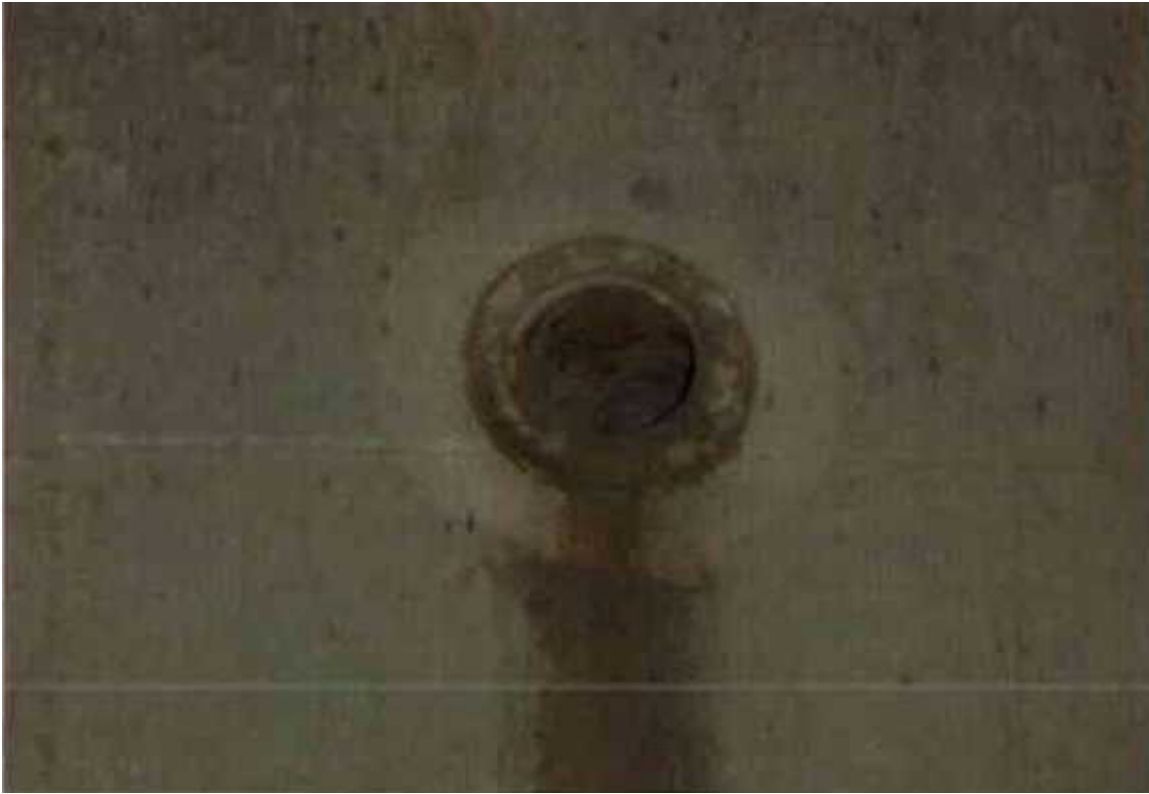
Figure 9 – Blocked Washdown Ports under the Conveyor

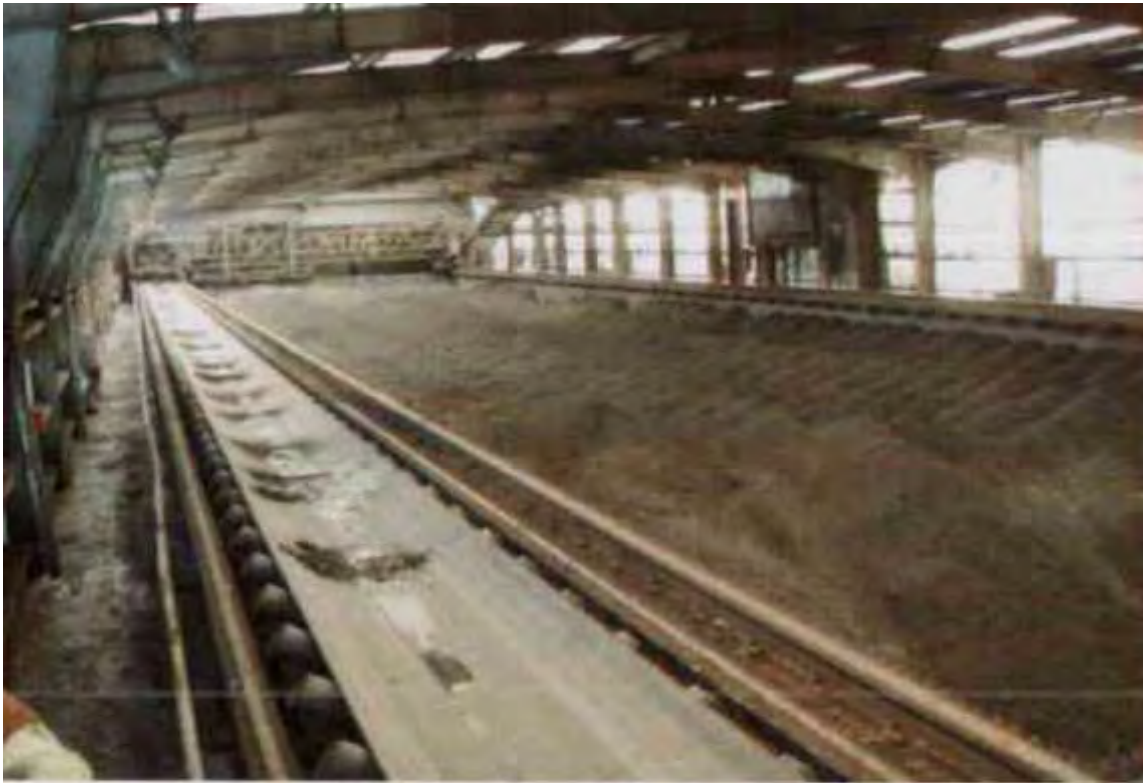
Figure 10 - Conveyor Port Side Walkway Showing Concentrate Deposits on Port Deck

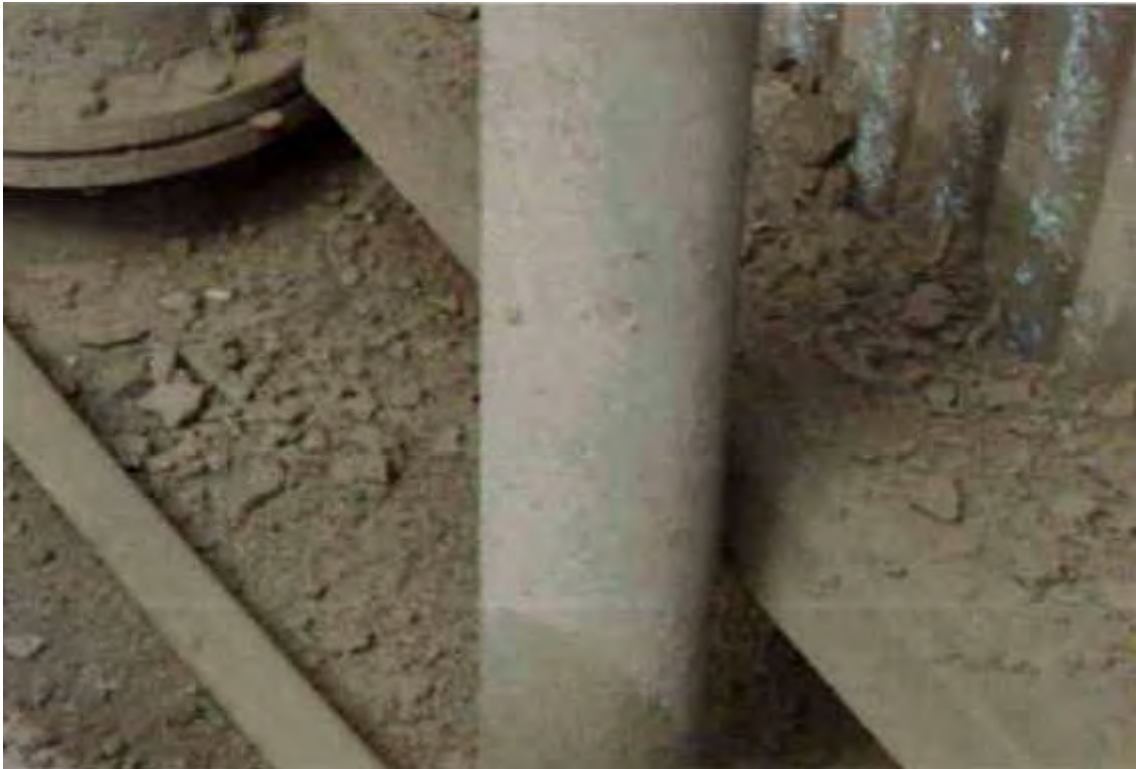
Figure 11 - Accumulated Concentrate on the Port Side Walkway

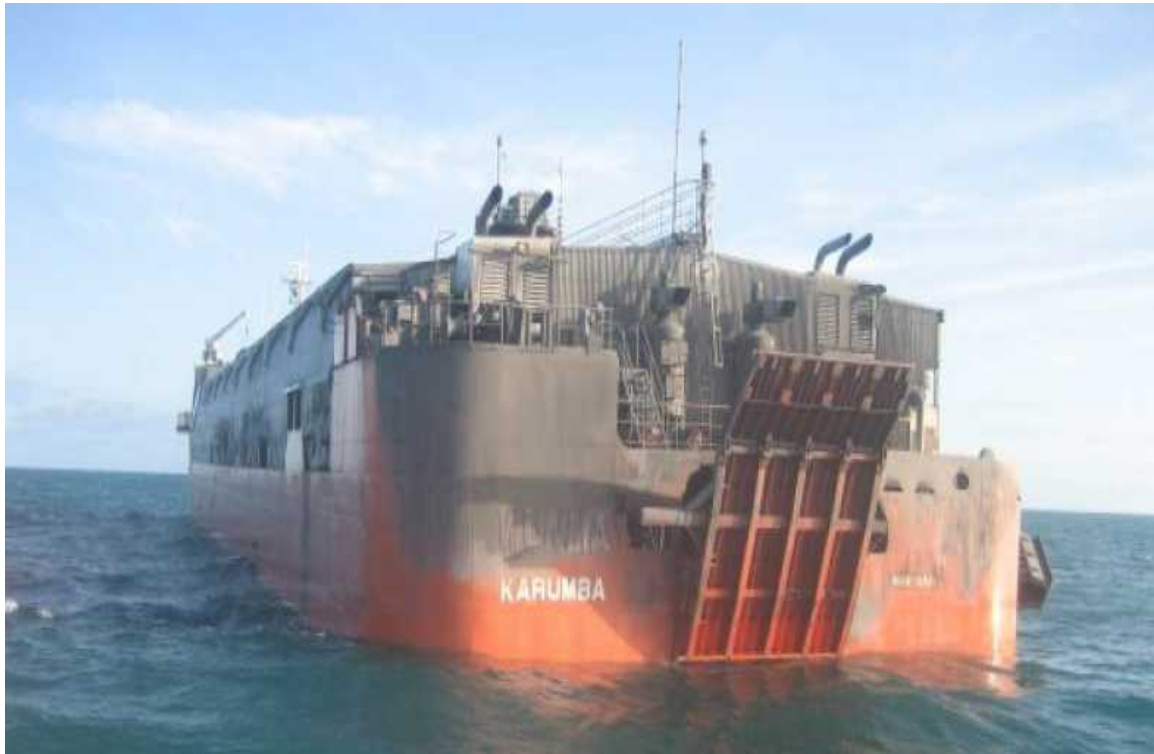
Figure 3 - The Wunma - Waterline at the Base of the Stern Door

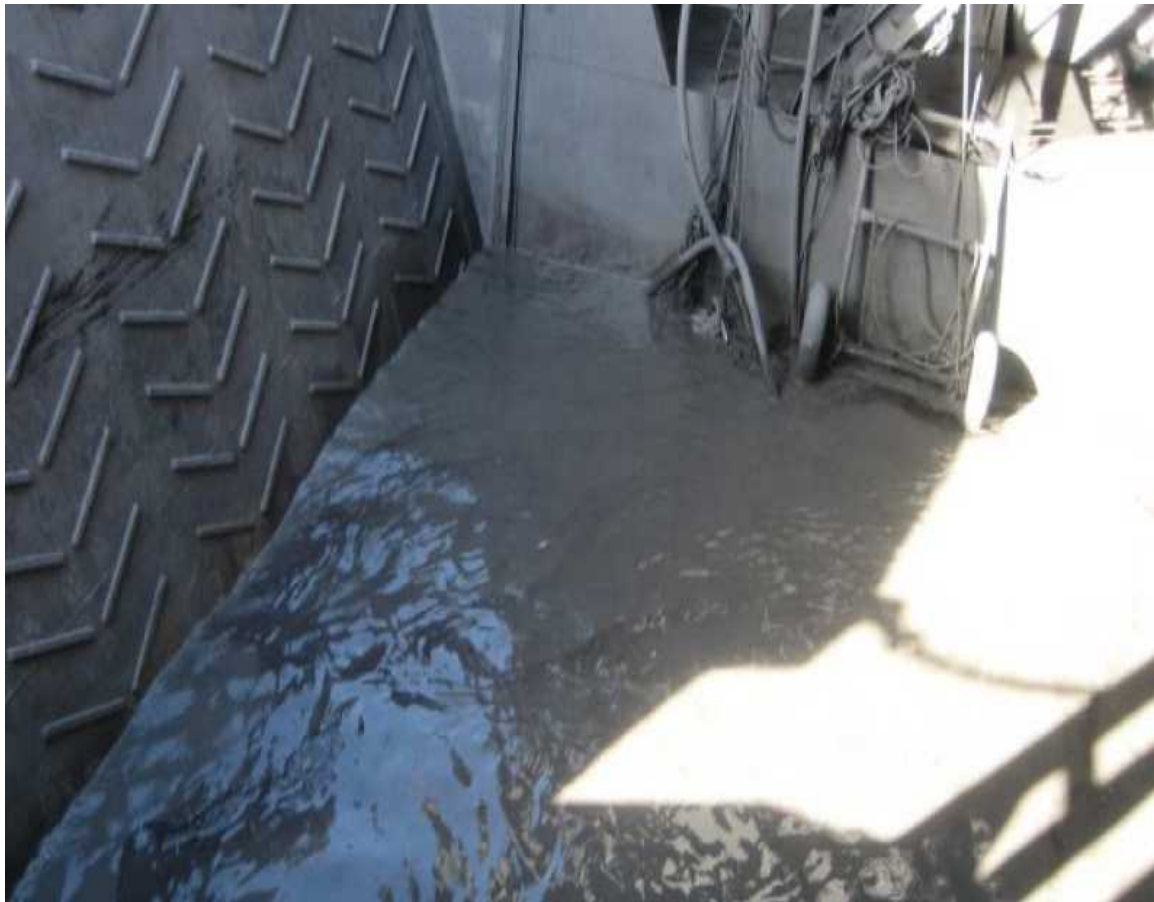
Figure 4 - Water in the Aft Well Deck

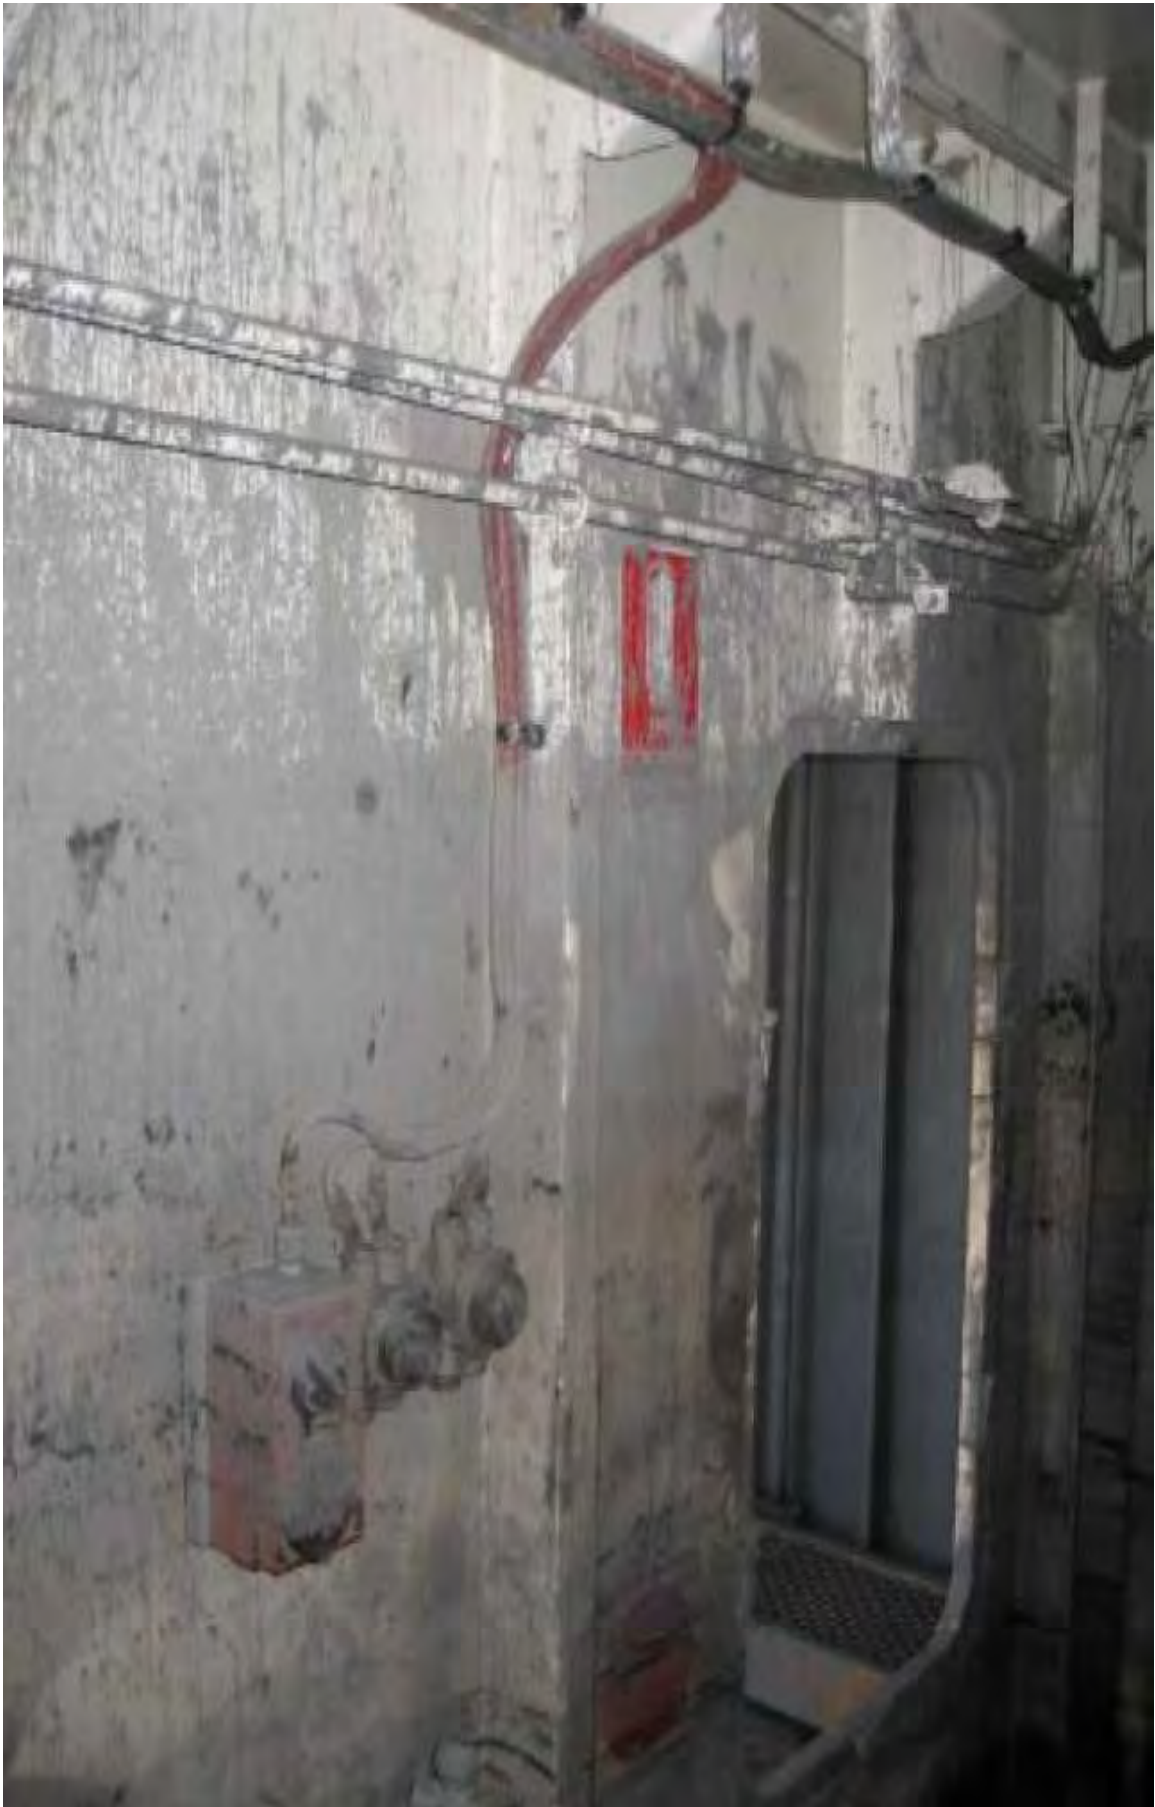
Figure 5 - The Hot Workshop Depicting Slurry Marks

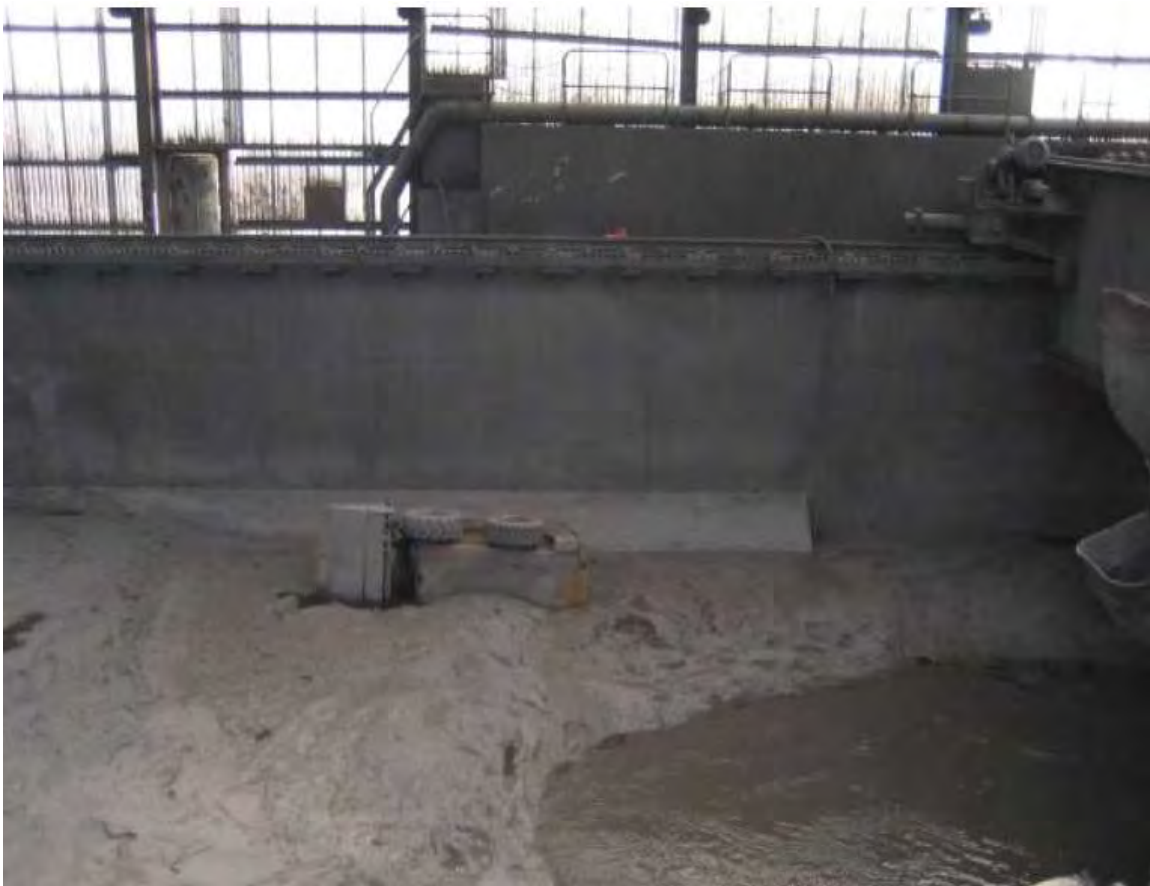
Figure 9 - Bobcat Overturned in the Cargo Hold

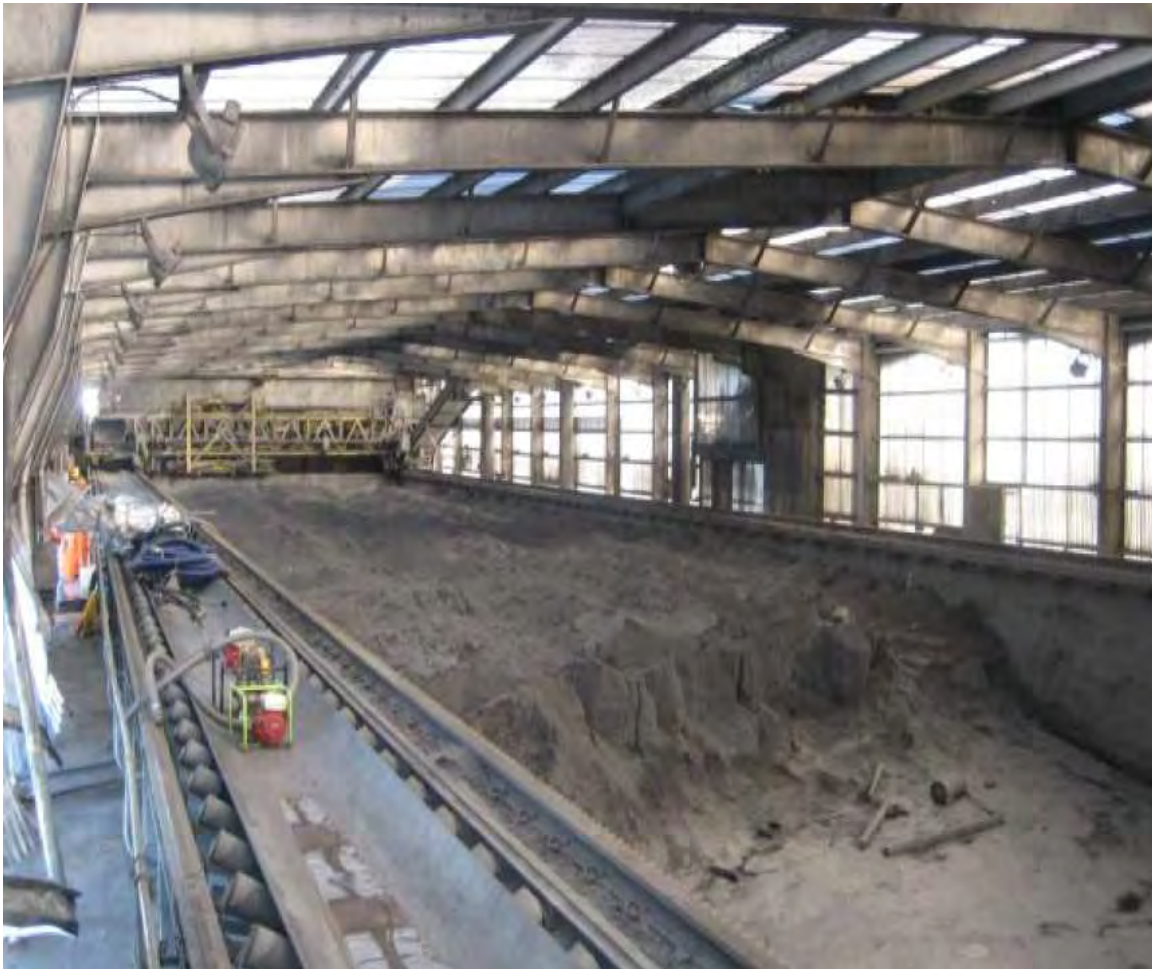
Figure 10 - Debris in the Cargo Hold

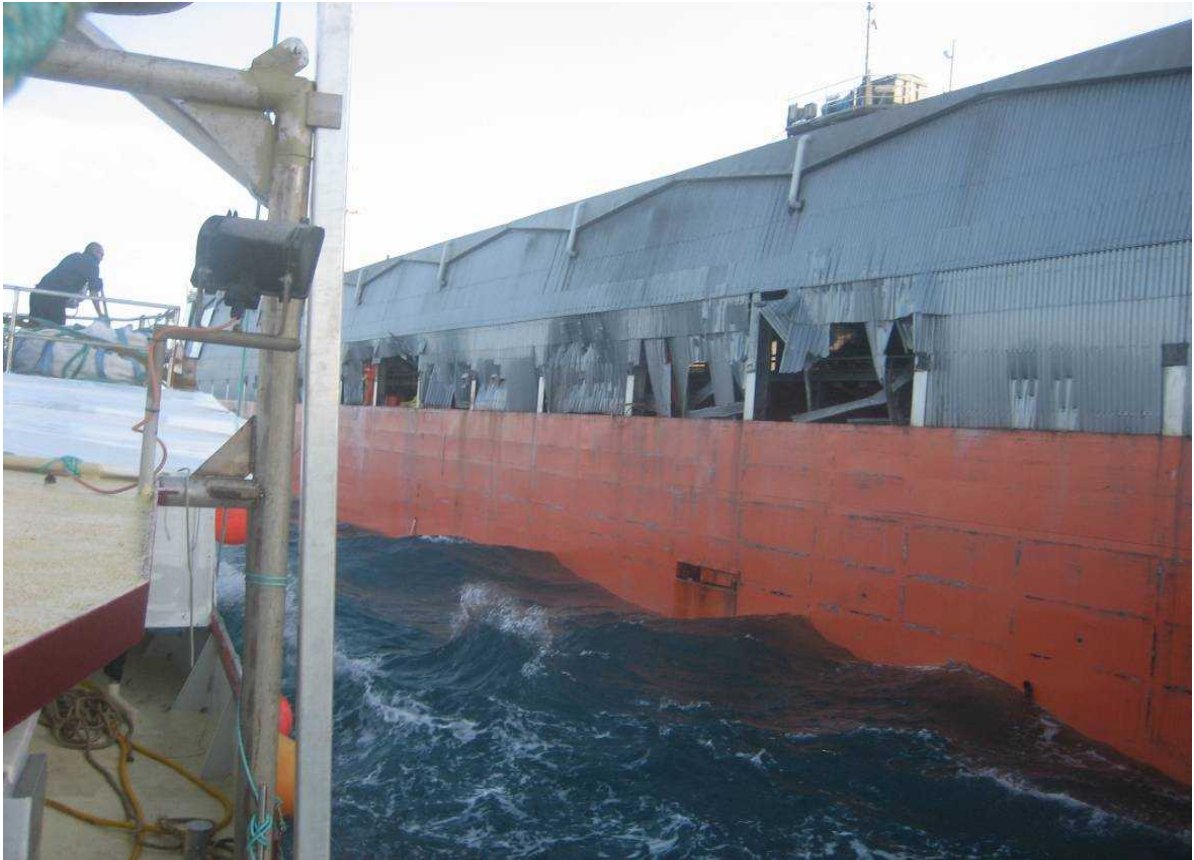
Figure 12 - Damage to the Canopy on the Port Side

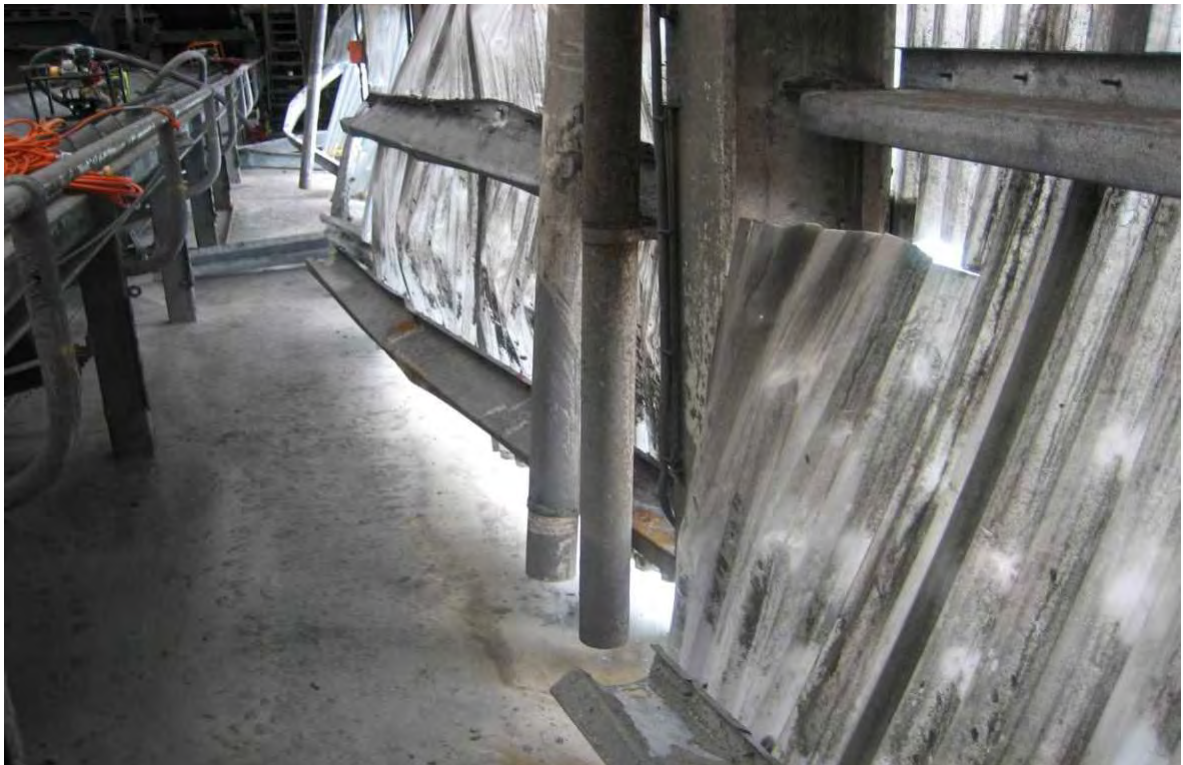
Figure 15 – Damage and Down Pipes and to the Port Side Deck

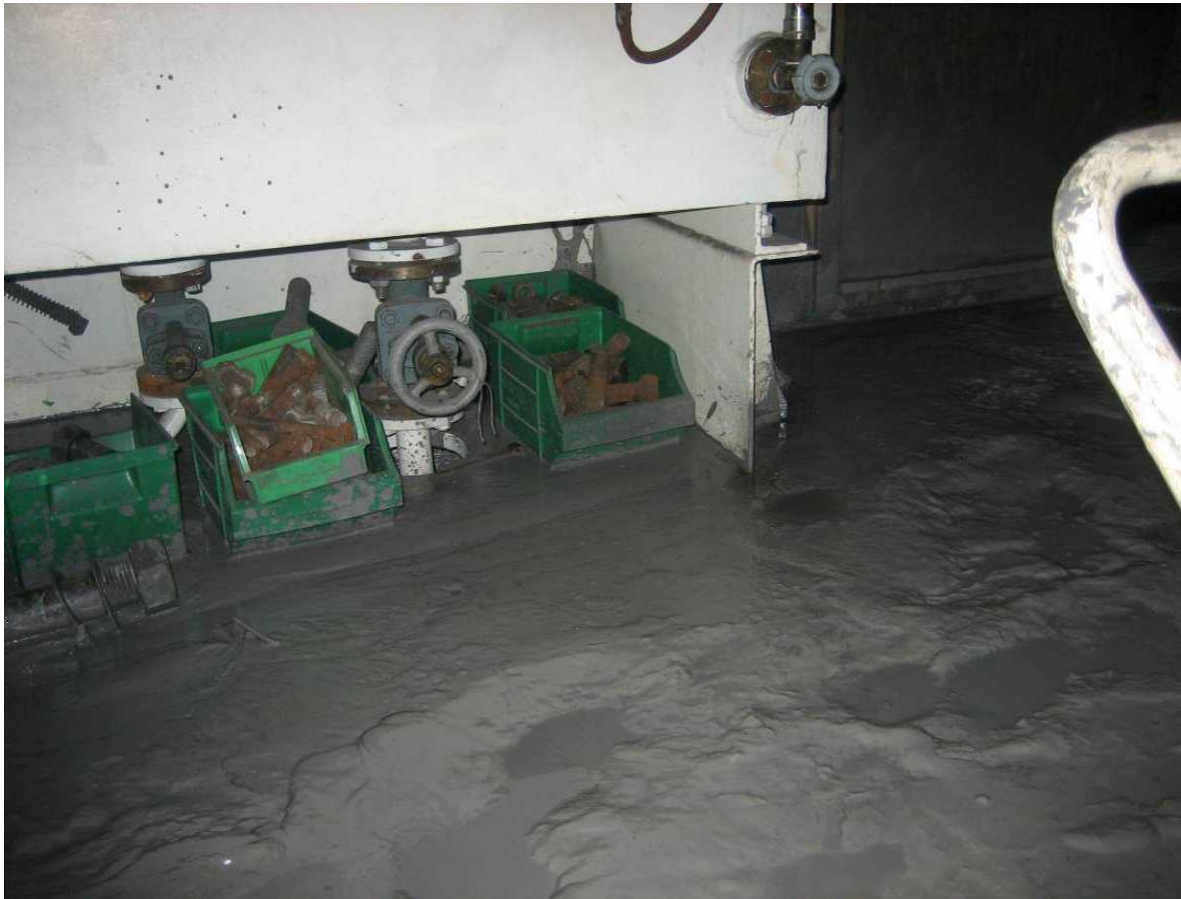
Figure 16 - Slurry on the Access Walkway to the Hot Workshop

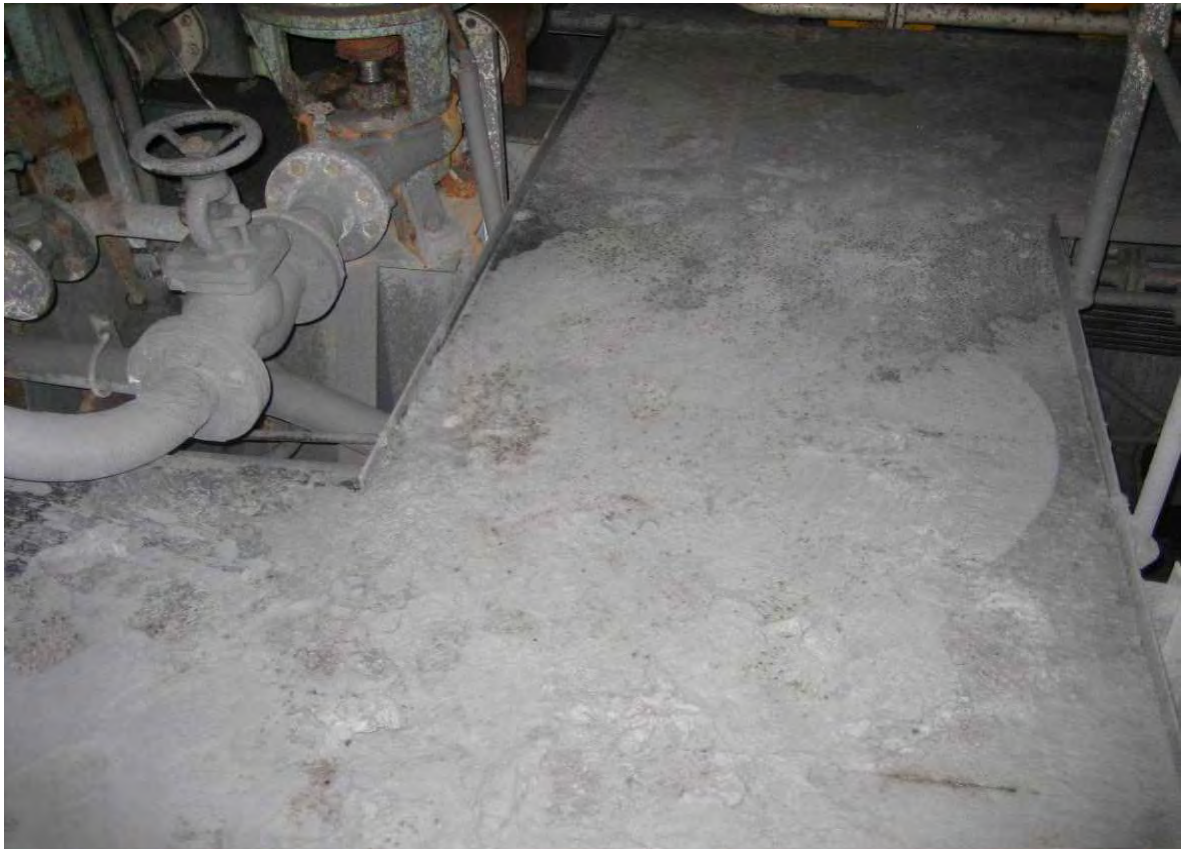
Figure 17 - Slurry on the Access Walkway in the Engine Room

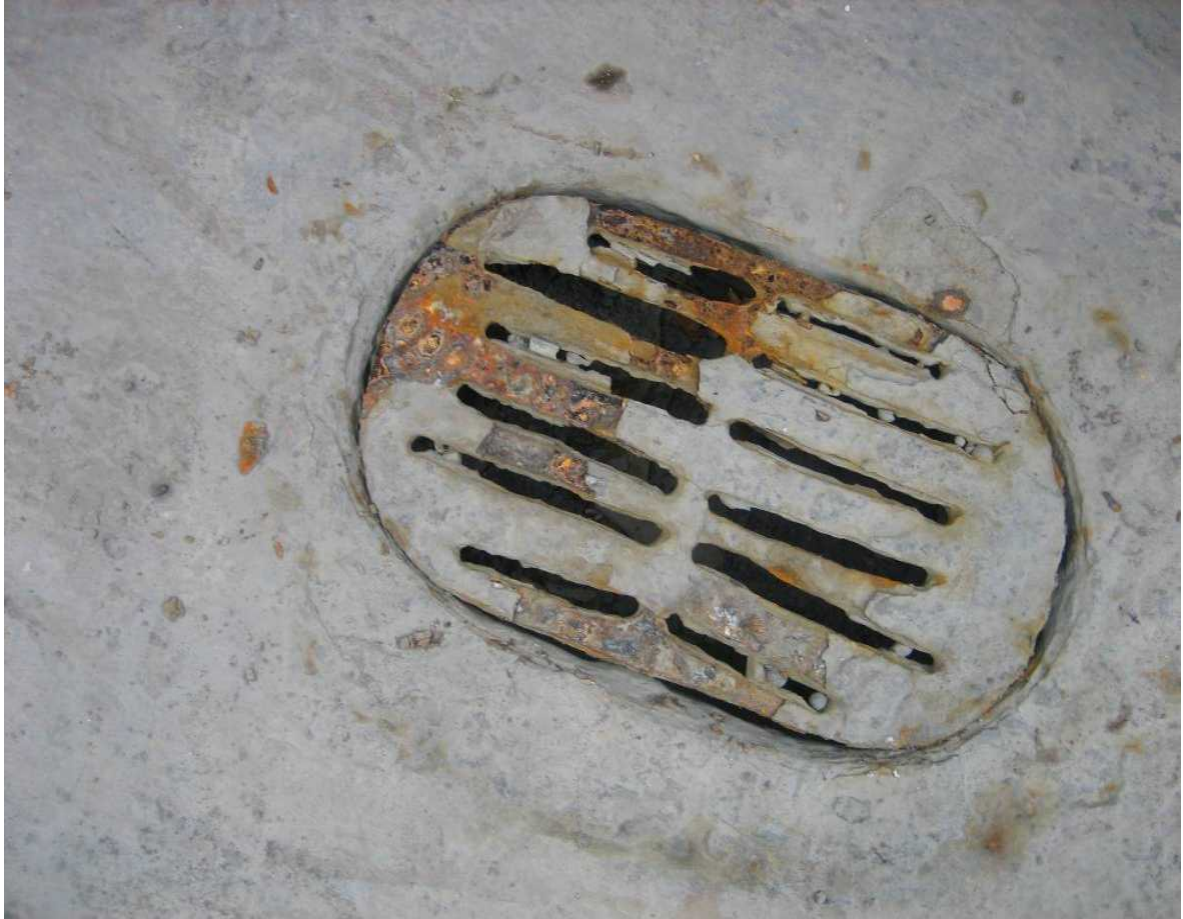
Figure 18 - Blocked Deck Drain - Starboard Deck

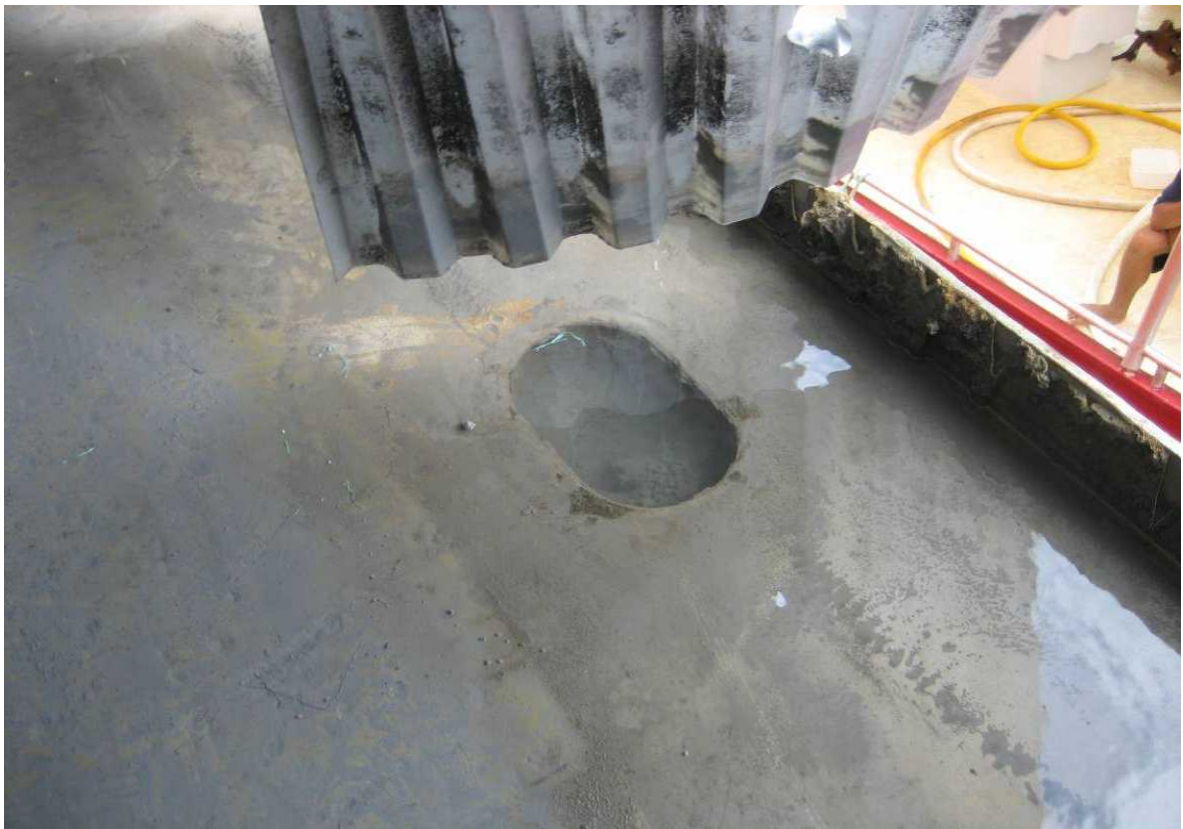
Figure 19 - Blocked Deck Drain - Port Side Deck

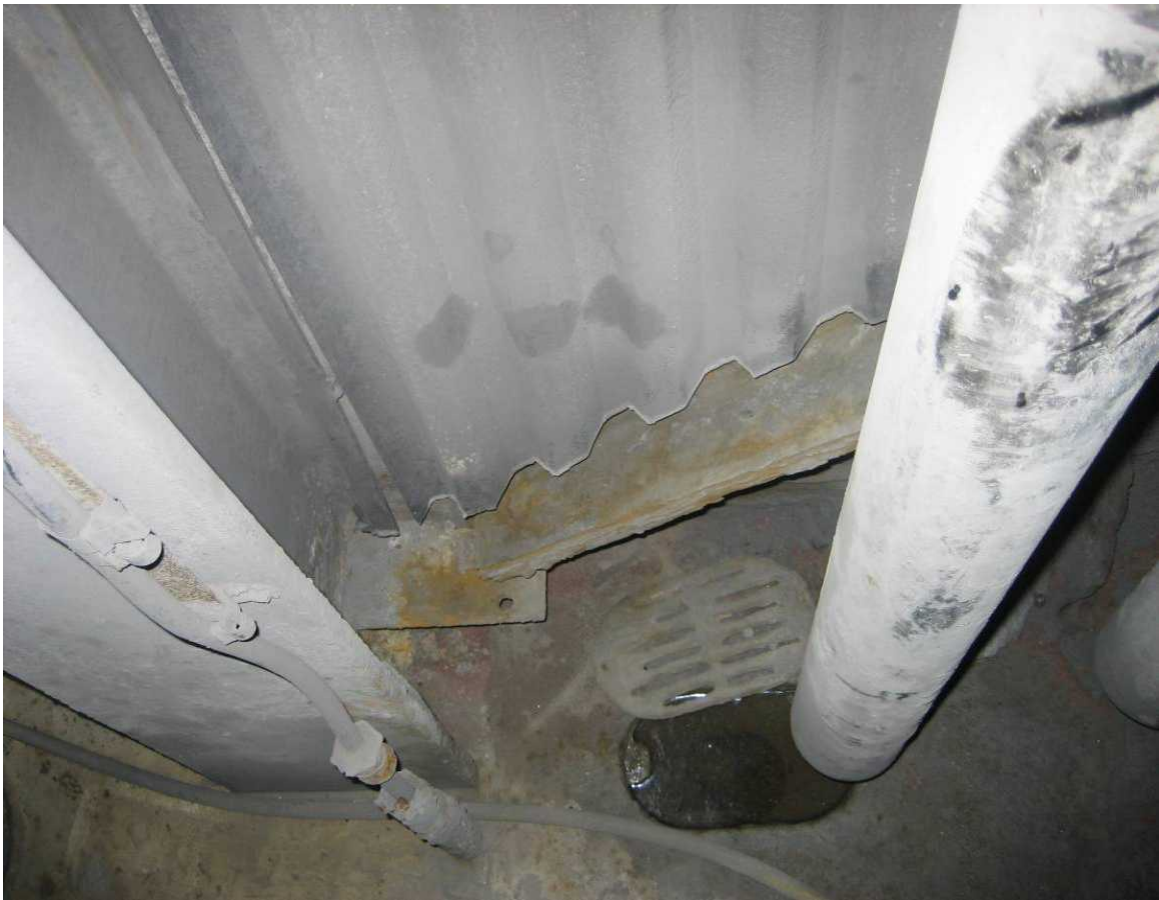
Figure 21 - Blocked Deck Drain - Port Side Deck
