**REPORT OF THE BOARD OF INQUIRY
INTO THE MARINE INCIDENT
INVOLVING THE SHIP *WUNMA* IN THE
WATERS OF THE GULF OF
CARPENTARIA ON 6 AND 7 FEBRUARY
2007**

WUNMA BOARD OF INQUIRY

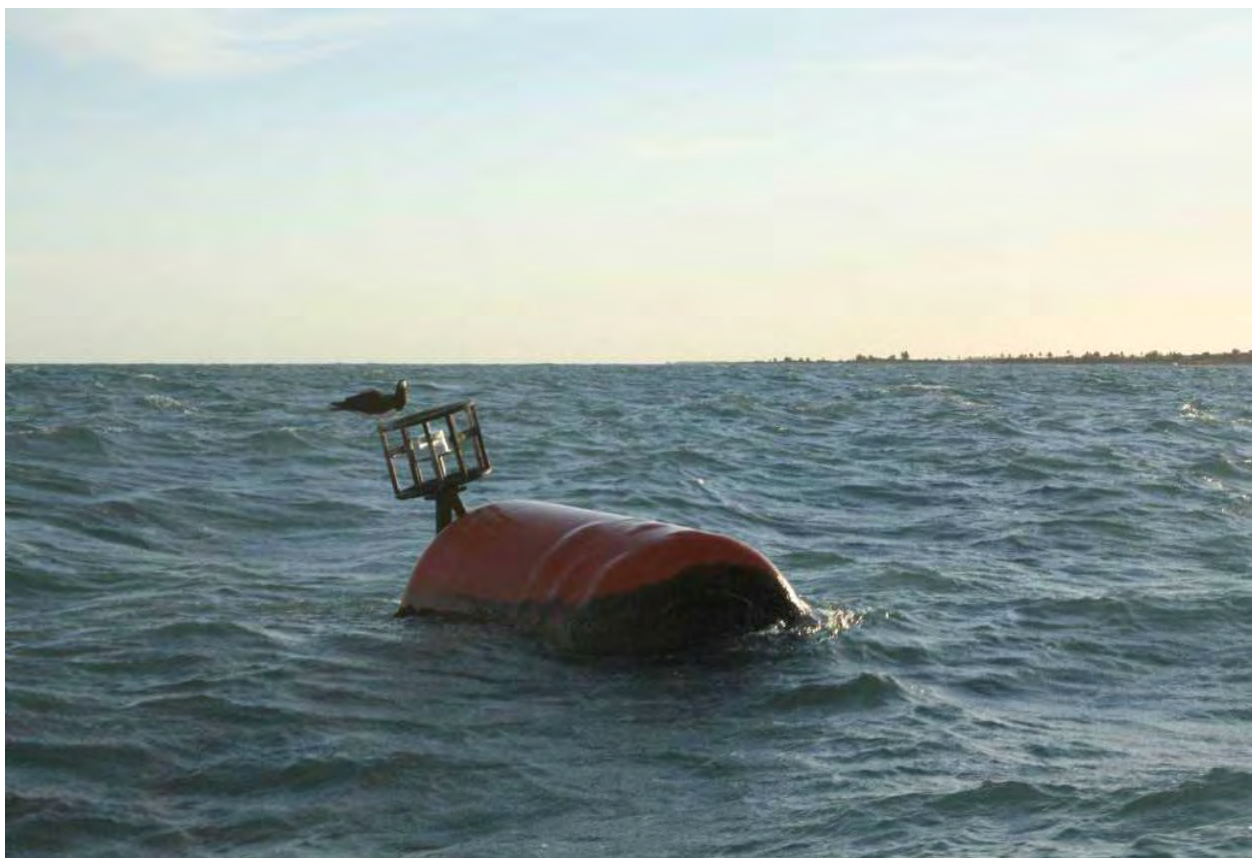
Figure 5 - The Sweers Island Cyclone Mooring

- [10] The existence of the cyclone mooring buoy at Investigator Road, Sweers Island and the risks associated with the ship using it in cyclonic conditions became a matter of ongoing controversy. Representatives of Gulf communities sought its removal. The owners and operators of the ship developed proposals to allow the ship to go into open waters in the event of a cyclone, rather than use the cyclone mooring. These proposals culminated in the upgrading of the ship's registration to Class 2B in September 2005 and the non-renewal in December 2005 of the cyclone buoy mooring authority. By early 2007 the cyclone mooring buoy had effectively been abandoned and it was probably not in an operational state.

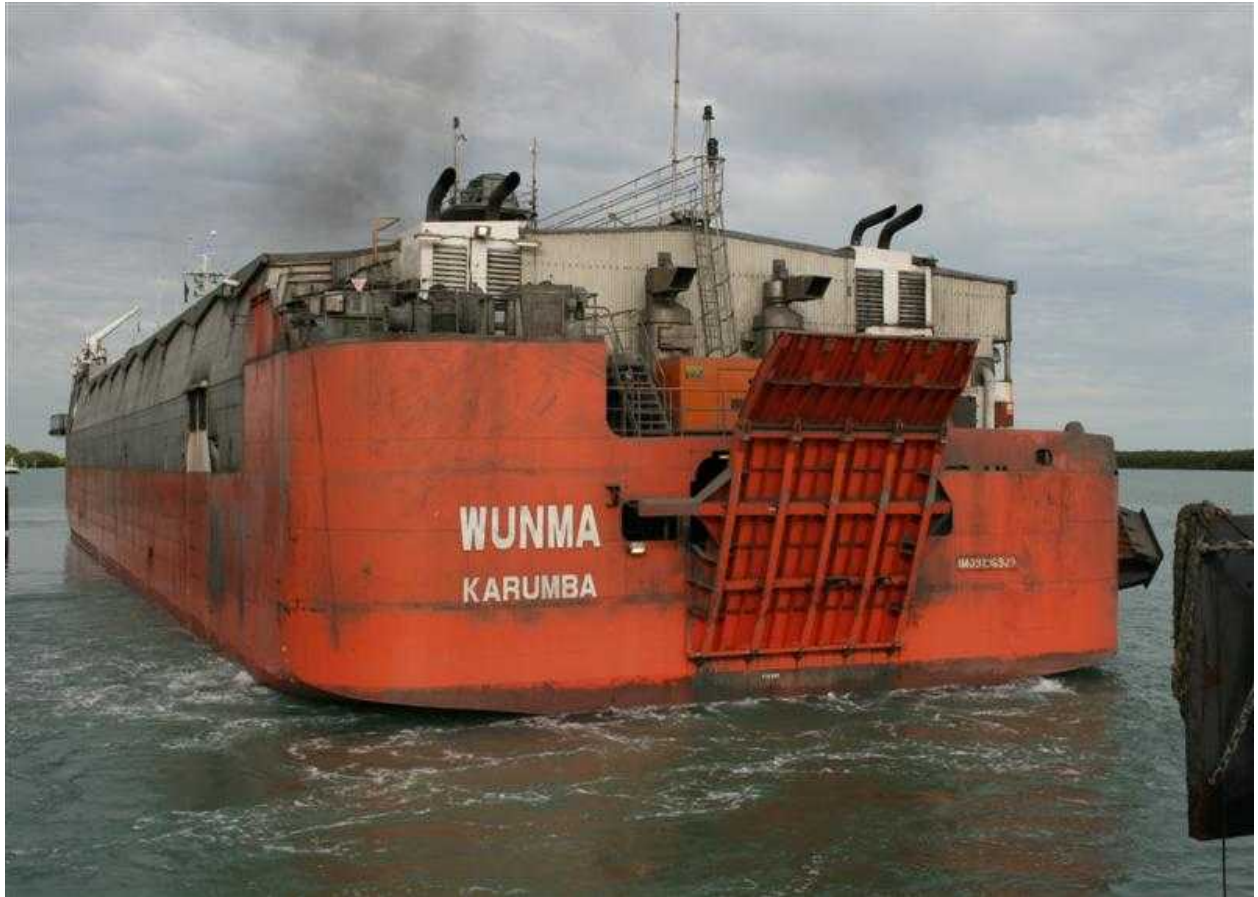
Figure 6 - The Stern

- (19) The entry of seawater over the stern, including through openings on either side of the stern ramp.
 - (20) The entry of seawater through holes in the portside canopy that had been caused by the impact of waves in cyclonic seas on materials that were incapable of withstanding the impact of waves.
