WUNMA BOARD OF INQUIRY

CHAPTER 7 THE OPERATIONAL REVIEW BY THOMPSON CLARKE SHIPPING

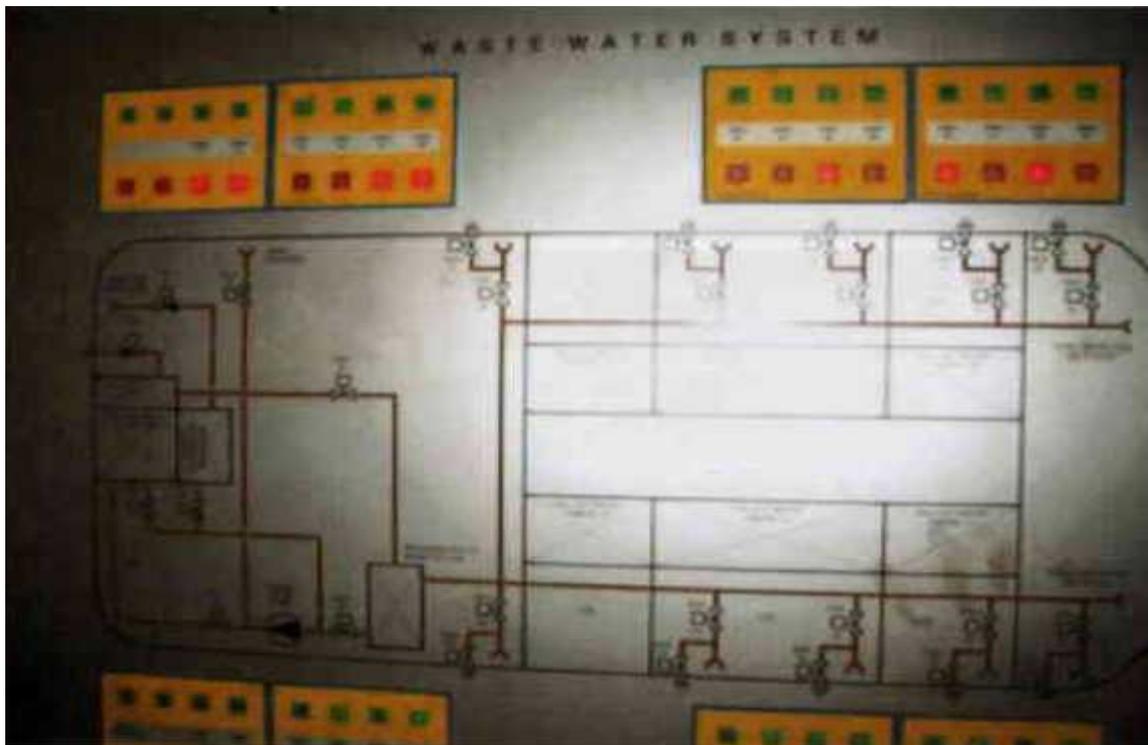
Figure 1 - Mimic Plate Showing Valve Arrangements for the Water Management System

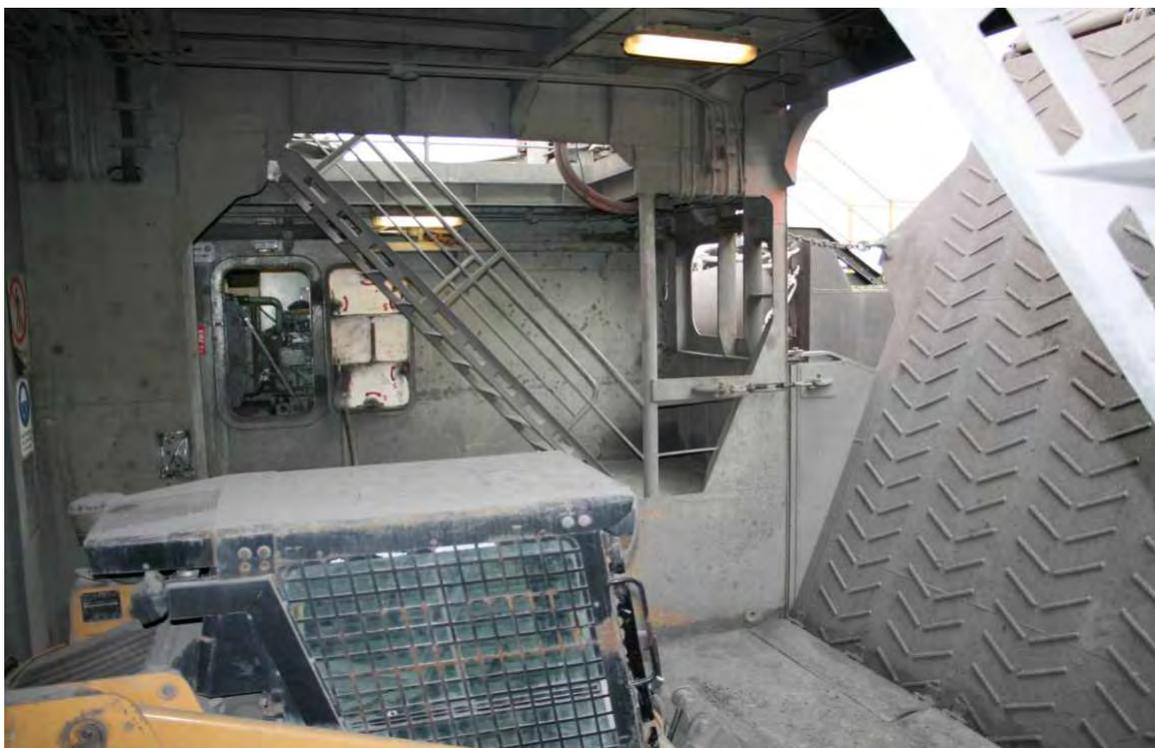
Figure 2 - The Aft Well Deck and Emergency Generator Room

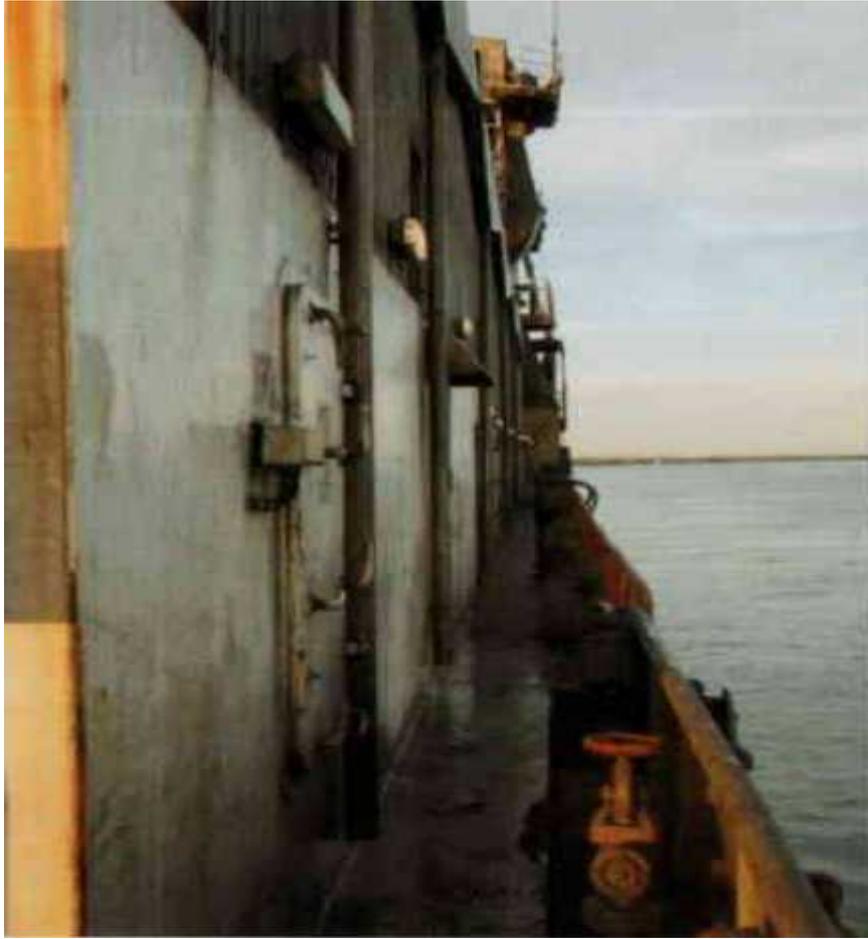
Figure 3 - Starboard Deck and Downpipes

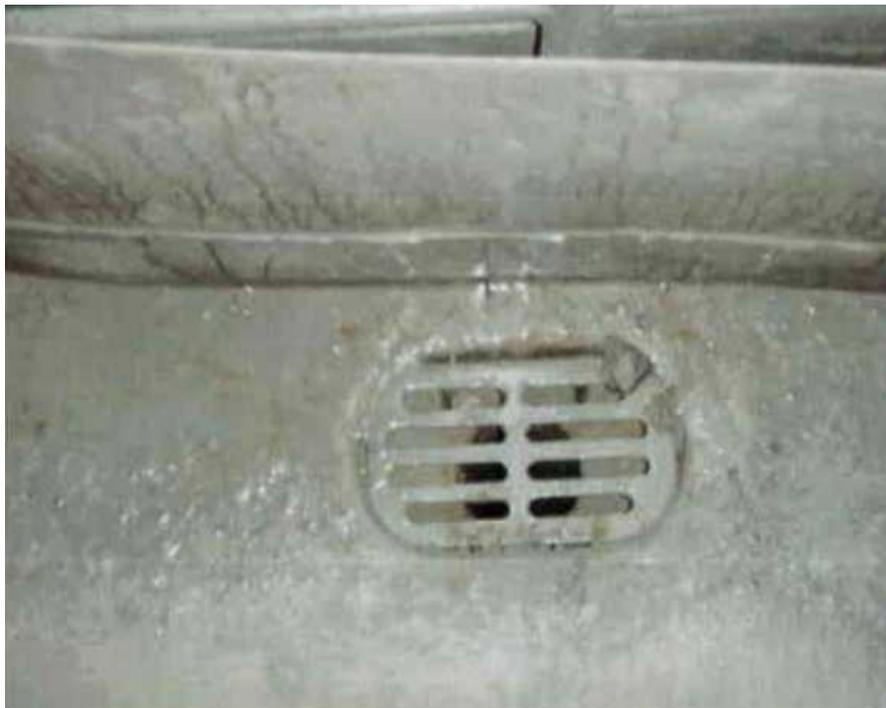
Figure 4 - Deck Drain on Starboard Walkway

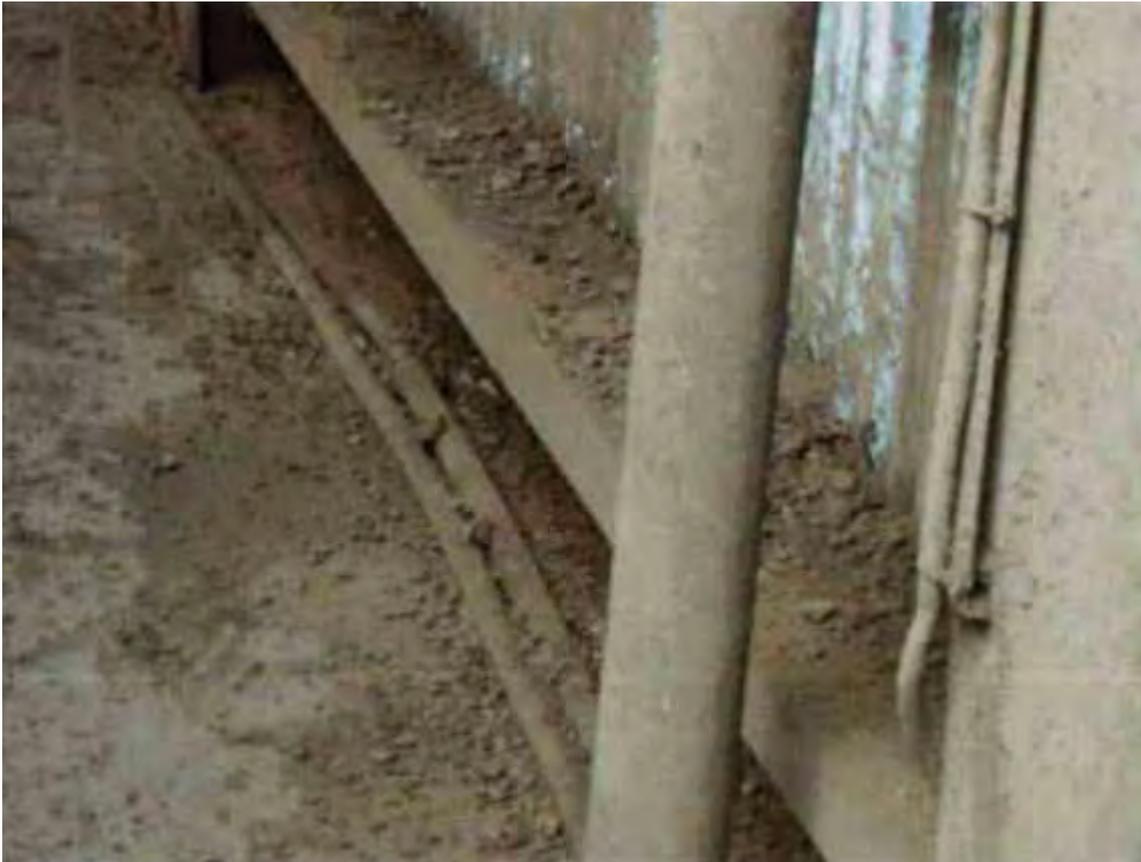
Figure 5 – Downpipe Extending from Roof Gutter on the Port Side Walkway

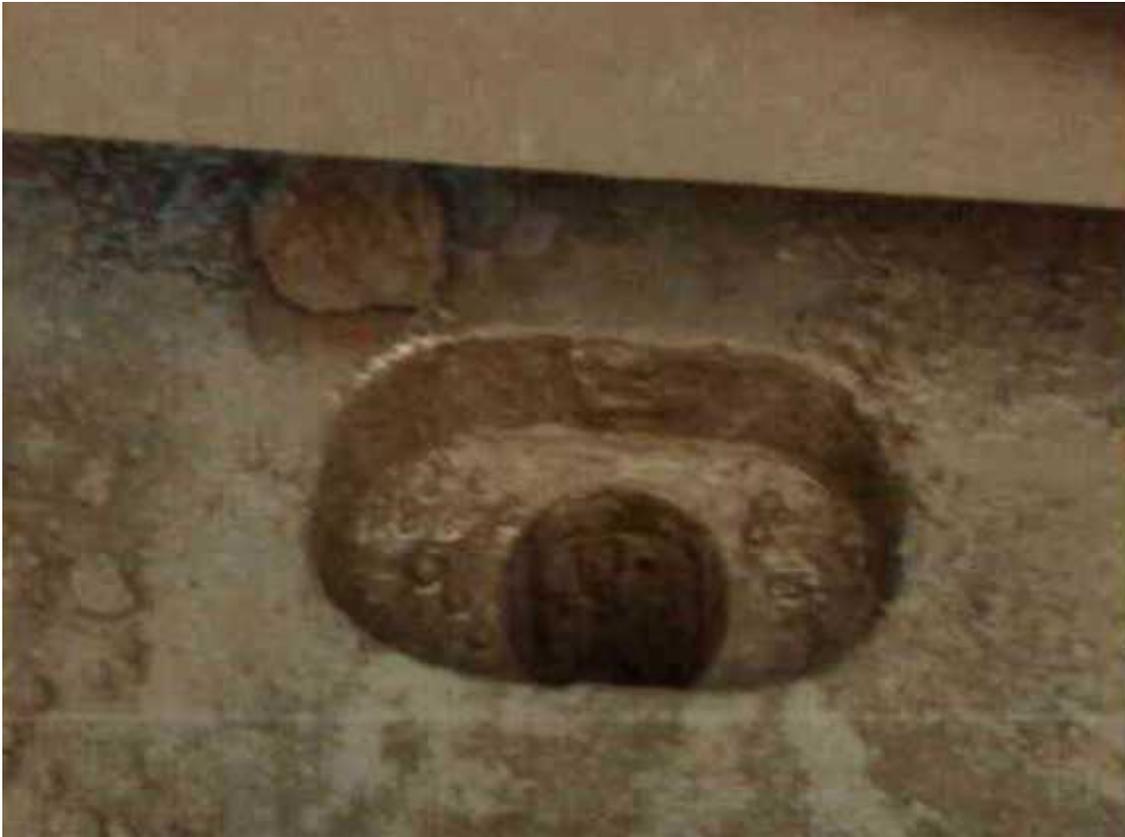
Figure 6 - Deck Drain on the Port Side Walkway

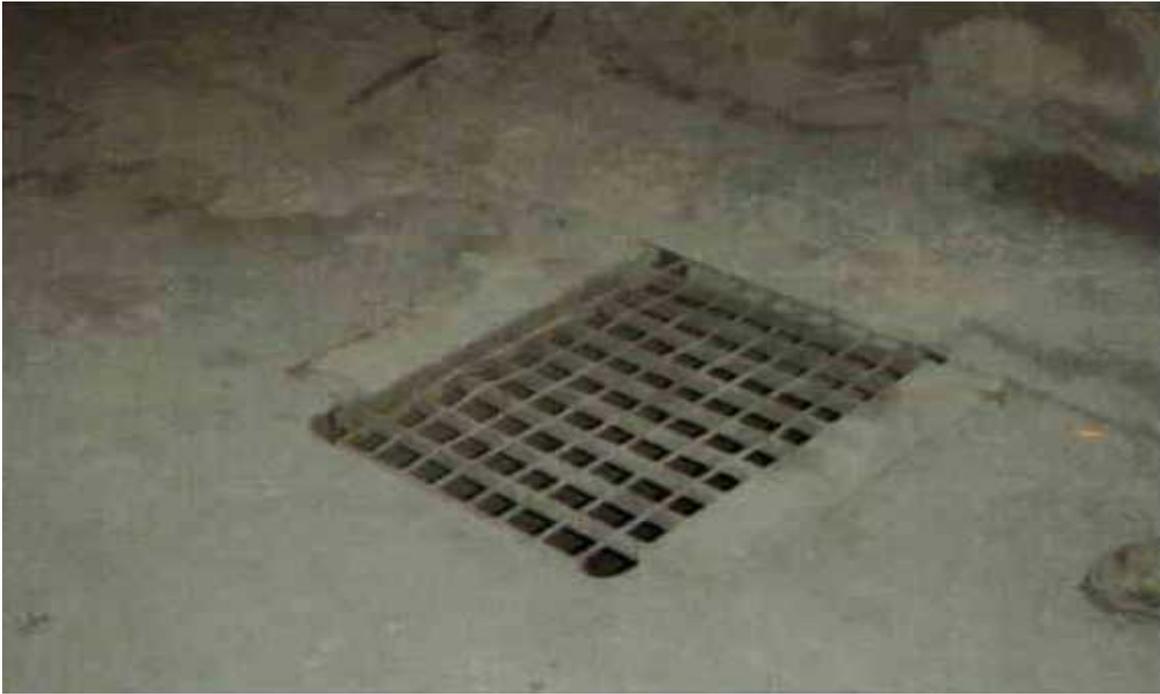
Figure 7 - Aft Well Deck Sump

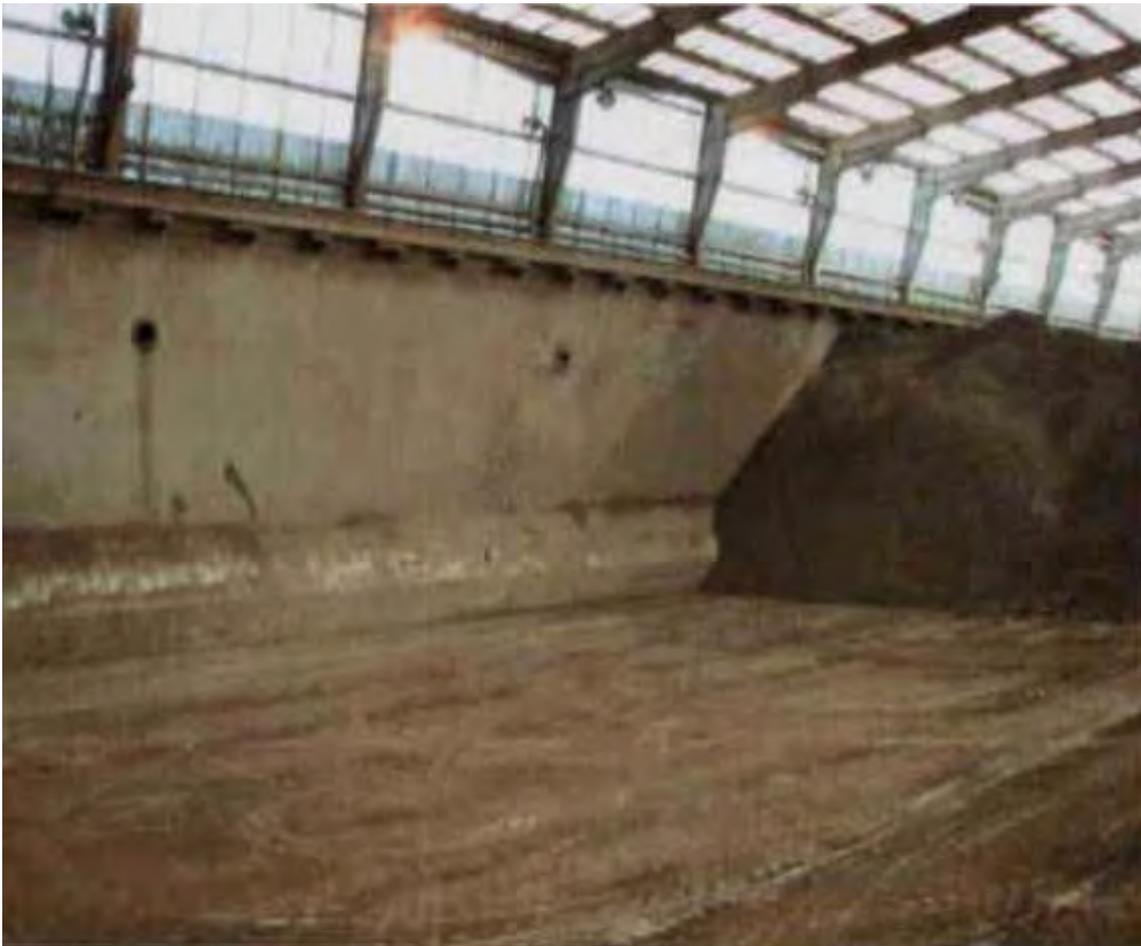
Figure 8 - Washdown Outlets from under the Conveyor

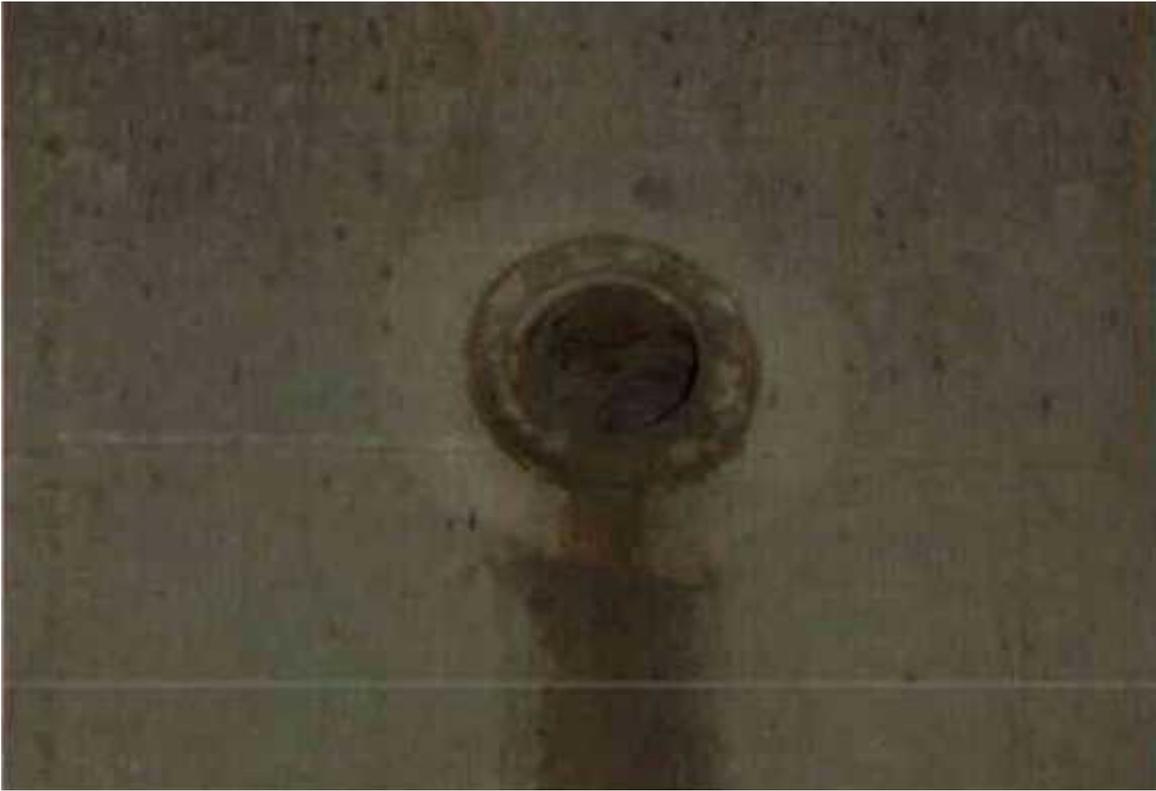
Figure 9 – Blocked Washdown Ports under the Conveyor

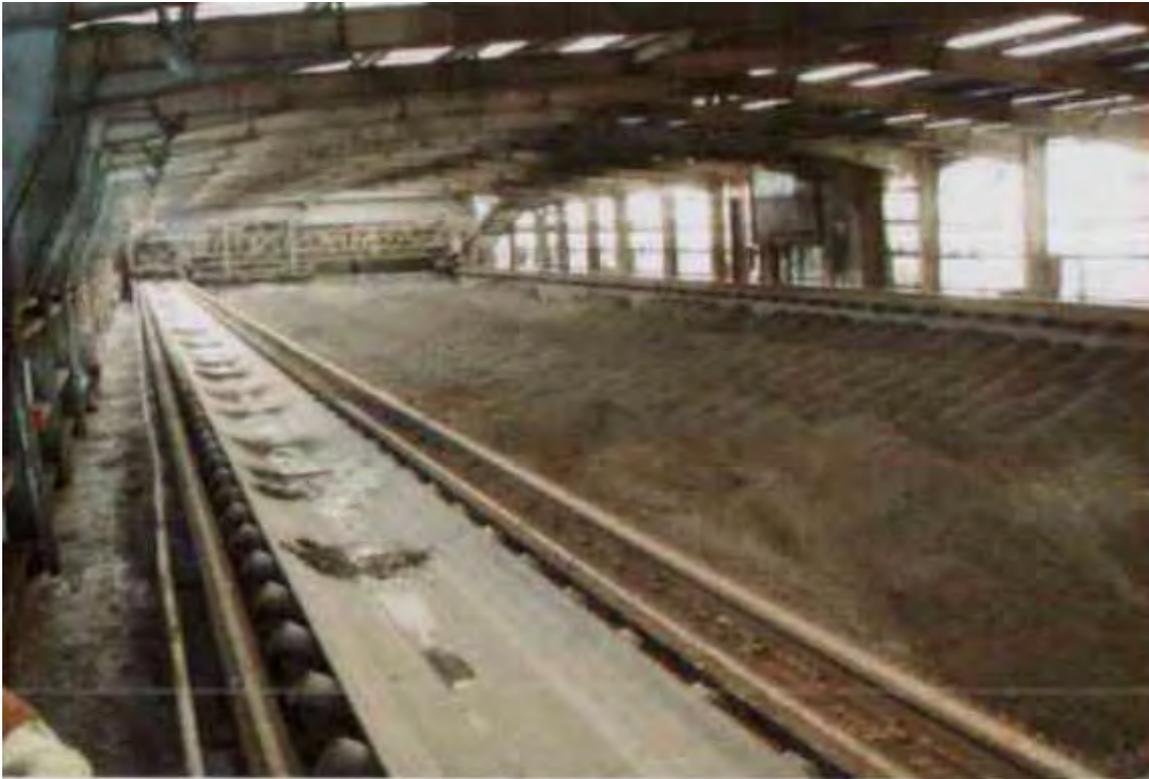
Figure 10 - Conveyor Port Side Walkway Showing Concentrate Deposits on Port Deck

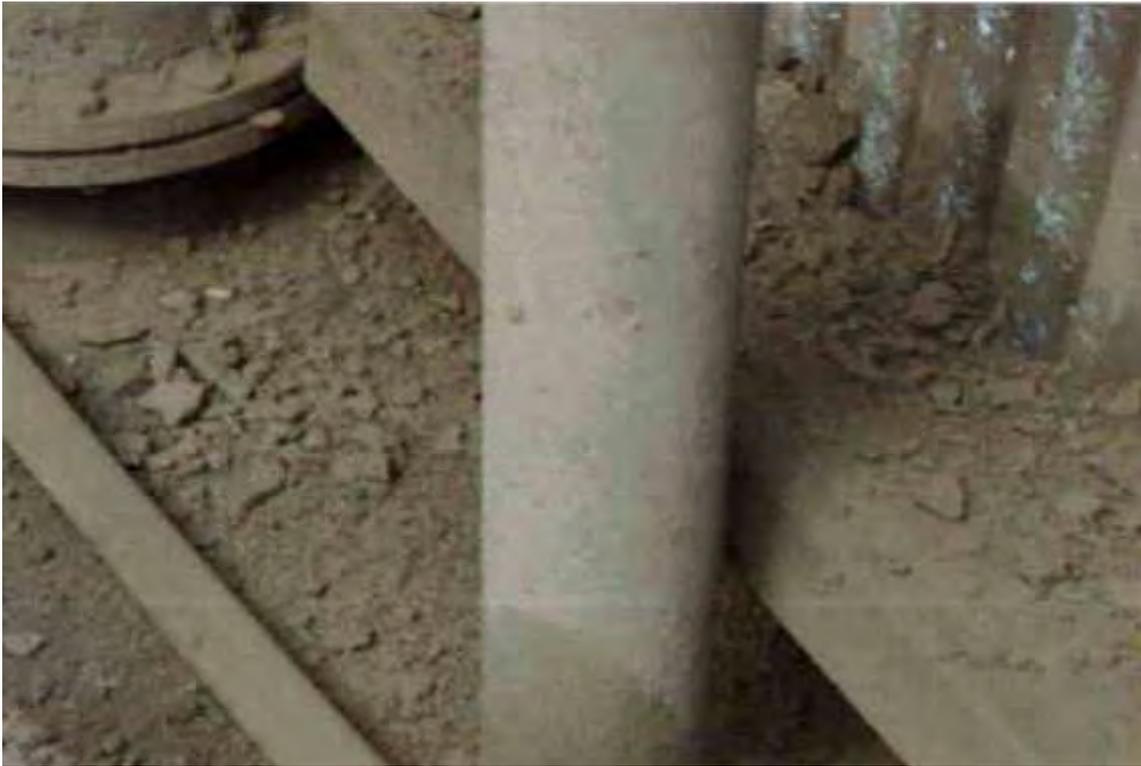
Figure 11 - Accumulated Concentrate on the Port Side Walkway

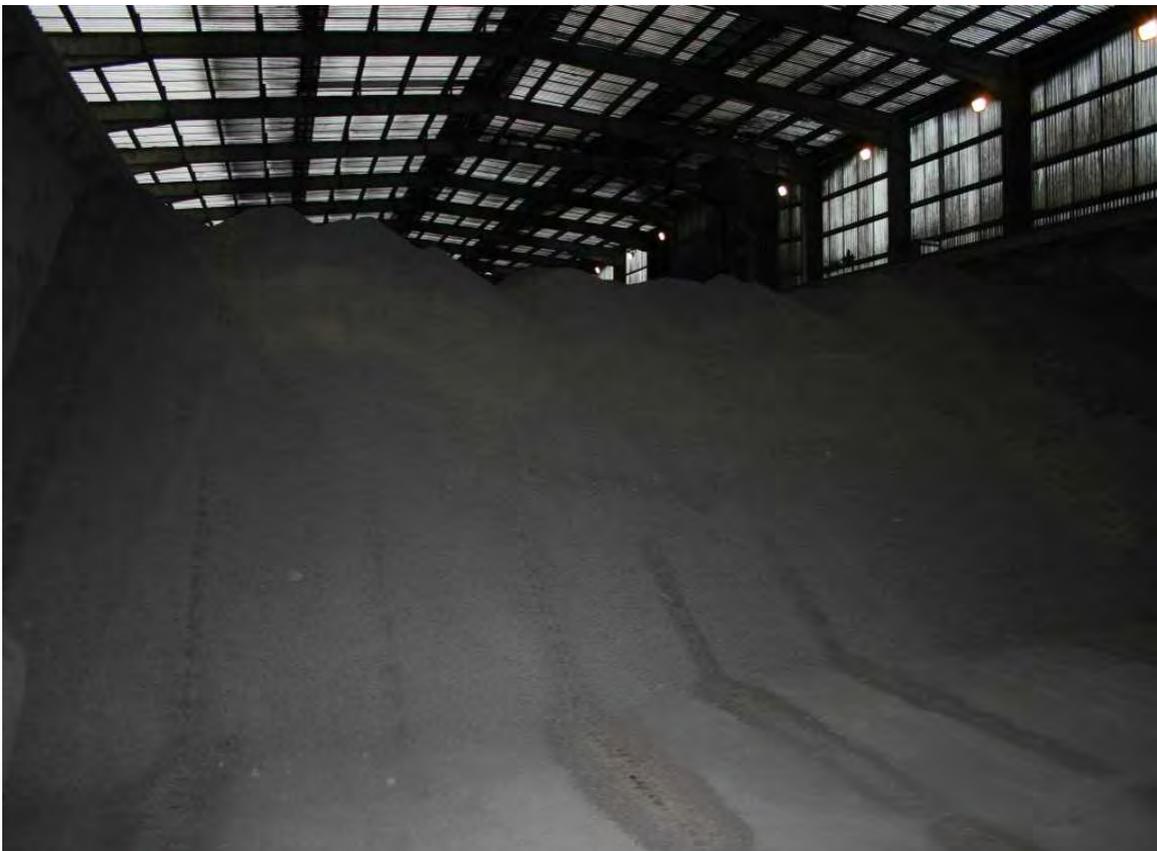
Figure 12 - Concentrate in the Cargo Hold in Typical Inclination

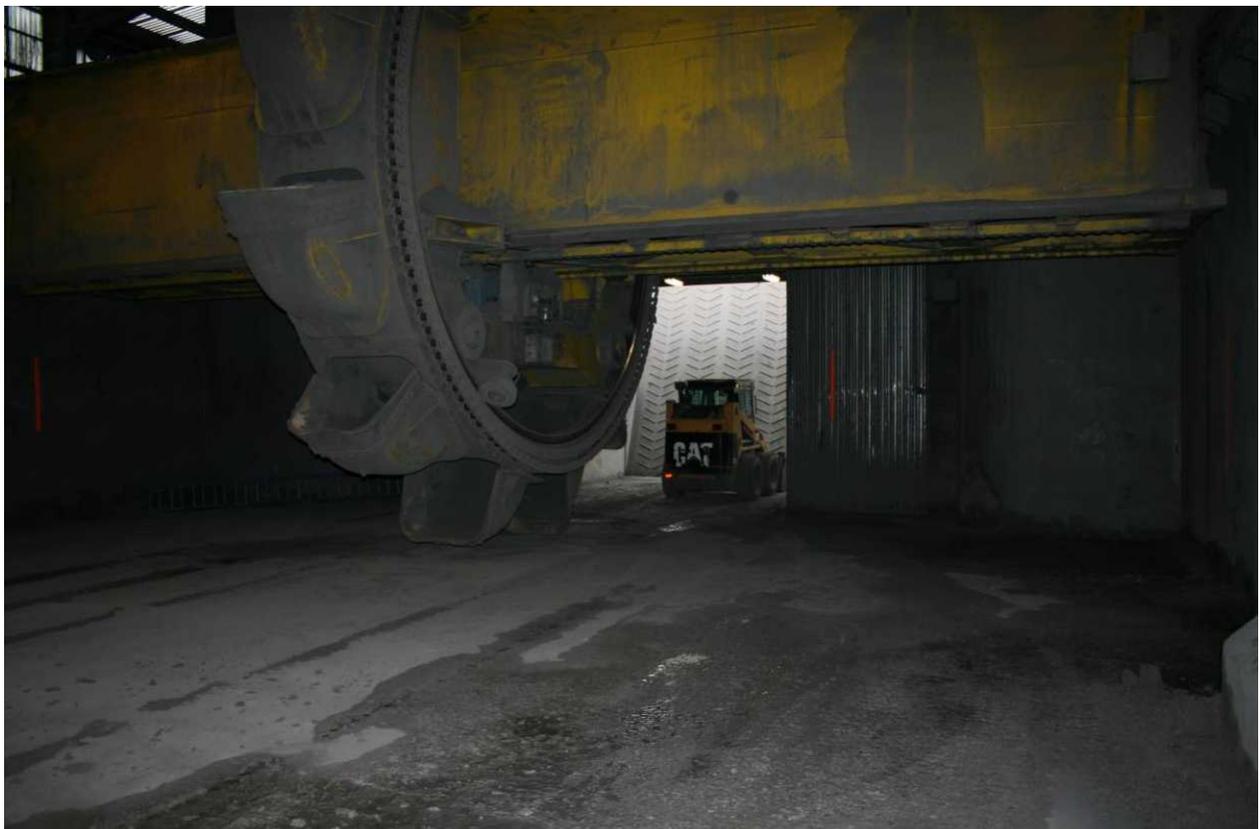
Figure 2 - View from the Cargo Hold to the Aft Well Deck

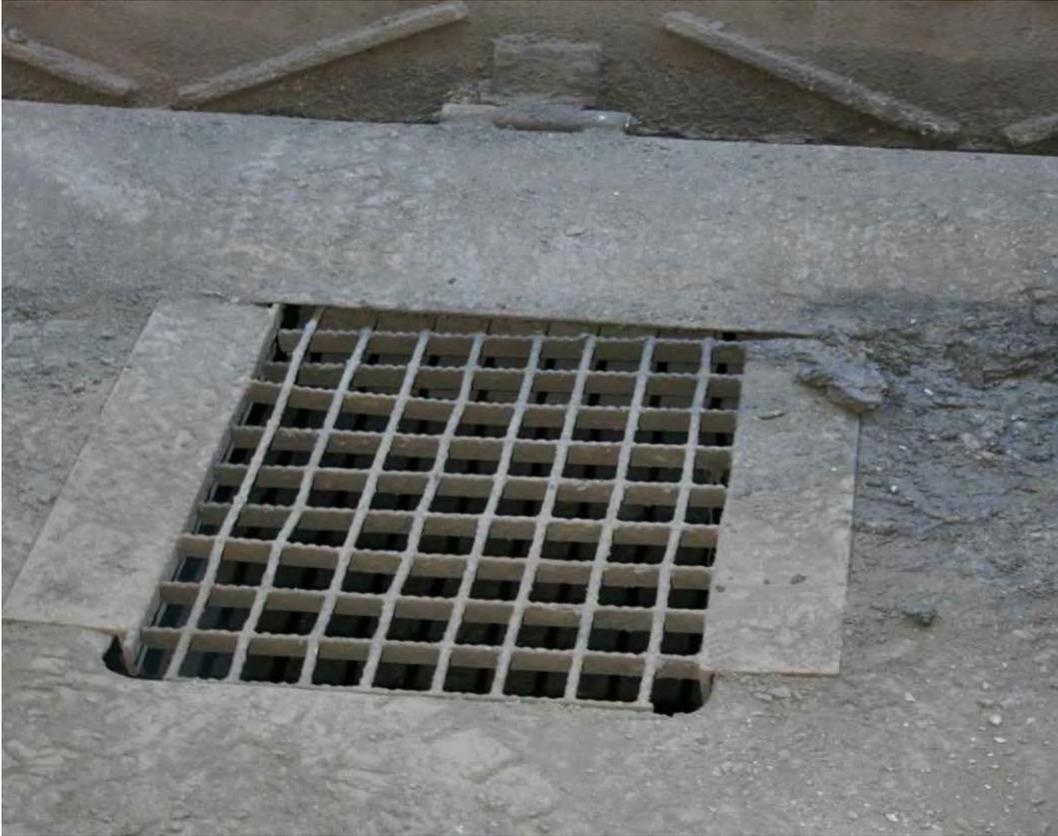
Figure 5 - The Aft Well Deck Sump

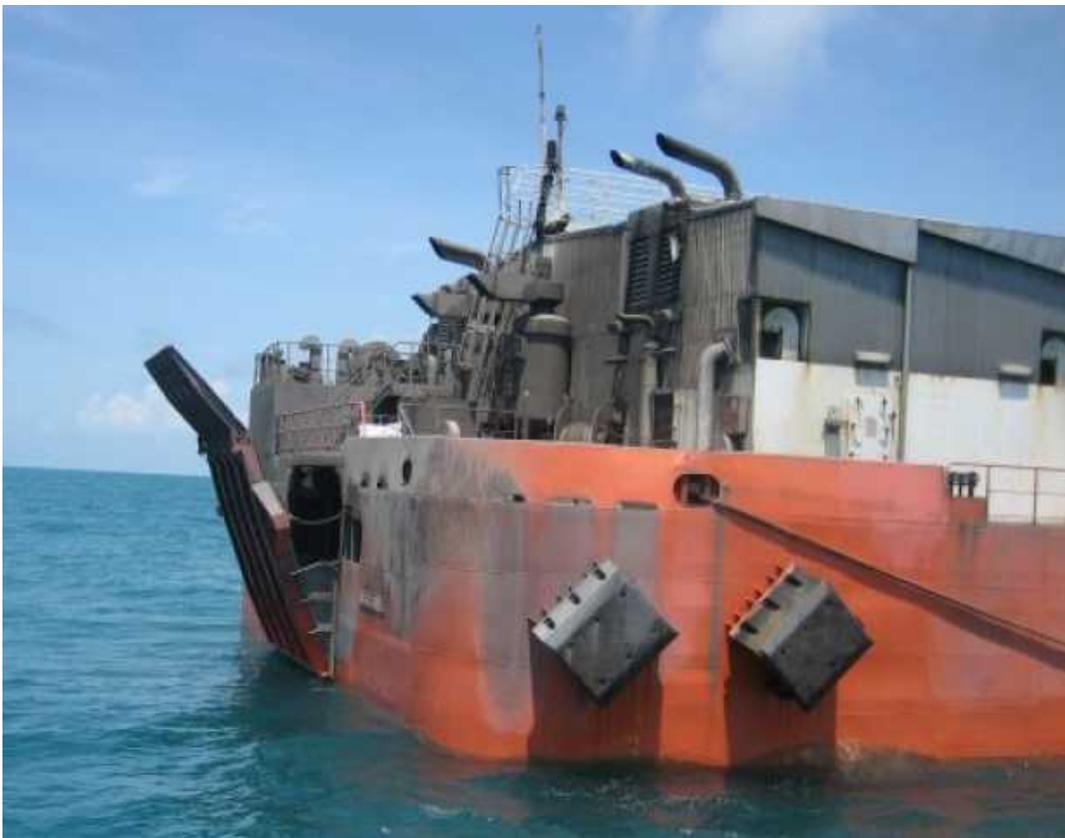
Figure 6 - The Stern Ramp

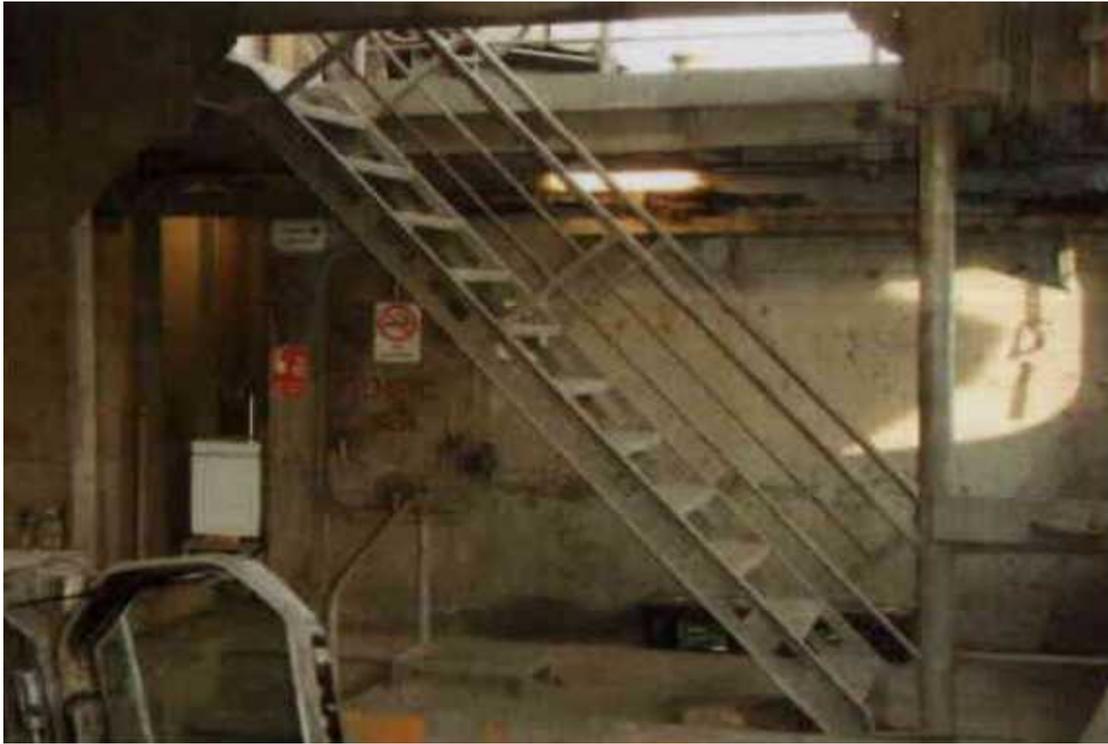
Figure 7- The Emergency Generator Room

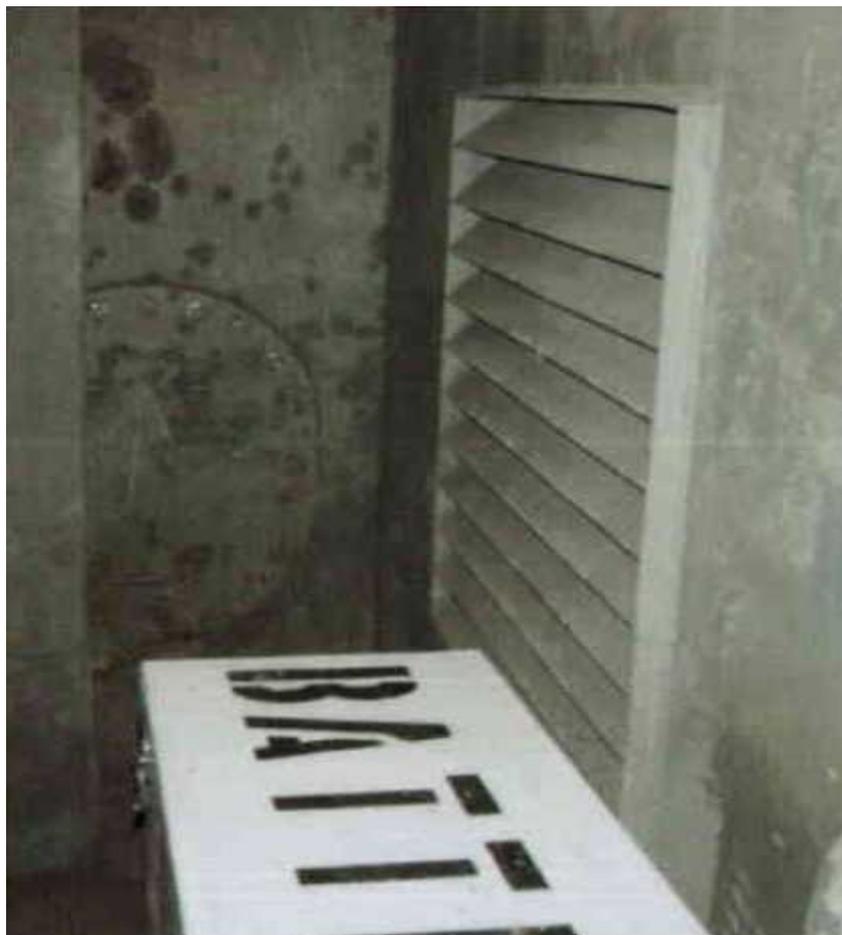
Figure 8 - Radiator Vent - Emergency Generator Room

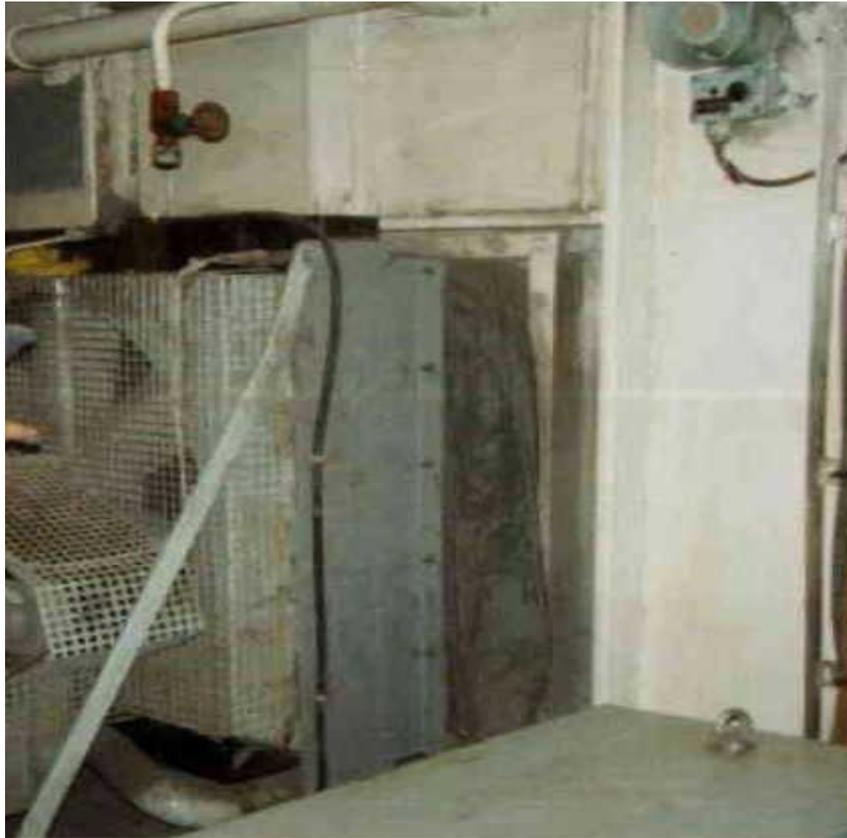
Figure 9 - Emergency Generator Radiator adjacent to Vent

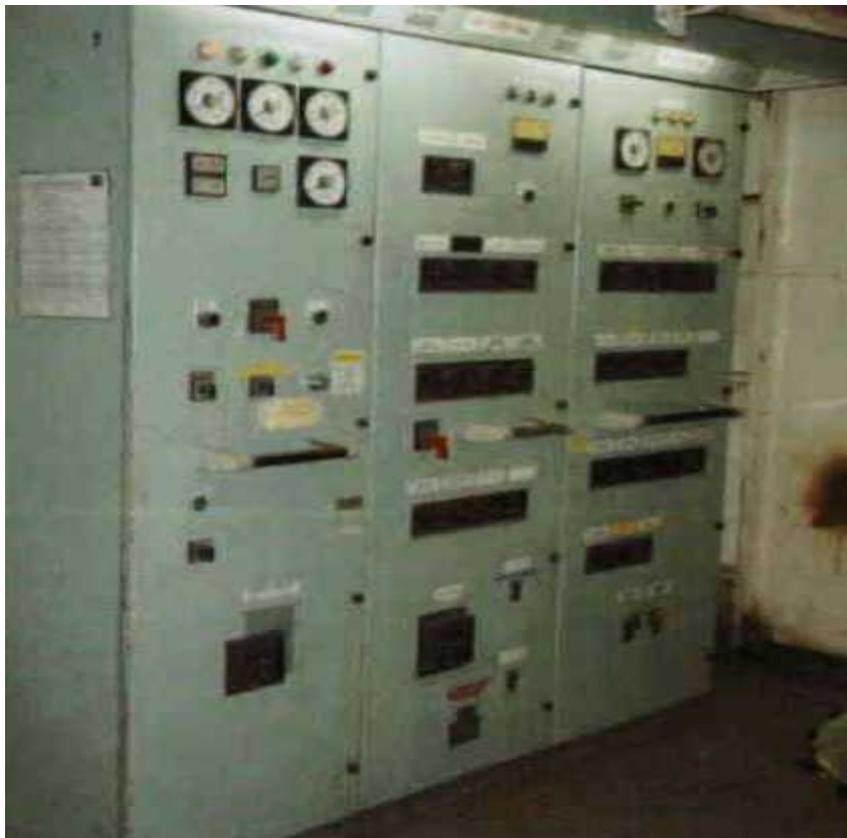
“However, the blackout was caused by having the switchboard in the EGR, if this was placed in another (higher) location the incident may not have happened.”²⁷

Figure 10 - Emergency Generator Switchboard
