## WUNMA BOARD OF INQUIRY

### **CHAPTER 10 TROPICAL CYCLONE NELSON AND THE WUNMA**

## CHAPTER 11 THE COURSE OF EVENTS

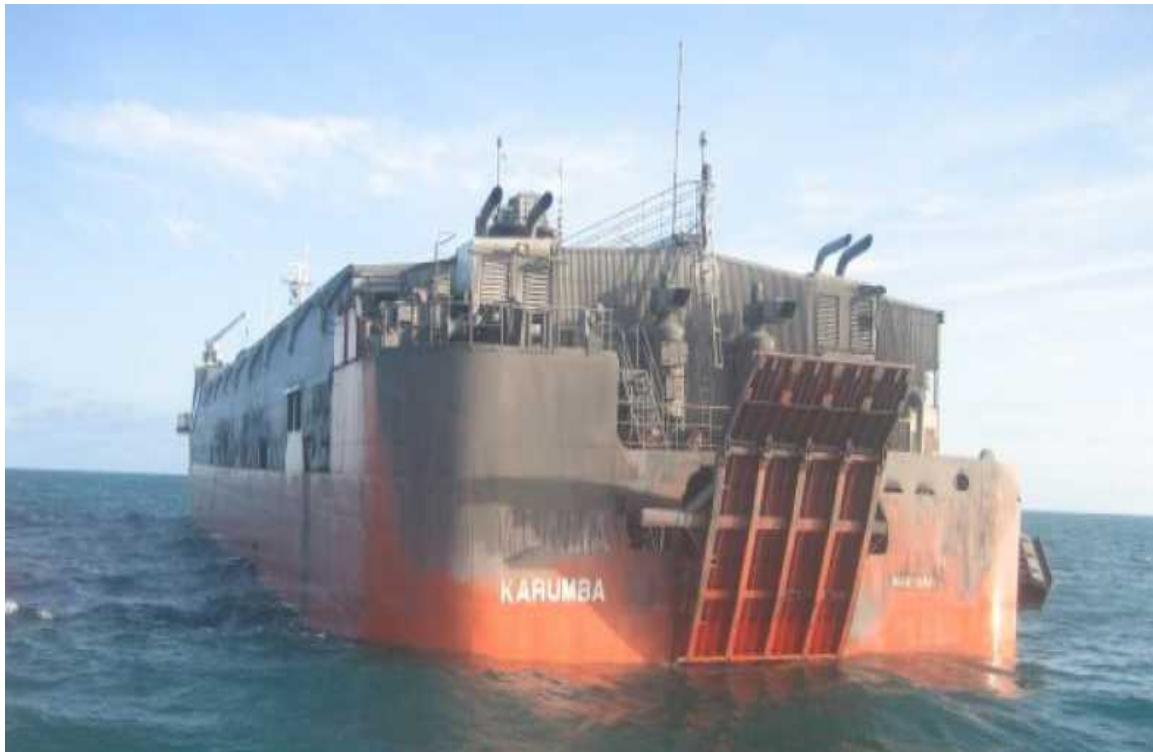
**Figure 3 - The Wunma - Waterline at the Base of the Stern Door**

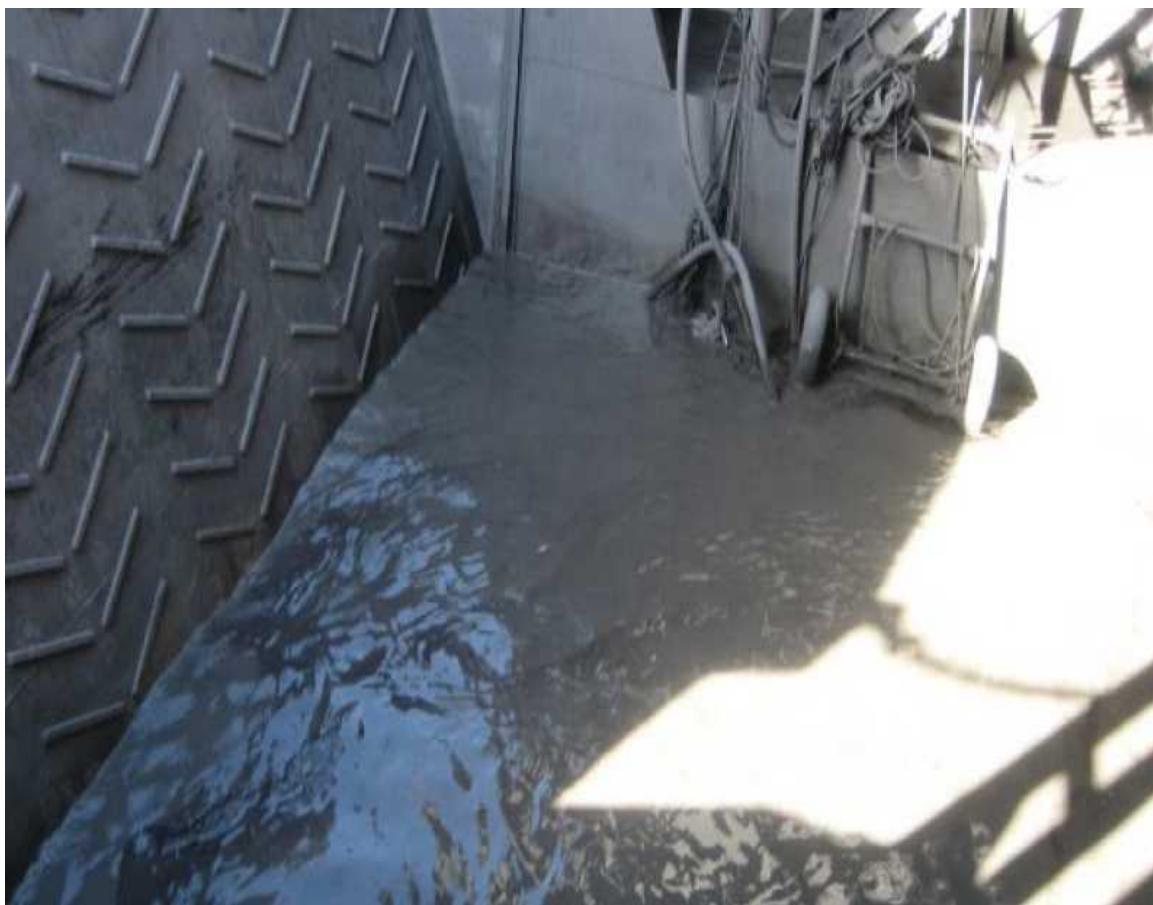
sump drain, but it was blocked.<sup>57</sup> The First Engineer, Mr Leeson, tried to clear it with a steel cable without success.<sup>58</sup> Two pumps were set up in the well deck but one failed and the other lacked suction. In the meantime, the water level in the well deck continued to rise and was estimated to be about half a metre by 1300 hours.

**Figure 4 - Water in the Aft Well Deck**

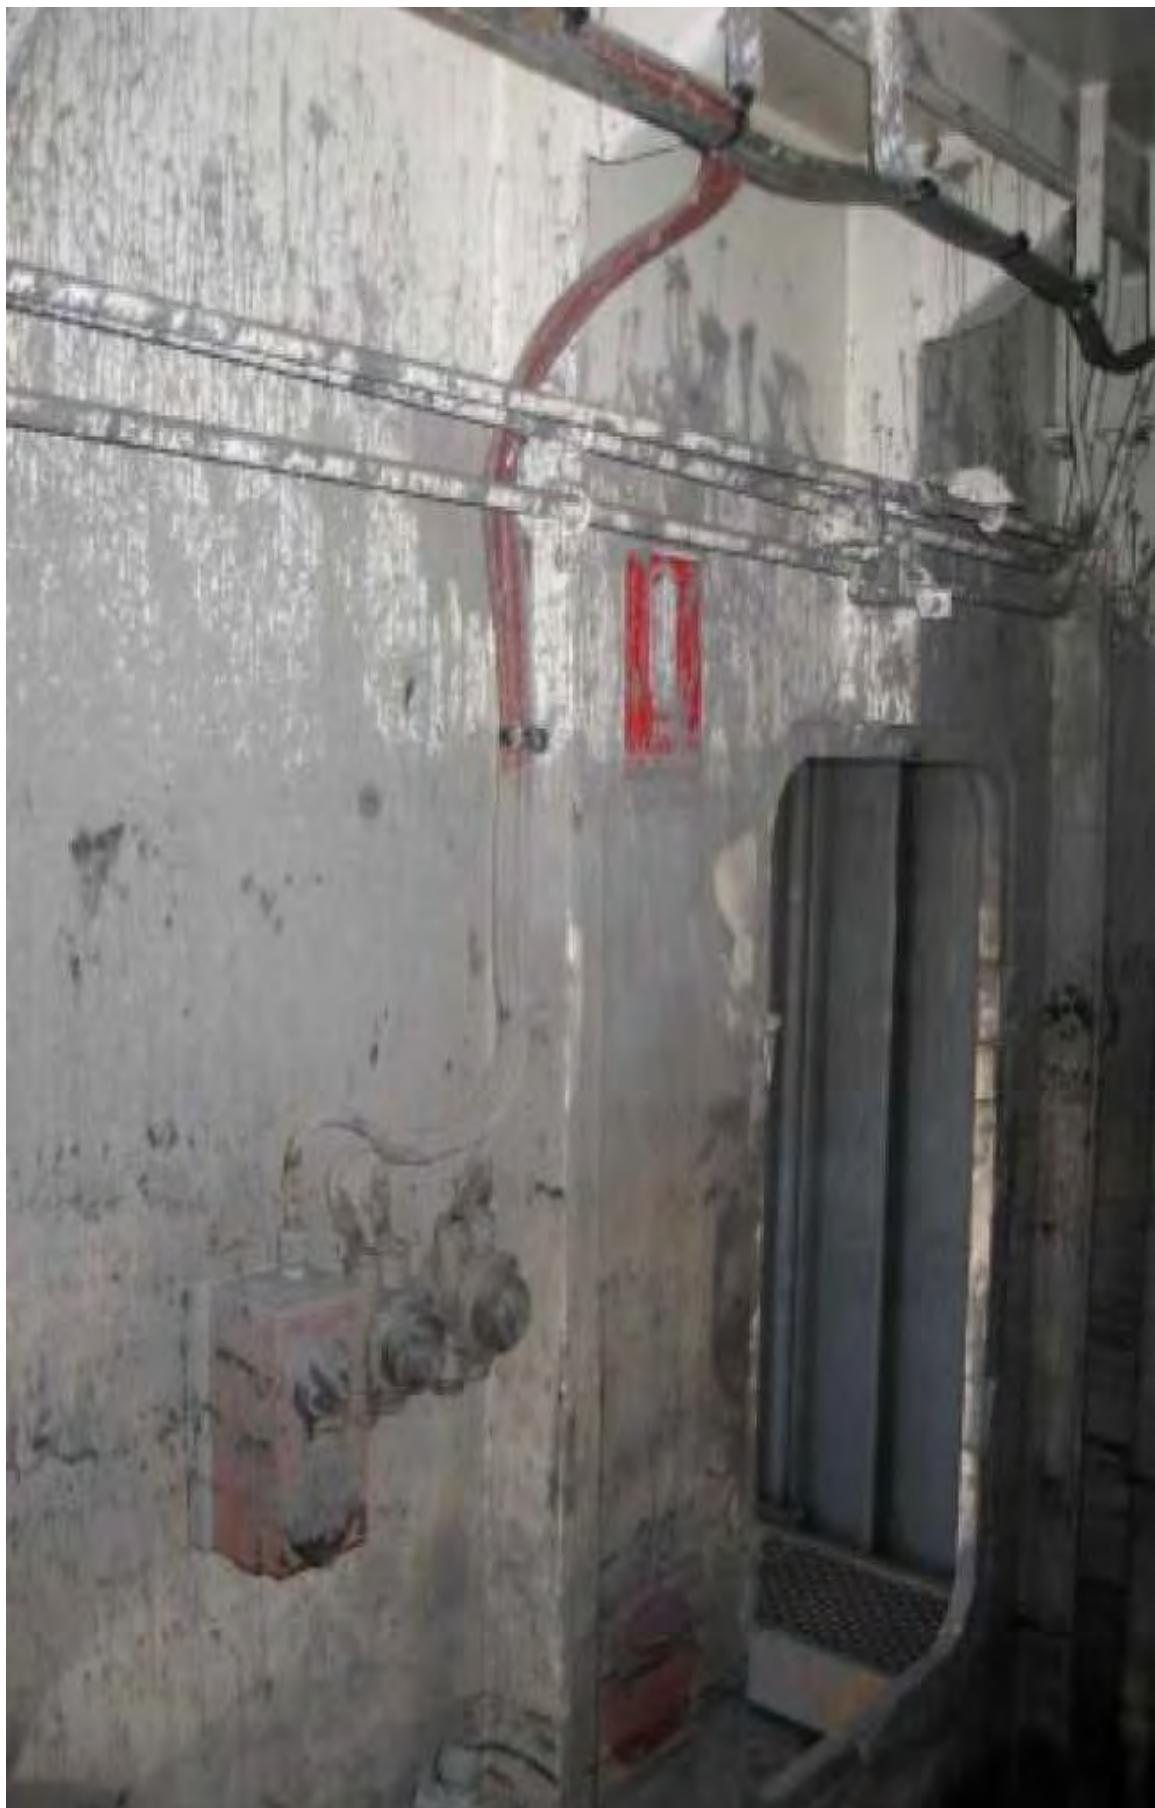
**Figure 5 - The Hot Workshop Depicting Slurry Marks**

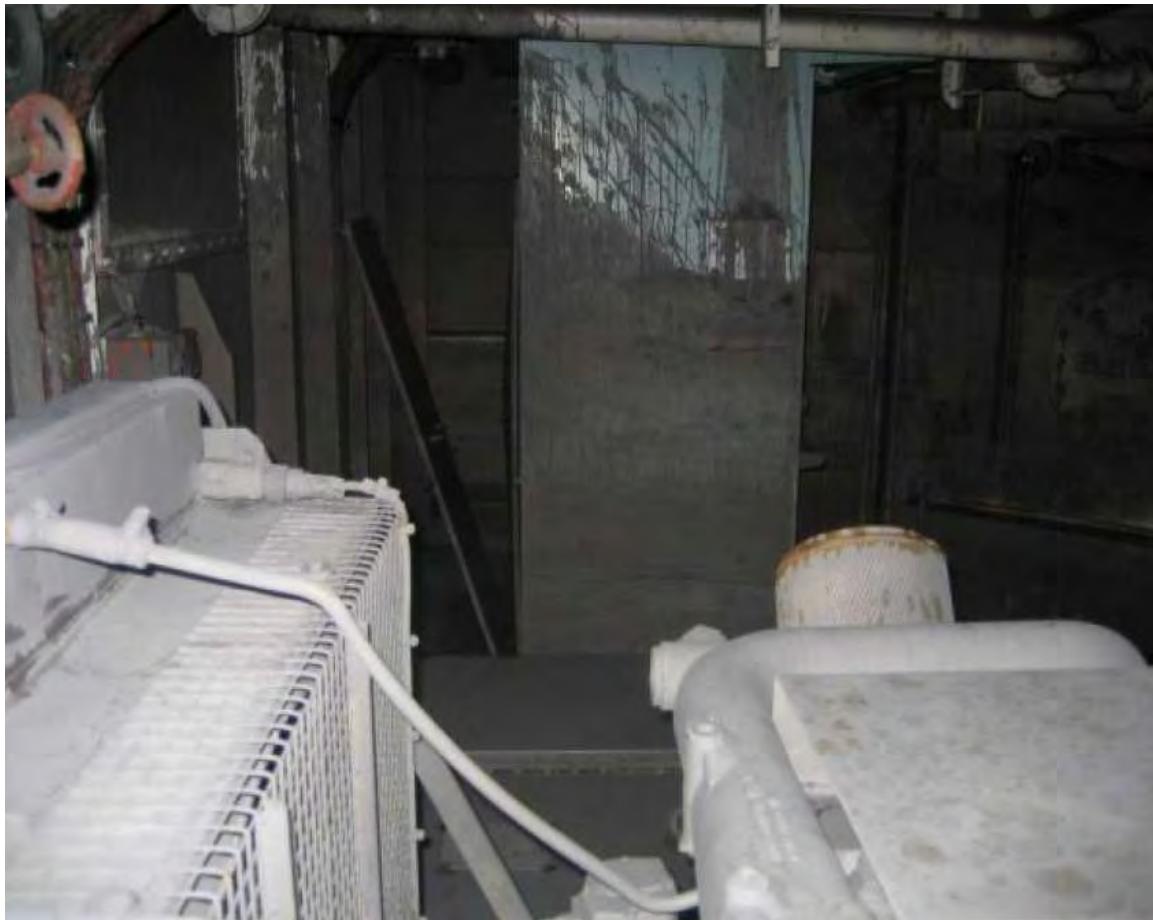
communication systems that were not backed up by battery. This was caused by the ingress of water into the emergency generator room and the arrangement and location of switchboards.

**Figure 6 - Inside the Emergency Generator Room**

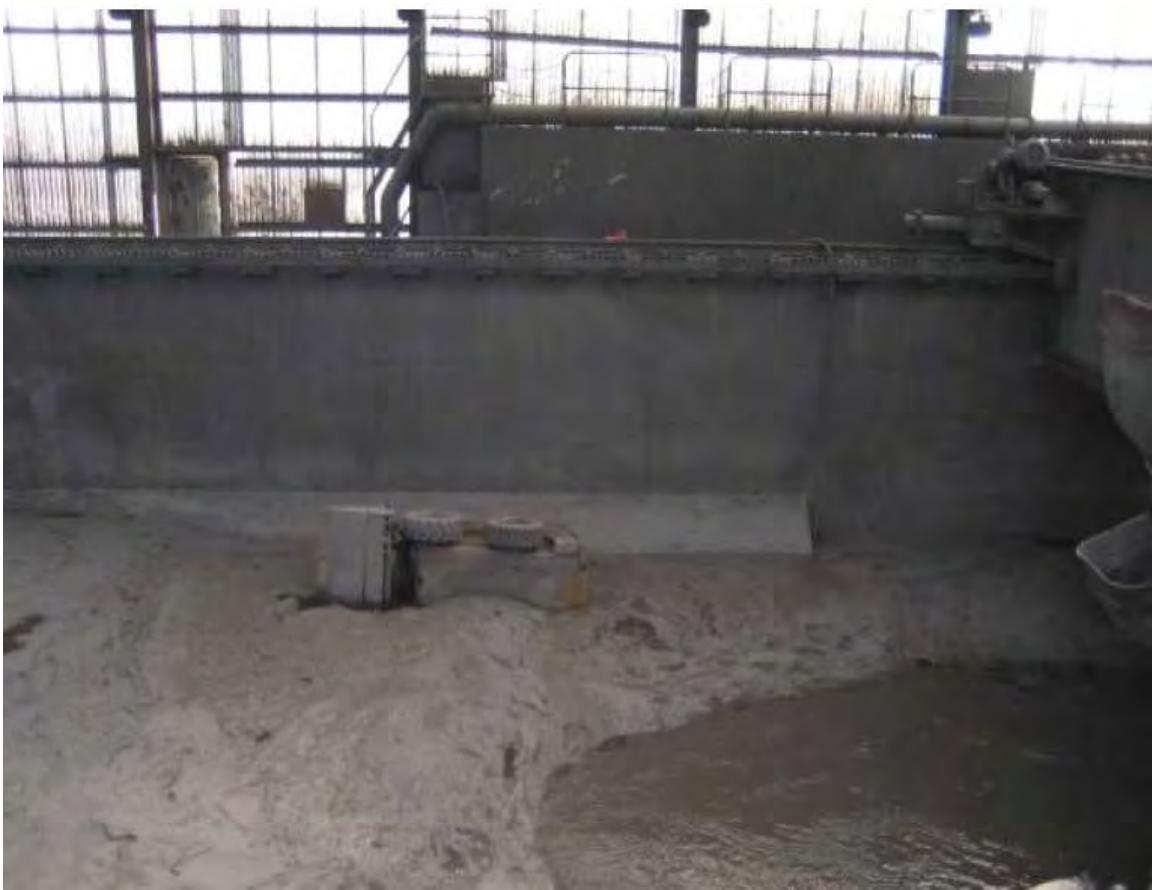
**Figure 9 - Bobcat Overturned in the Cargo Hold**

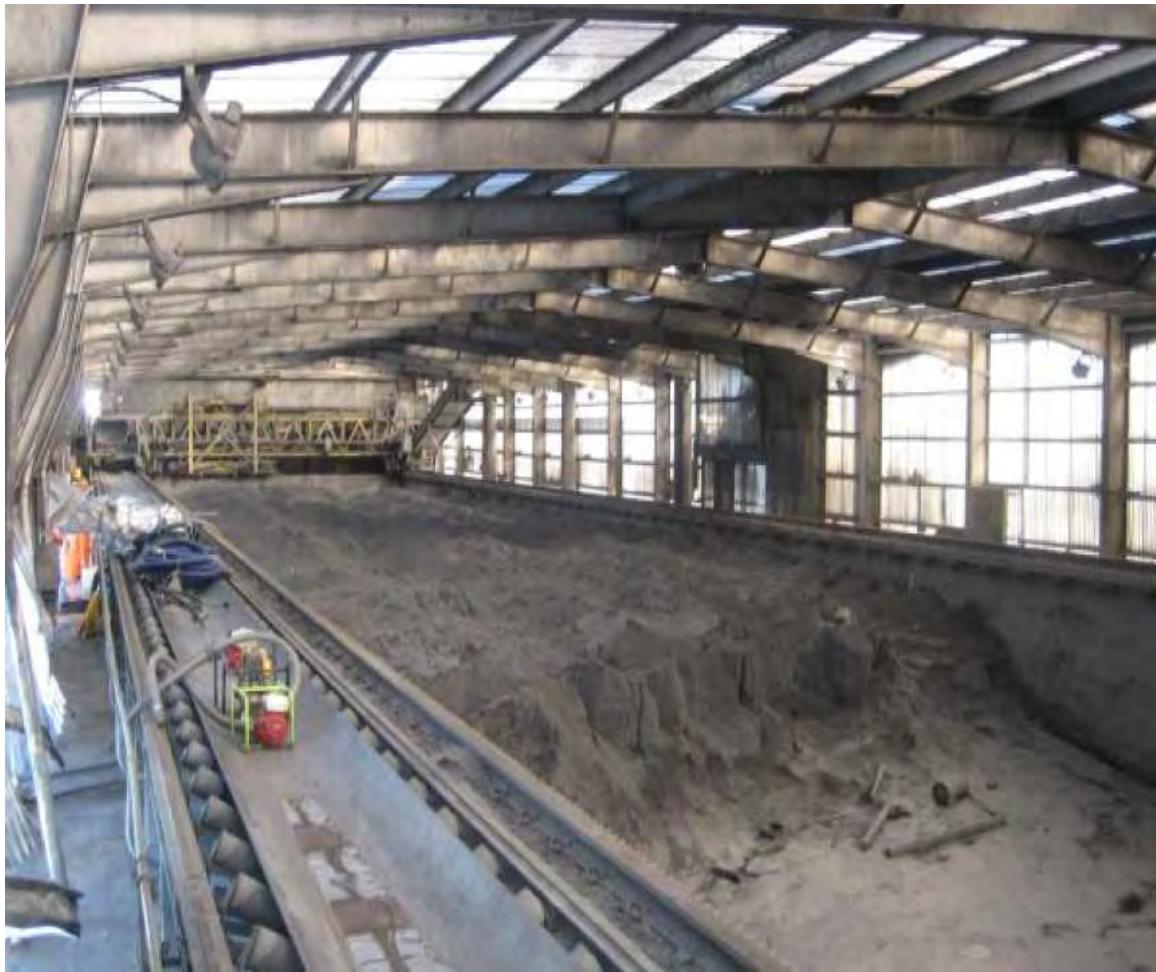
**Figure 10 - Debris in the Cargo Hold**

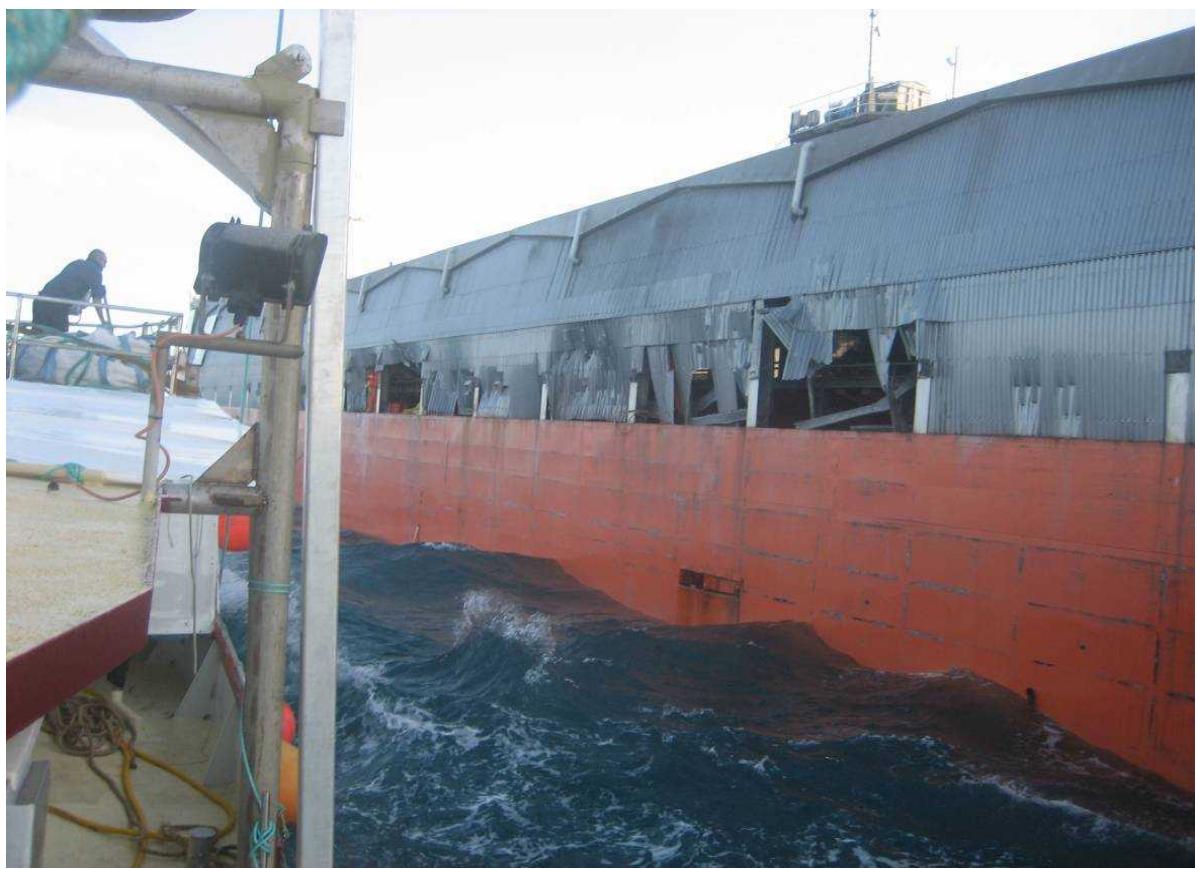
**Figure 12 - Damage to the Canopy on the Port Side**

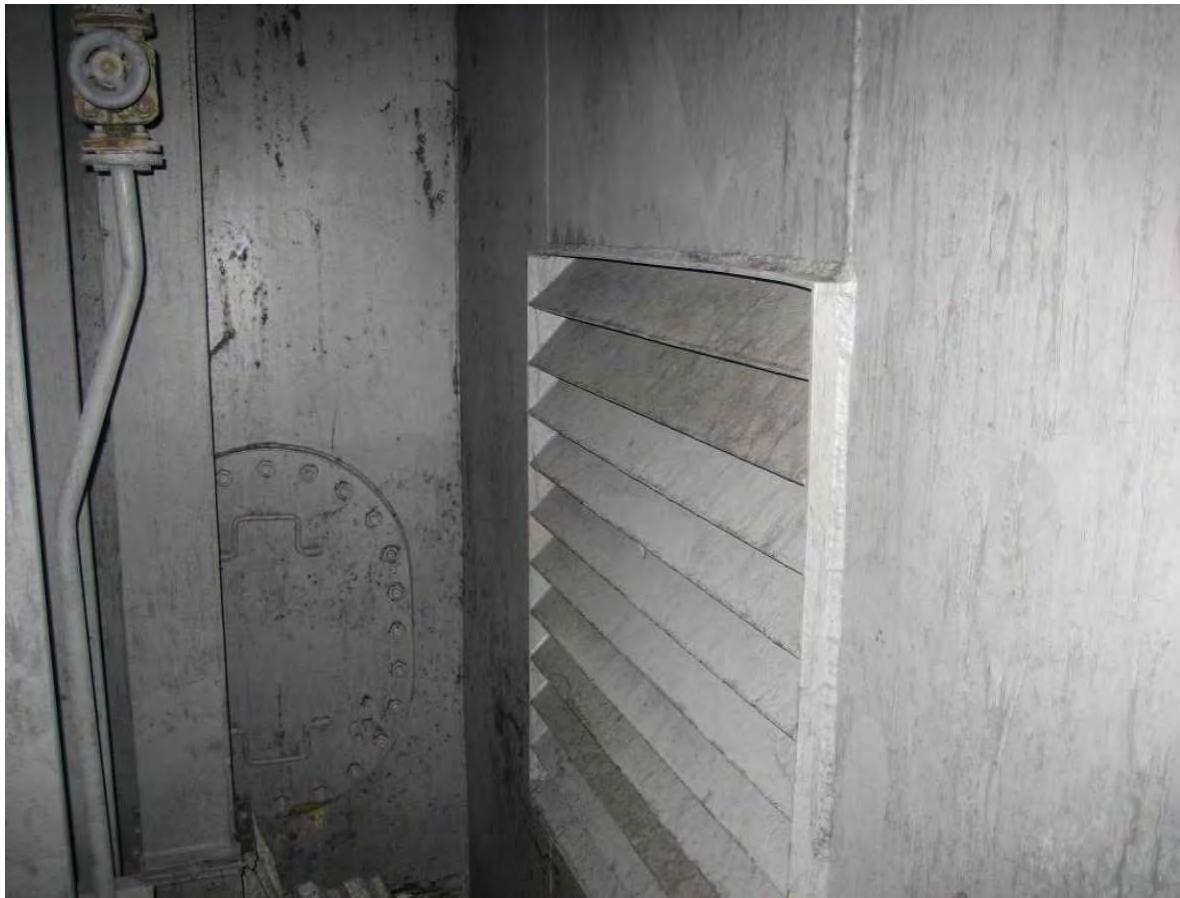
**Figure 14 - Louvered Vent from the Emergency Generator Room**

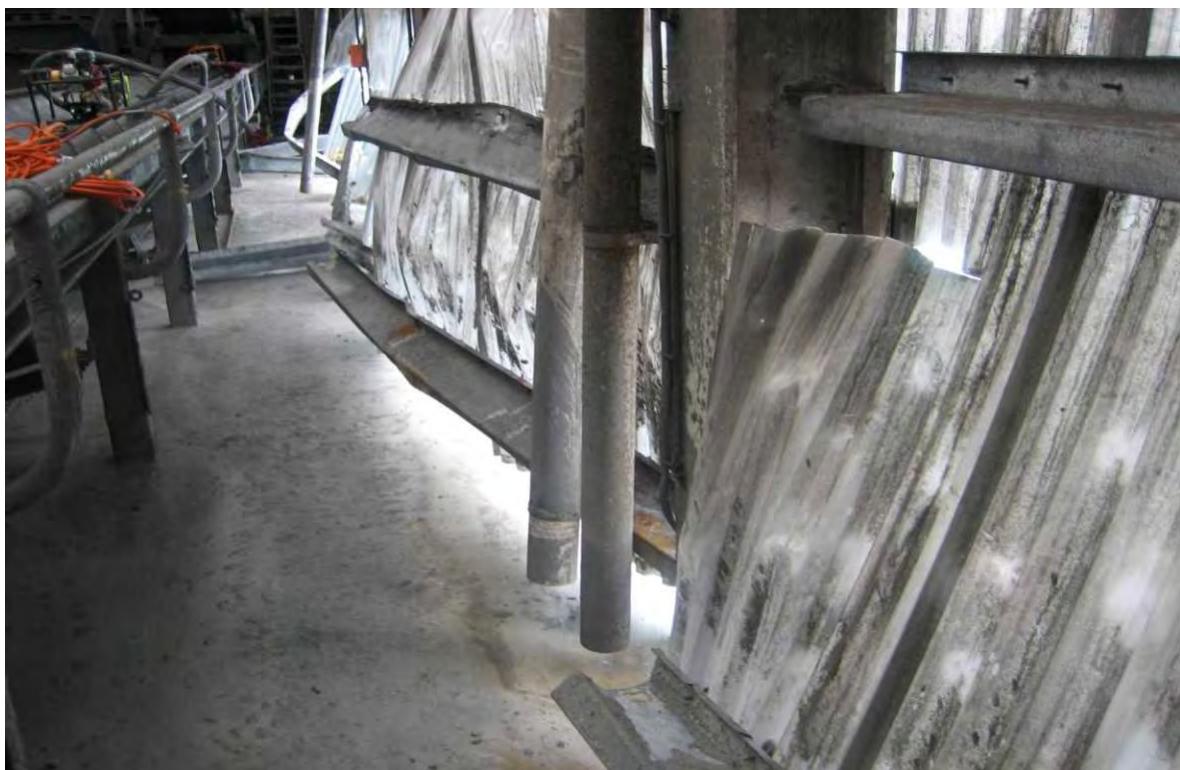
**Figure 15 – Damage and Down Pipes and to the Port Side Deck**
