WUNMA BOARD OF INQUIRY

CHAPTER 14: THE IMMEDIATE RESPONSE TO THE INCIDENT

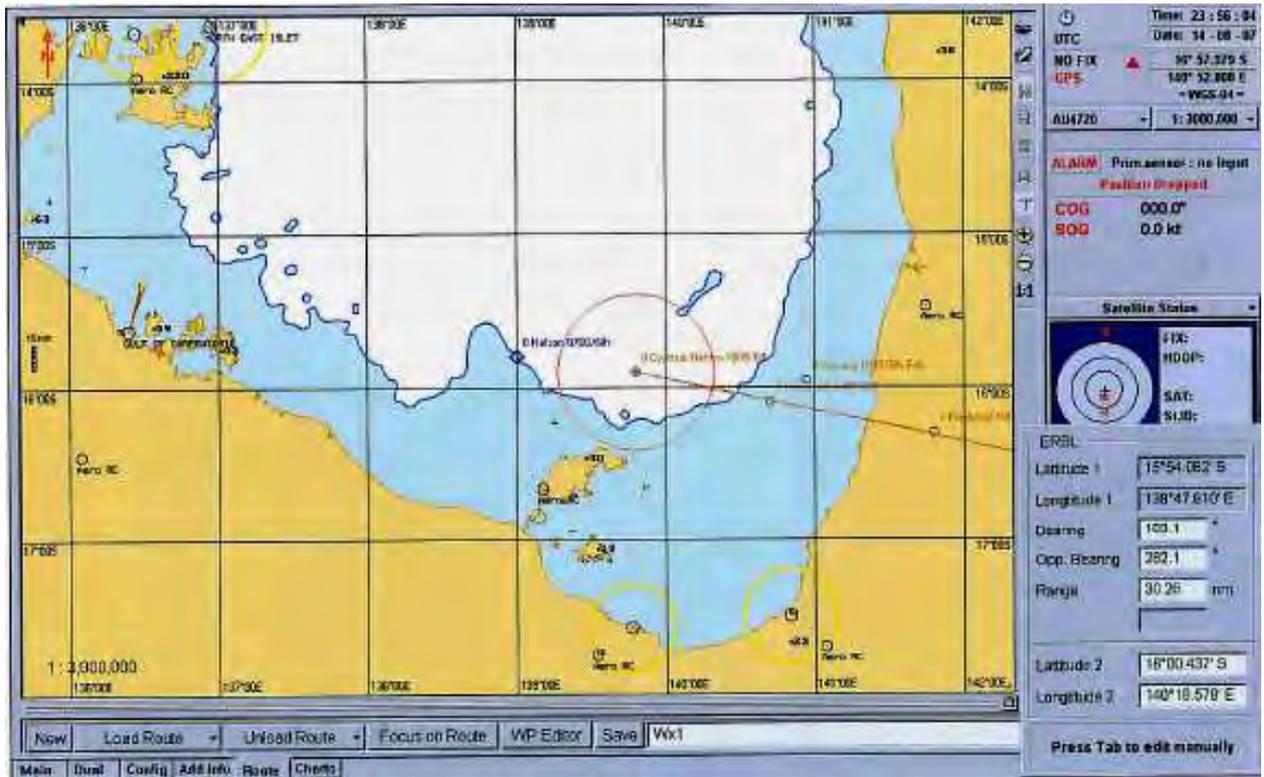
Figure 1 - Simple Plot of the Position of the *Wunna* Relative to the Predicted Path of Tropical Cyclone Nelson

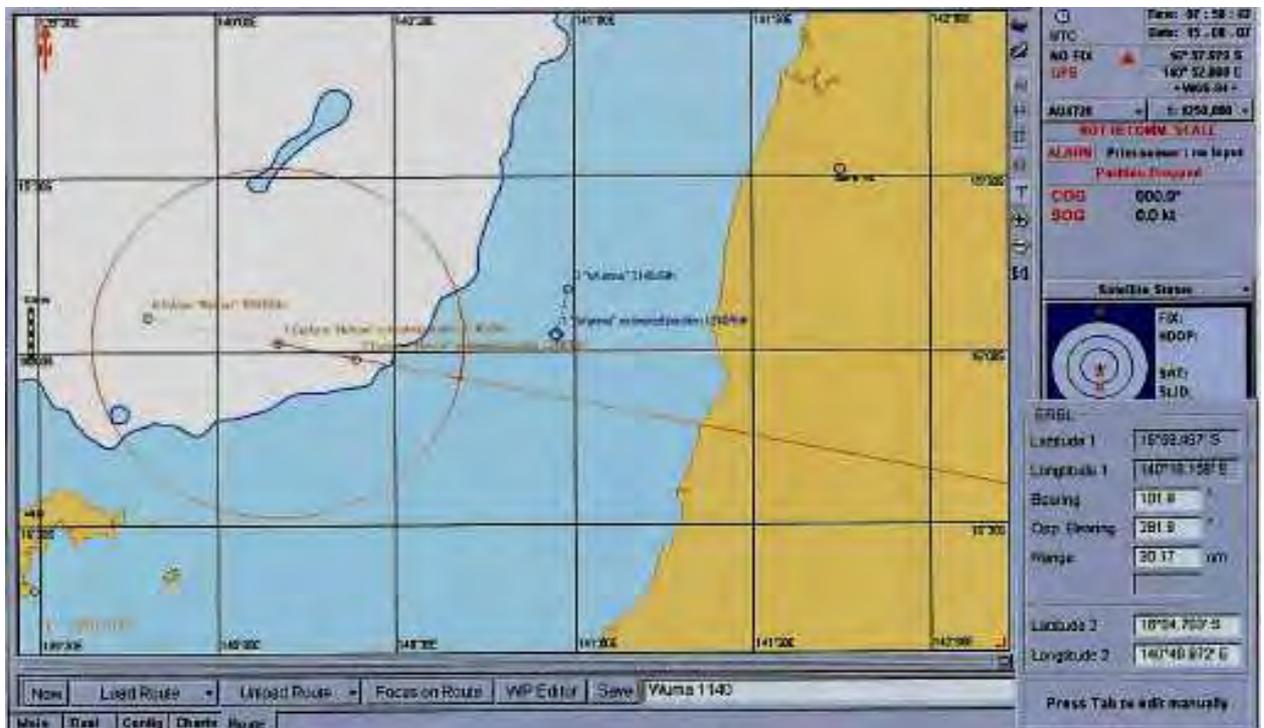
Figure 2 - Showing the Actual Position of the *Wunma* and Tropical Cyclone Nelson at 1000 Hours on 6 February 2007

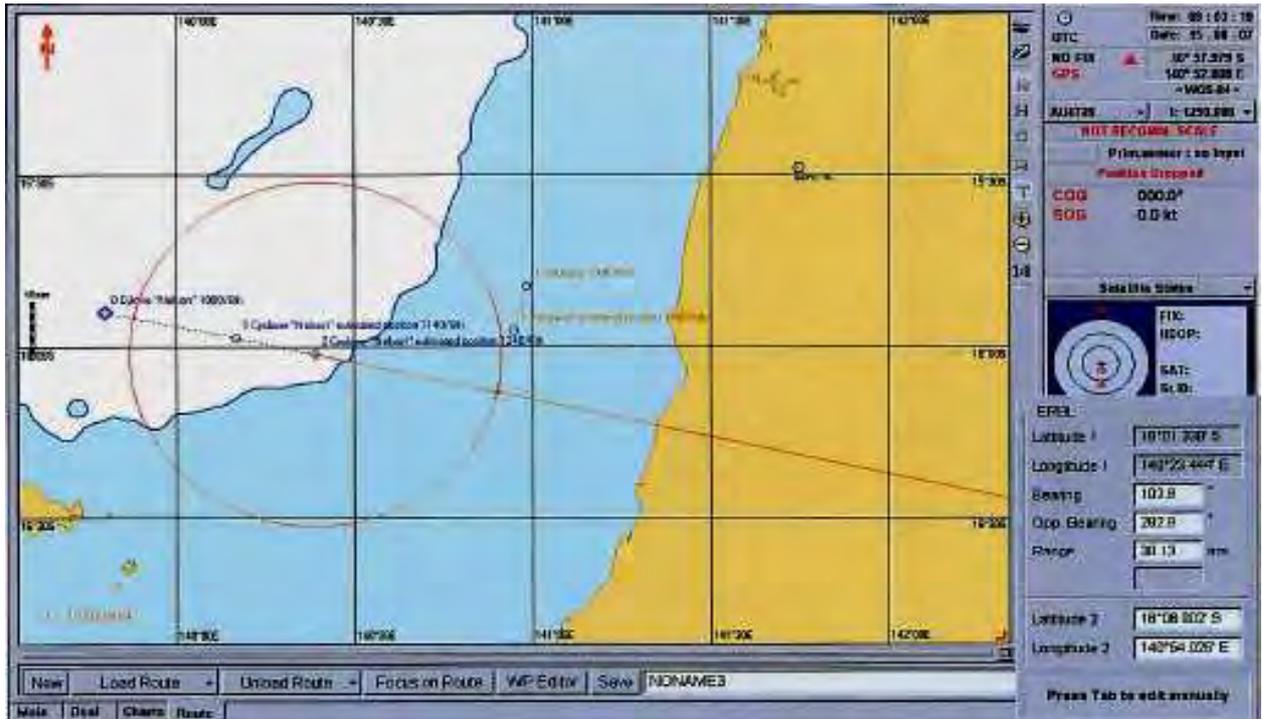
Figure 3 - Showing the Predicted Positions of the *Wunma* and Tropical Cyclone Nelson at 1140 Hours on 6 February 2007

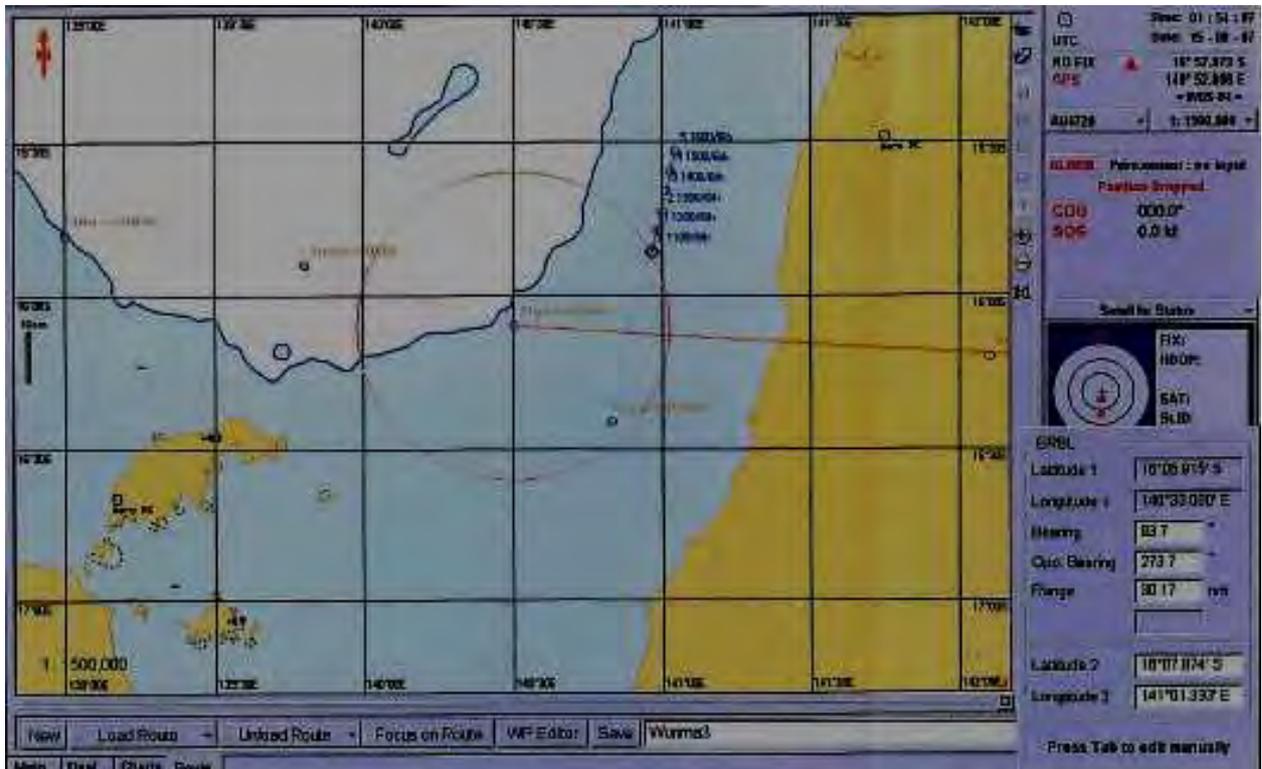
Figure 4 - Showing the Predicted Positions of the *Wunma* and Tropical Cyclone Nelson at 1240 Hours on 6 February 2007

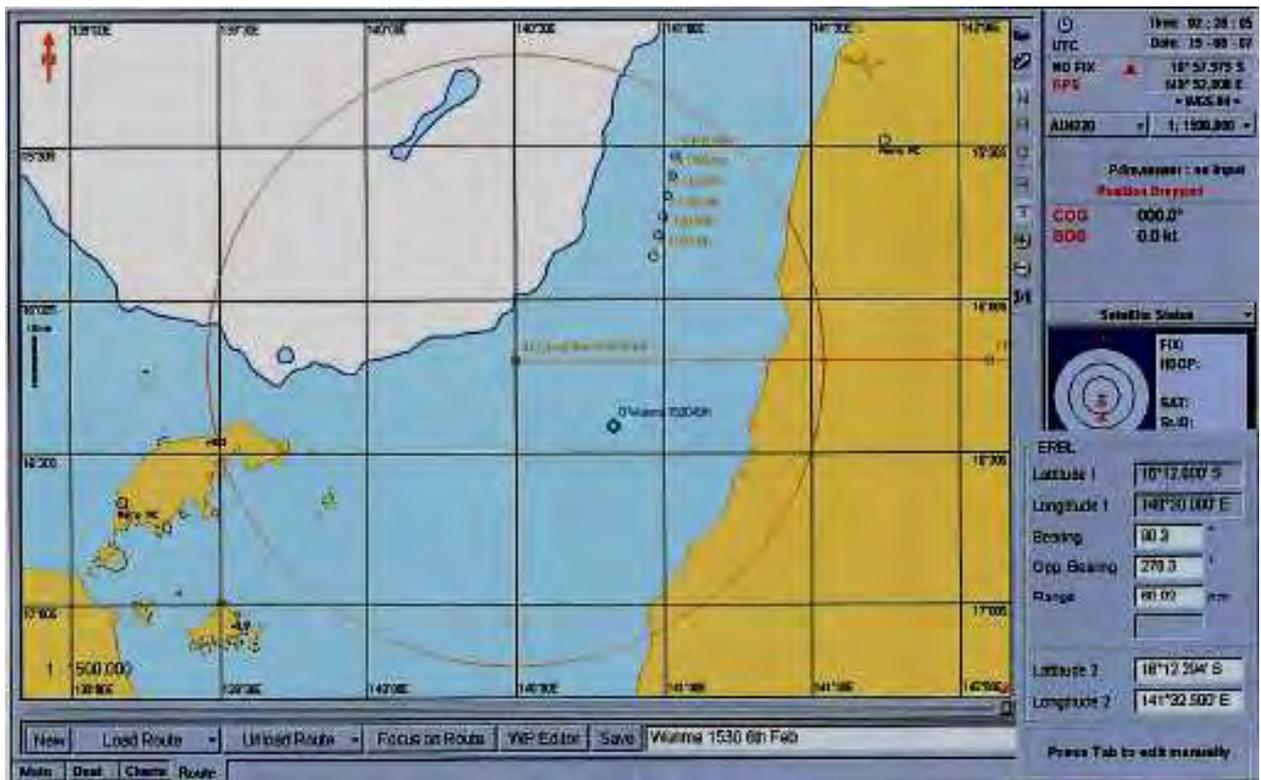
Figure 5 – Showing the *Wunma* and the Relative Track of the *Wunma* at 1530 Hours on 6 February 2007 had the Master Maintained a Northerly Heading
