5.0 Regional marine incident summaries

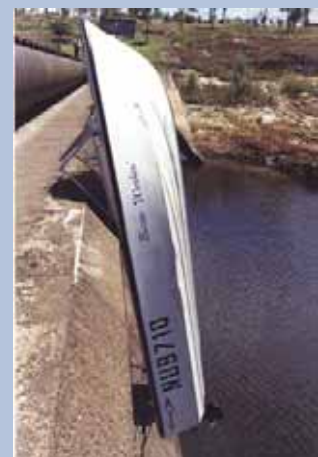
Incident study 4

Three men were boating late at night on an inland river. While travelling at speed the master realised too late that he was too close to a weir across the river. Despite his best efforts to steer clear, the runabout struck the rubber wall extension bladder of the weir. One of the passengers was instantly thrown from the boat over the weir wall, landing in the overflow pond 11 metres below the weir. With the force of the impact, the runabout catapulted sideways then backwards over the weir wall, ejecting the other two men in the process. The vessel came to rest upside down hanging from a water break bollard at the top of the weir.

The two men made heavy contact with the concrete weir wall before tumbling down the wall into the overflow pond. The first man ejected, still conscious after his fall, was able to raise the alarm and emergency services were activated. A search ensued and one of the remaining two men was quickly found, unfortunately dead. A search continued for another 48 hours before the remaining man's body was also found in the overflow pond.

- Maintaining a proper lookout and safe and manageable speed are critical, particularly in restricted visibility, darkness and restricted areas.
- Masters must ensure they have knowledge of local conditions and hazards.

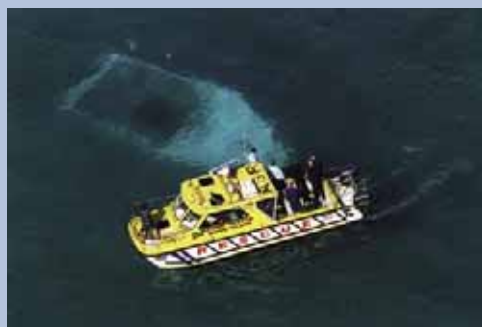
Incident study 5

On a fine Friday evening, the owner of a 30 foot timber cabin cruiser decided to go fishing for the weekend. He set out with his trusty dog, and a friend on board as deckhand. During the night, the vessel's engine stopped and the owner dropped anchor to assess the problem. When he went to investigate, he discovered the rear deck was awash and that the vessel was sinking quickly. The vessel sank shortly thereafter.

So sudden was the vessel's demise that neither man was able to fit a life jacket before abandoning the vessel. In the darkness they hung onto whatever floating debris they could find. Eventually the two men were separated by tidal currents. The deckhand subsequently managed to locate a life jacket floating in the current and was able to fit it to himself in the water. After several hours, he drifted onto the shore of a nearby island, but it was not until the following morning that he could raise the alarm and get assistance. The owner and master of the vessel was located some time later washed ashore on the same island. He had drowned.

It was subsequently established that the vessel's lifejackets were stowed under the bunks rather than in an easily accessible location in the wheelhouse.

- A personal flotation device is a mariner's best friend.
- Personal flotation devices should be easily accessible to all persons on board the vessel at all times.
- If time permits, do not abandon ship without first fitting a personal flotation device.
- At any time that there is doubt as to the watertight integrity of the vessel, personal flotation devices should be fitted.

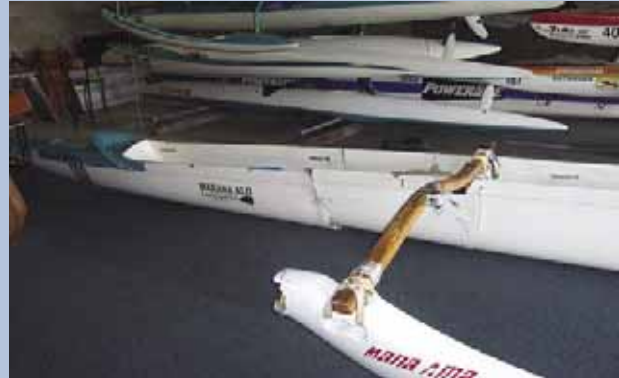
Incident study 6

A group of employees from one of the Whitsunday's most popular island resorts had set off in one of the resort's outrigger canoes for a late afternoon training session. In ideal conditions the young men had only been paddling for a short time when they noticed a power boat nearby towing a wake board and tube. When the wake board rider fell off, the power boat started to turn at speed to return and pick up the rider.

It seems that the master of the power boat, focusing on picking up his skier, didn't notice the outrigger in front of him, even though the men aboard the canoe did their best to attract his attention. Fearing the worst, the paddlers scrambled and jumped for their lives, just as the power boat slammed directly into the side of the outrigger. One unlucky paddler took the full force of the power boat's impact, throwing him into the water and causing major injuries to his back, pelvis, leg & foot.

- Masters need to maintain a proper lookout by sight and hearing to adequately assess the risk of a collision, particularly when involved in waterskiing type activities.
- When waterskiing, it is the spotter's job to watch out for the skiers – the master's job is to operate the boat safely.
- Excessive speed can be dangerous. Going slower allows more time to react to unexpected circumstances.
- A safe speed is one that takes account of all prevailing conditions including complementary boating activity.

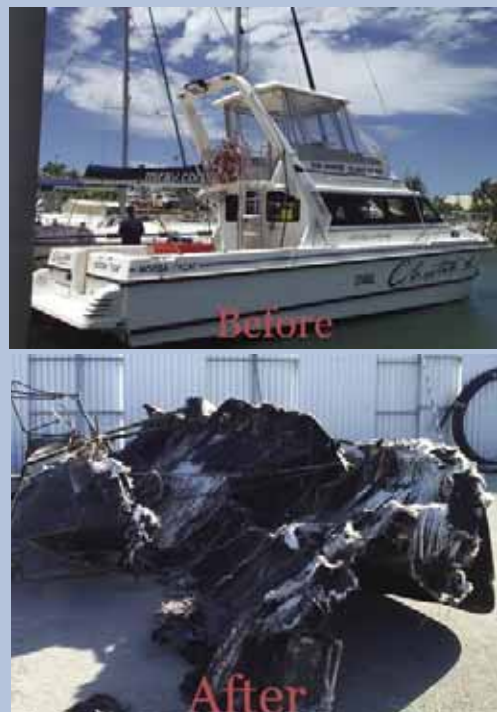
Incident study 7

A commercial passenger charter vessel set out for a one day fishing charter offshore from Townsville with eight passengers onboard. While underway, smoke was noticed coming from the starboard engine compartment. The fire began to spread rapidly.

The master immediately radioed Coastguard of the fire onboard and soon after had no alternative but to order all passengers and crew to abandon ship. All were recovered by rescue vessels and returned to Townsville. The charter vessel proceeded to burn to the waterline.

Miraculously, only one person was injured—suffering mild smoke inhalation. The vessel was a total write-off.

- Fire onboard commercial passenger carrying vessels has been assessed as one of the top 10 marine safety risks in Queensland.
- There is no room for heroics during an incident involving fire onboard—it is often prudent to abandon the vessel (as proved to be the case in this incident).
- Quick thinking and response is critical when there is a fire onboard.
- Onboard fire incidents underline the importance of having emergency procedures, emergency drills and passenger briefings.

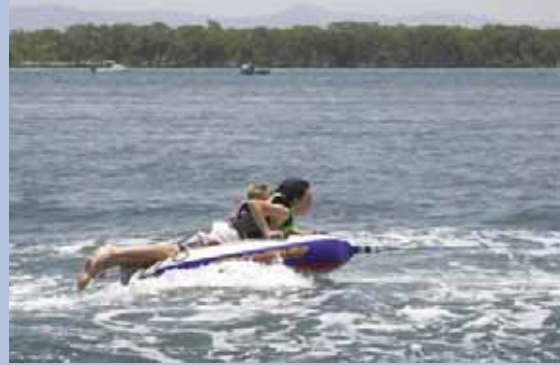
Incident study 8

On a clear day at a popular skiing spot on an inland lake a high powered skiboat was attempting to pull a skier out of the water when it struck an inflatable ski biscuit behind another skiboat. There were two children on the inflatable tow at the time and one of them, a 13 year old boy, was struck by the bow of the skiboat. The boy suffered serious head injuries requiring admission to hospital.

- Maintaining a proper lookout and a safe and manageable speed are critical when undertaking water ski activities, particularly given the close proximity to other vessels and skiers and the frequently chopped and lumpy surface conditions.
- The role of the spotter/lookout when water skiing is to keep an eye out for the person being towed. The skiboat master must keep a proper lookout in relation to the safe operation of the vessel and its interaction with other vessels and water users.
- Inattention, even for a second, can result in unexpected and often catastrophic events.
