# Mooloolaba Boat Harbour Eastern Breakwater Extension

Constructability Report

Prepared for:  
DEPARTMENT OF TRANSPORT AND MAIN ROADS

BEJ952-TD-ST-REP-0001 Rev 0

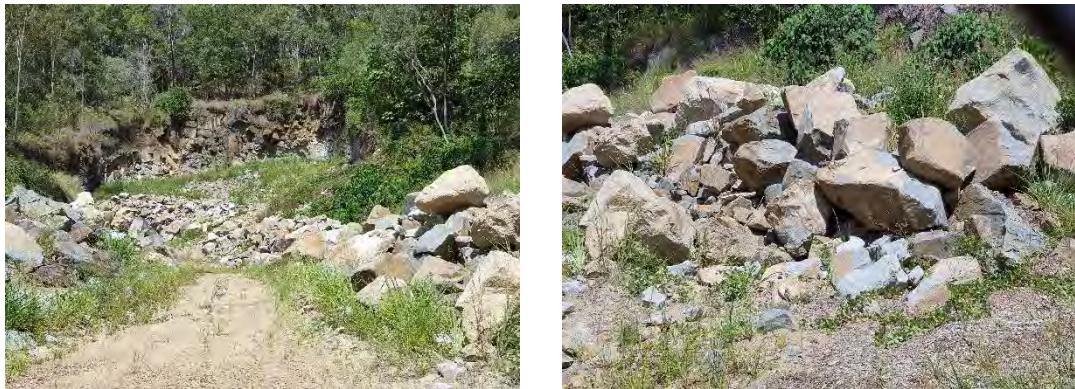
From a roadside inspection of the quarry conducted on 15 March 2019, the stockpiled rock appeared to be of reasonable quality. Joint spacing appeared acceptable from the visible rock armour stockpiles (Figure 2.1). However, it could not be established if primary armour rock sizes greater than previously used for the Mooloolaba Breakwater could be quarried at this site.

Figure 2.1 View into Kuluin Quarry and rock armour stockpiles from Commercial Road, Kuluin. Larger pictured armour is estimated to have a median diameter ( $D_{50}$ ) of about 1.2 m at 15 March 2019.

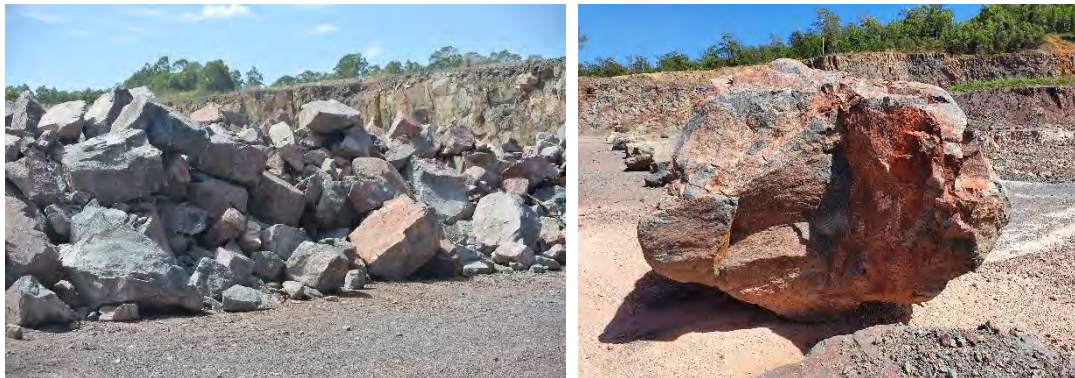
Rock samples observed during a quarry inspection appeared to contain close joint spacing, cleavage planes and weathered rock inclusions. Quartz banding was also observed in armour rock (300mm) from this quarry as used for bank protection in the Maroochy River (Bradman Avenue).

It was concluded from the quarry inspection on 15 March 2019 that the rock may be prone to fractures, decomposition and weathering in an exposed breakwater environment. Further petrographic and mechanical testing would be needed to confirm if the Glass House Quarry material is suitable for rock primary and secondary armour applications. This quarry material could supply the core or underlayer material in sufficient quantities.

Figure 2.2 Left: stockpile of Glass House Quarry armour rock with estimated  $D_{50}$  of 0.75 m. Right: large boulder ( $D_{50}$  approximately 1.7 m).

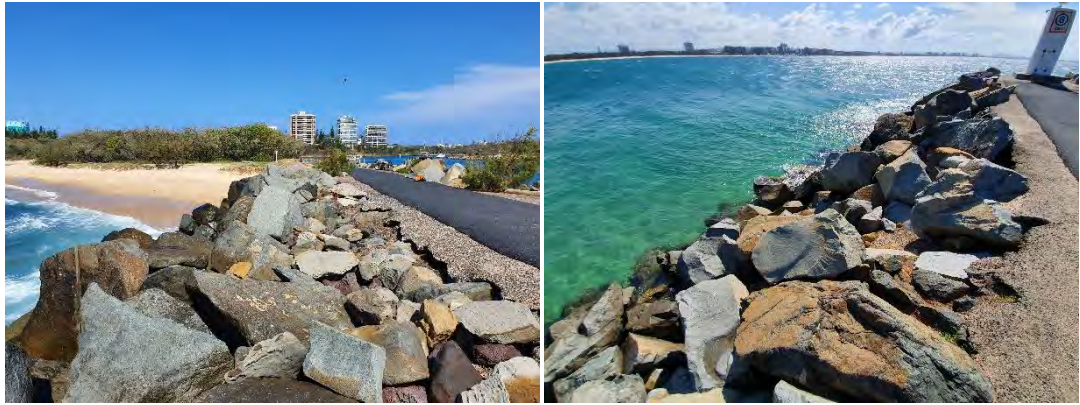
Displaced armour rock was observed on the leeward side of the breakwater and adjacent to the toe on the Mooloolah River seabed.

Figure 3.1 Existing Mooloolaba breakwater. Left: looking southeast along the seaward side of the breakwater. Right: Looking northwest along the leeward side of the breakwater. Signs of rock slumping and undermining of the concrete blinding layer under the footpath observed. Wide rock grading also observed.

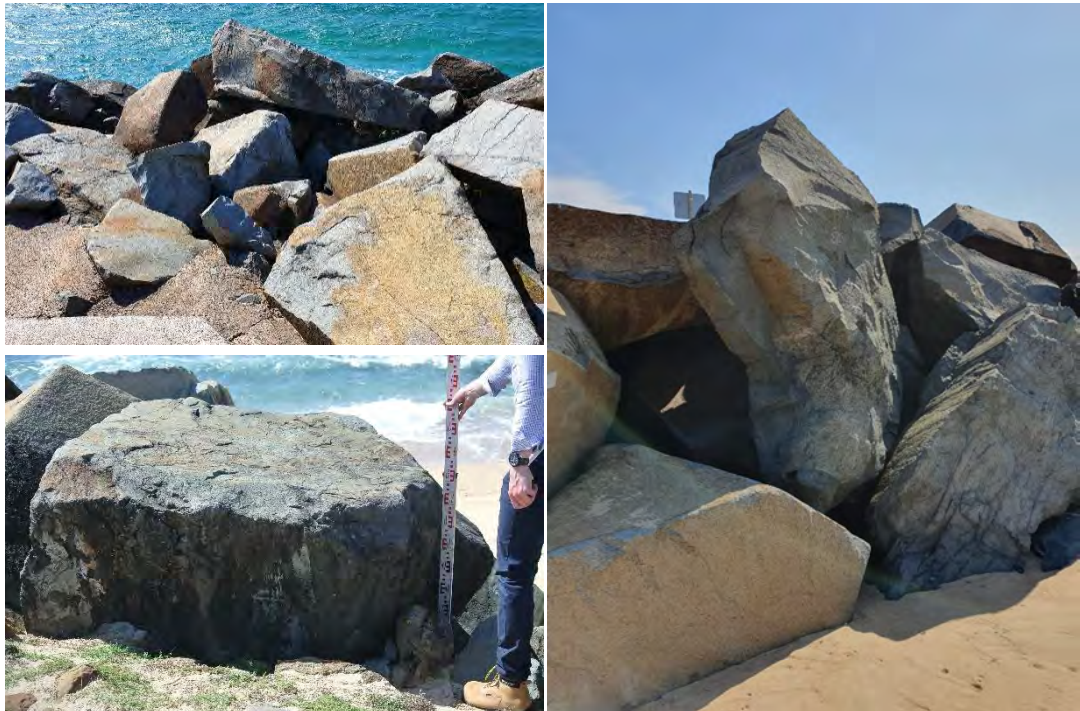
In some instances the existing breakwater armour has a poor aspect ratio shape (Figure 3.2) that is not good practice as it affects the random placement of layers and may become dislodged. AS2758.6-2008 advises for a heavy rock grading no more than 5% by number of blocks are to have a length to thickness ratio (L/E = aspect ratio) greater than 3. Large cracks were noted on some armour rocks (e.g., Figure 3.3), however for the most part, armourstone integrity appeared to be acceptable (no testing was undertaken).

Figure 3.2 Primary rock armour along the existing eastern Mooloolaba breakwater. Considerable rock aspect ratio deficiencies noted in some instances. Right: aspect ratio approximated to be  $L/E = 2.5 \text{ m}/0.5 \text{ m} = 5$ .

- Stability of the existing breakwater. As identified in Section 3.1.2, the existing breakwater displays signs of slumping and also has a large number of rocks with a length to thickness ratios (L/E) greater than 3. The adverse L/E ratios of the existing breakwater rocks pose rock instability risks, with resultant crushing risks to construction personnel and the public. Further assessment of the stability and safe loads for the existing breakwater prior to construction is advised. Repair works and replacement of rocks with adverse length to thickness ratios may be required in combination with the breakwater extension works.

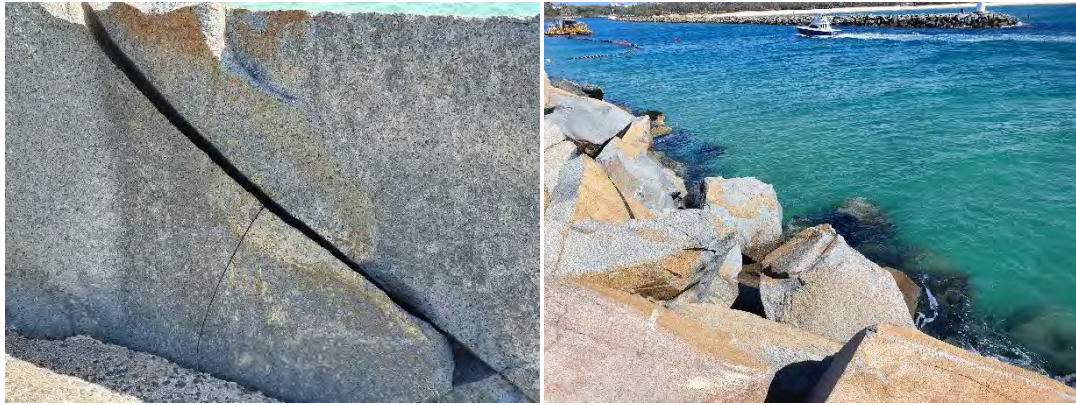
Figure 3.3 Left: cracking of rock armour on the leeward crest of the existing breakwater. Rock believed to have been sourced from the Kuluin Quarry. Right: potential signs of rock instability on the leeward side of the existing breakwater.

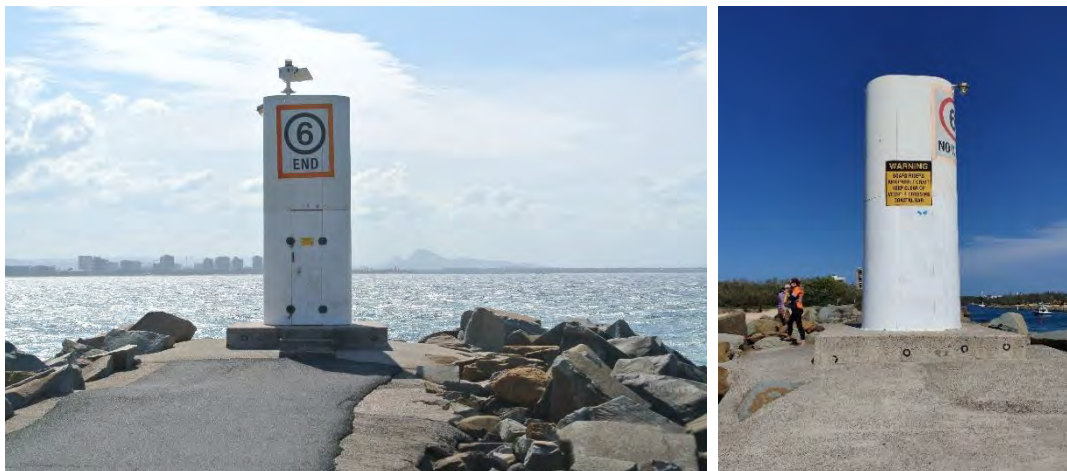
Without access to the door of the navigation beacon, an external inspection was conducted. No lifting lugs were noted on the structure. It appears to be structurally sound with no signs of external deterioration. Therefore it should be able to be relocated and reused (subject to internal inspection).

Figure 3.4 Existing navigation beacon. Left: landward perspective towards the northwest. Right: seaward perspective looking towards the southeast.

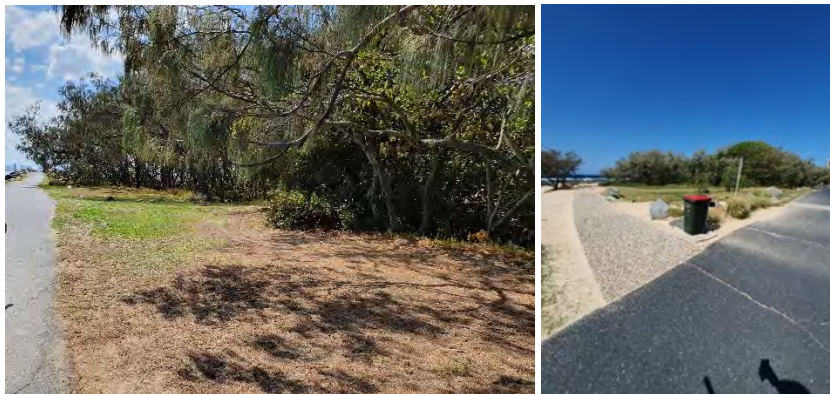
Figure 4.3 Observations indicating minimal area available for land-based laydown areas near the breakwater. Left: laydown area approximately 200 m<sup>2</sup> along the Mooloolah River entrance seawall. Right: laydown area approximately 300 m<sup>2</sup> at the Point Cartwright Beach, adjacent to the existing breakwater. (Refer Figure 4.2 for locality)

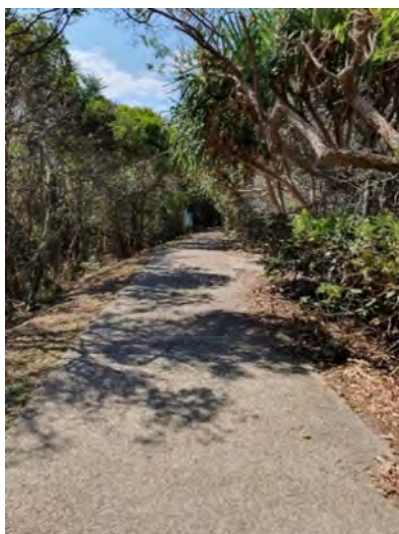
Following inspection of the Pacific Boulevard carpark and footpath access, access via the lighthouse pathway was identified as impracticable. Reference source not found..

Figure 4.7 Pathway leading to Point Cartwright water reservoir and lighthouse from the car park located at the termination of Pacific Boulevard.

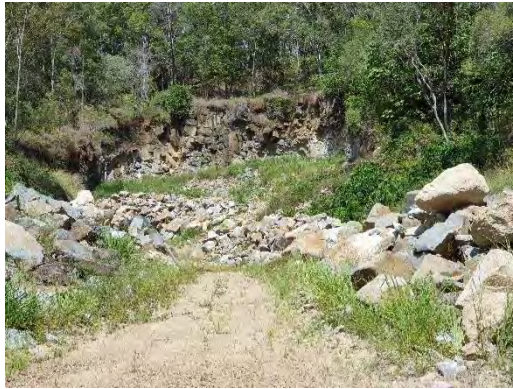
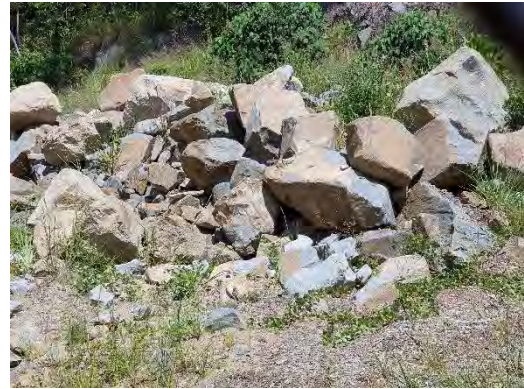
Figure 1.2 Kuluin Quarry from fence-line (15 March 2019). Estimated rock  $D_{50}$  is approx. 1.2 m.

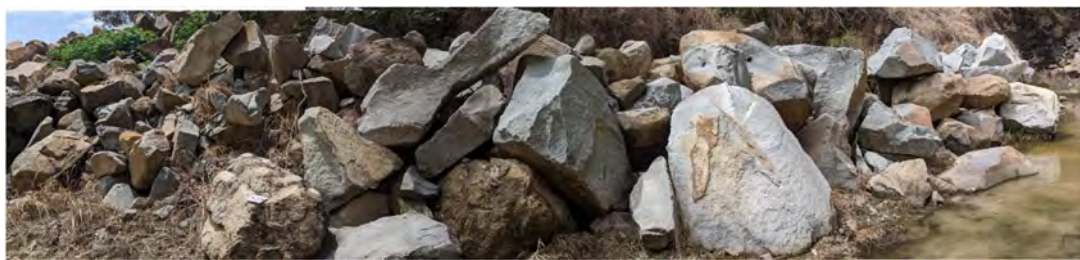
Figure 4.2 Panoramic view of E-2 Stockpile (Eastern area) showing widely graded rock (approx. 15 kg to 40kg rock to the left and approx. 0.8 to 2.4t rock toward the right)

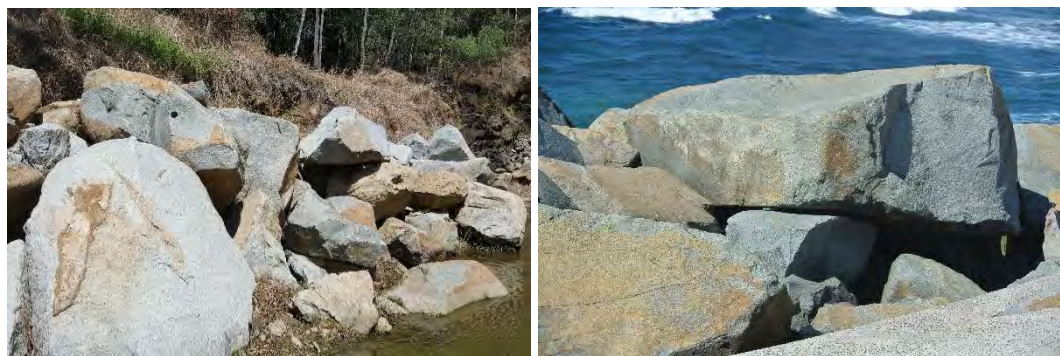
It is evident that the rock armour at the Kuluin Quarry is generally consistent with the armour material observed on the Mooloolaba Breakwater, as demonstrated in Figure 4.4 (a) (quarry rock at Kuluin Quarry) and Figure 4.4 (b) (Rock observed on Mooloolaba Breakwater).

Figure 4.4 (a) Stockpiled Kuluin Quarry Rock and (b) Armour rock on the crest of the Mooloolaba Breakwater (seaward side)

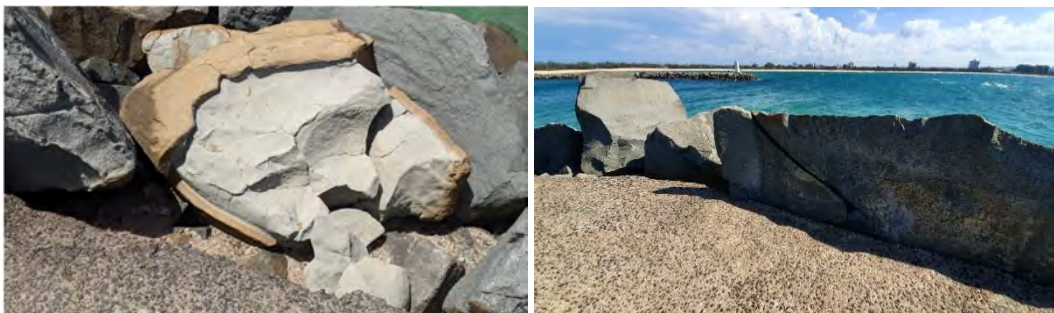
Observations of the breakwater rock indicate material that is prone to fractures, decomposition and weathering in an exposed breakwater environment (shown in Figure 4.5a and b). Evidence of fracturing of material was also noted for a sample of pieces at the quarry site (refer observations in Appendix A).

Figure 4.5 (a) weathering of the Kuluin Quarry Rock on the crest of the Mooloolaba Breakwater (seaward side) and (b) fracturing of larger rock armour (lee side)
