# Mooloolaba Boat Harbour Eastern Breakwater Extension

Design Report

Prepared for:  
DEPARTMENT OF TRANSPORT AND MAIN ROADS

BEJ952-TD-ST-REP-0002 Rev 0

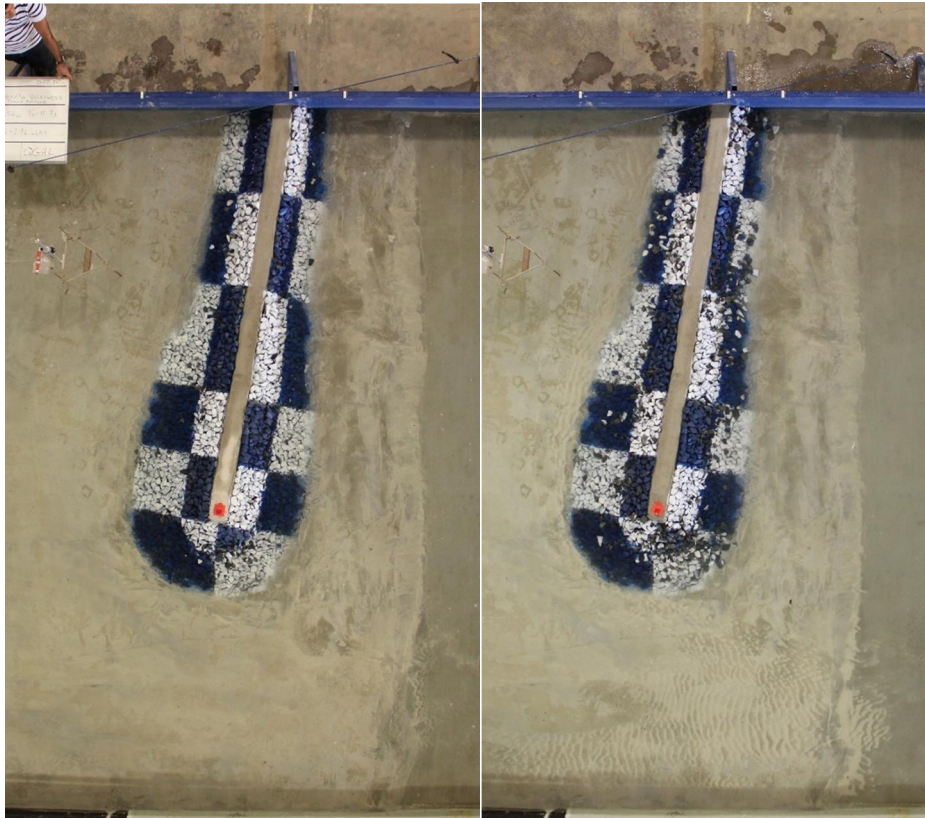
Figure 3.1 Plan view of physical model (Before – Left, After – Right)

Physical modelling of the breakwater revealed that a median 6-tonne rock weight was not suitable for the breakwater extension due to an unacceptable level of damage during the design event, sustained primarily at the transition zone between the new and existing breakwater, and on the roundhead (as demonstrated by the 'before' and 'after' shown in Error! Reference source not found. Figure 3.1). It was concluded that a larger primary armour unit was needed to meet the damage criterion of <5%.

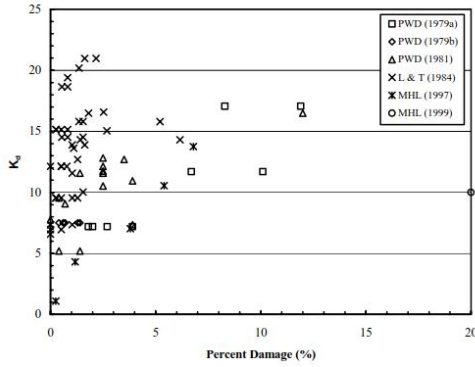
Figure 4.1 Hanbar unit damage coefficient

The 7.0t Hanbar primary armour unit has been sized using the Hudson (1961) equation for 0-5% damage criteria during the ultimate 200 year ARI design event.

The damage coefficient adopted is consistent with values compiled by the Water Research Laboratory (WRL) of the University of New South Wales (UNSW) (2005) from physical modelling studies testing the standard upright Hanbar unit placement method (provided in in Figure 4.1). A desktop review of several Hanbar unit studies (I, Jayewardene, 2018 and G, Russell, 2013) suggest a Hudson damage coefficient (K<sub>d</sub>) of 5-7 is a conservative estimate for the standard upright placement method with 0-5% damage.

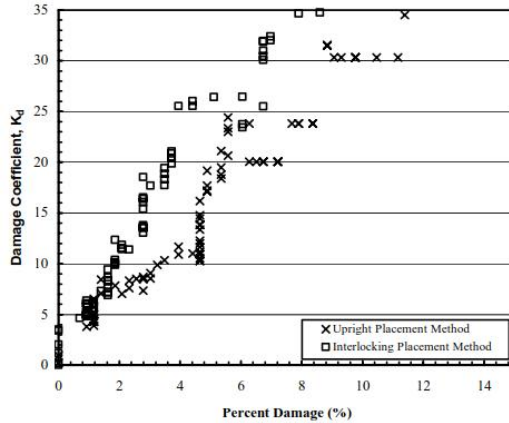
Figure 4.4 Interlocking Hanbar unit damage coefficient modelling results (WRL, 2005)

The ‘interlocking is placement method’ is applied for this design due to the improved interlocking compared with the standard upright hanbar placement.

Physical modelling of Hanbar units is recommended consistent with recommendations by WRL (2005), to confirm the structure’s hydraulic performance and resistance to damage, however it is understood that the time of writing further physical model testing is outside the scope of this project. Based on the findings of limited previous Hanbar unit studies, a conservative damage coefficient of  $K_d=10$  for interlocking Hanbar units is therefore adopted for the design of the Mooloolaba breakwater extension (Taken from Figure 4.4) assuming 0 – 5% damage. Physical modelling will provide more accurate verification of the design inputs and structure’s hydraulic response.

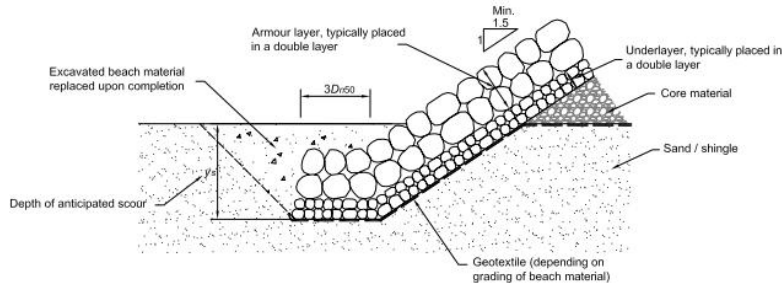
Figure 4.5 Toe design of breakwater extension (Typical toe detail per Figure 6.62 CUR Rock Manual)

The breakwater extension toe detail provides protection against scour, undermining, revetment sliding, and slope slumping. The nominated toe detail is based on recommendations in CIRIA Rock Manual (2012).

Rock toe protection in front of the Hanbar concrete armour units at the base of the structure is proposed. Use of rock at the toe is generally preferred over concrete armour units to avoid structural overload of the units (i.e. the mass of the slope crushing the toe units). Additionally, the Hanbar type of concrete armour unit rely on downslope interlocking for stability in addition to their weight. Therefore they don't perform inadequately on a flat base.

The toe design is a conventional type founded on an impermeable layer (i.e. rock) as shown Figure 4.5, however no geotextile is required. The toe will be founded on an impermeable bed rock surface after removal of the overlying sand by the dredge. This design will form a berm on the toe with a 2.8m width. With these dimensions it is intended that the toe will comprise of approximately 3 rocks in height.

It is intended that over time the toe will be buried by natural build-up of sand.

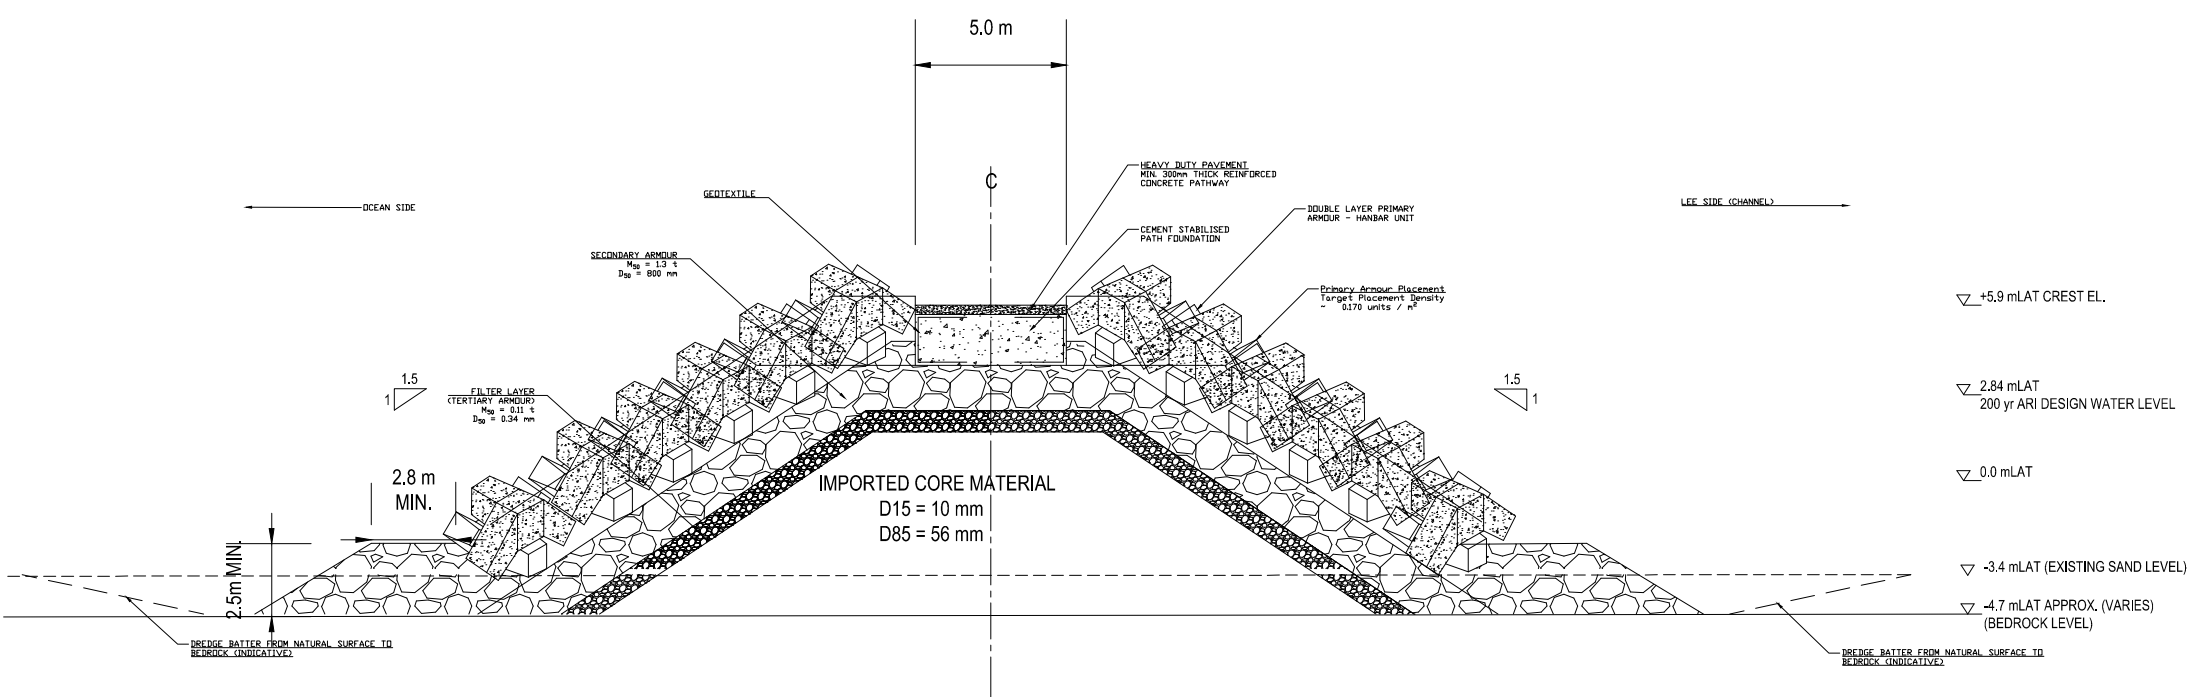
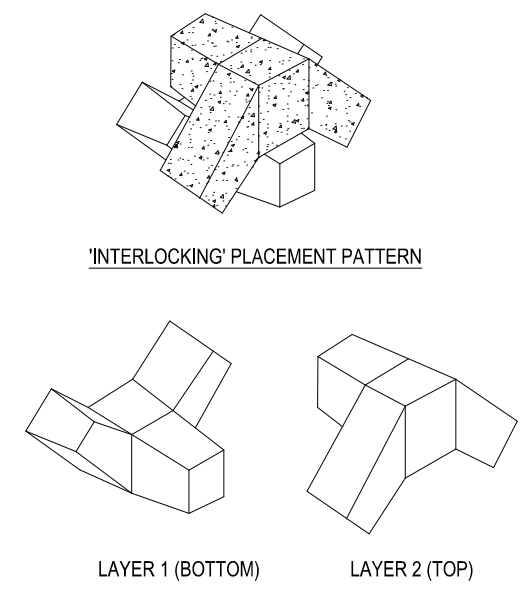
1. LEVELS IN m LAT (LOWEST ASTRONOMICAL TIDE) U. N. O.
2. SURVEY LEVELS FROM TMR PLAN E251-455
3. BEDROCK LEVELS FROM FRC BEDROCK SURVEY

TABLE 1: HANBAR UNIT GEOMETRIC DETAILS  
Width of Joint = 7 t

Dimension	Value
A	30°
B	1:5
C	97°
D	97°
E	114°
F	34°
G	84°
H	106°

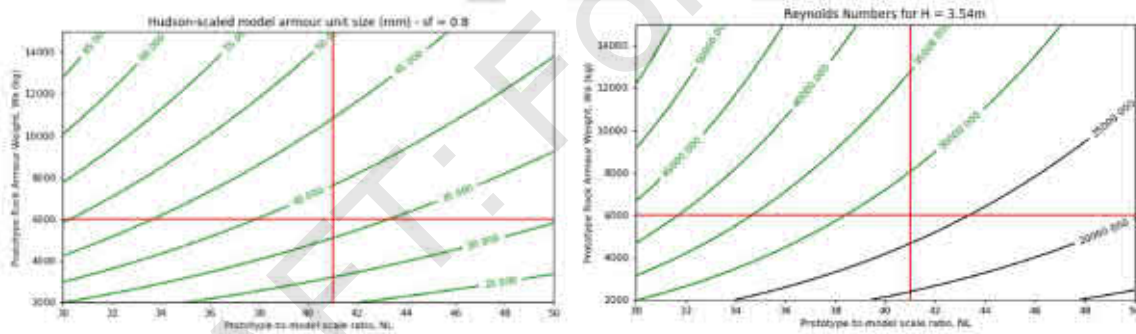
Figure 2: Left: Scaled nominal model rock sizes. Right: Reynolds stability number for the rocks over range of scales for a 3.54 m prototype wave height.

Using a model rock density ( $2,712 \text{ kg m}^{-3}$ ) indicates that the model rock dimensions are above the acceptable size limit ( $d_{50} > 25 \text{ mm}$ , Frostick et al., 2011) in the flume model scale for the weight range specified by the Client, see Figure 2. The Reynolds stability number indicated for a 3.54 m prototype wave height is a little lower than the recommended value of  $R_n > 30,000$  (Hudson et al., 1979, Figure 3). However, the Reynolds numbers are still considered turbulent and the scatter associated with the original Hudson et al. (1979) figure indicates a fair degree of variability in the potential stability numbers.

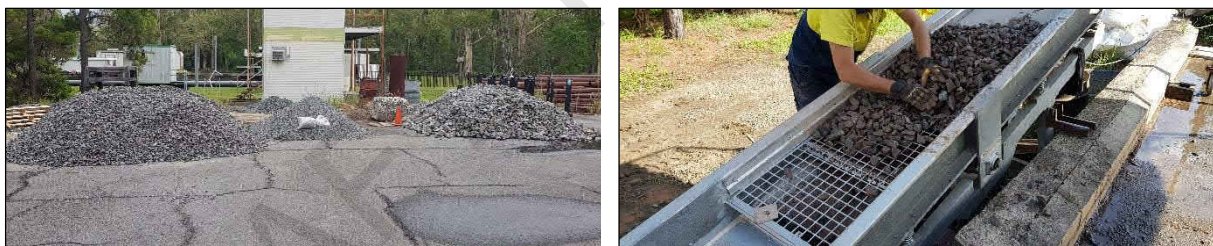
Figure 4: Example photos of rock sorting. Raw stock rock piles (left); sieve fractionation of model rock (right).

Rock sorting was conducted at the QGHL rock sorting facility (Figure 4), where raw rock was sorted by size and weight to ensure the grading of the primary armour conformed to the design grading, supplied by the Client. The final armour layer grading curves for the 6 tonne primary armour rock used in the model are provided in Figure 5. Good agreement was achieved between the target and measured weight grade. Figure 6 shows an image of a sample of the sorted rock used for the the primary armour.

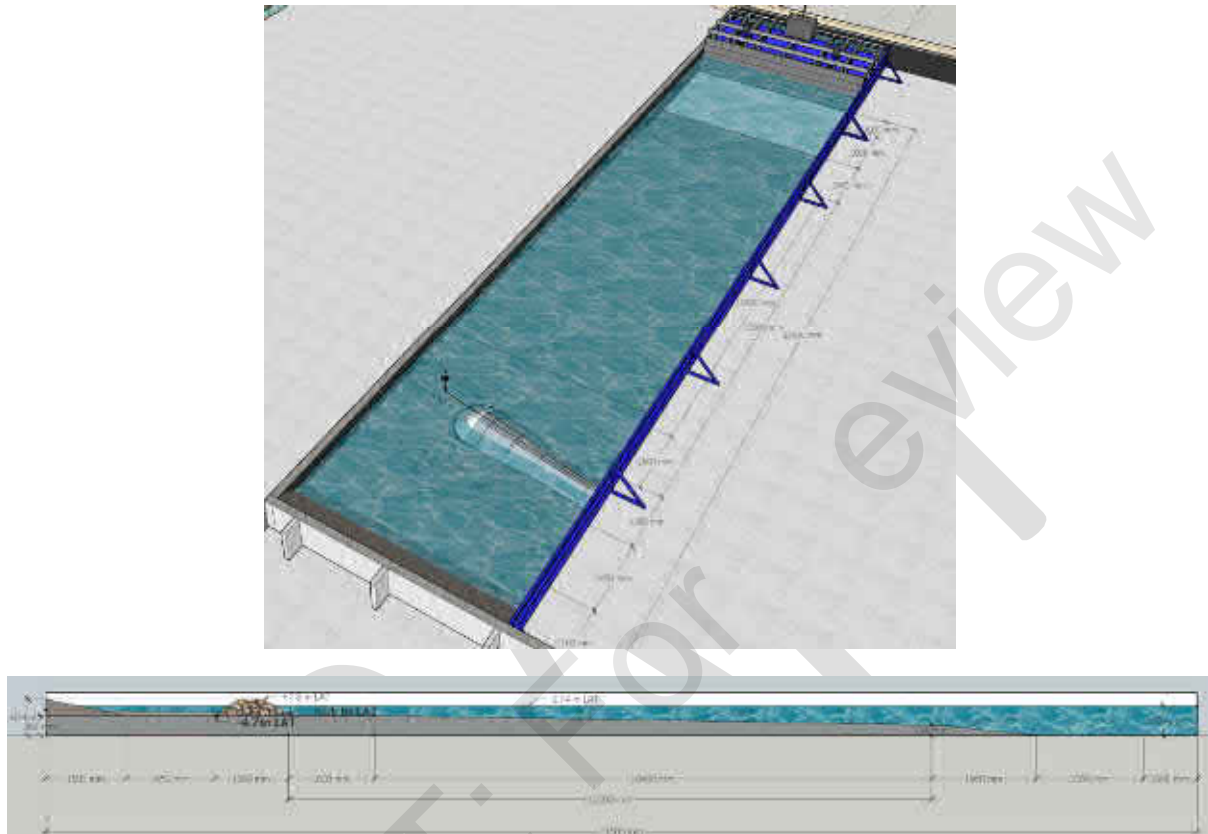
Figure 9: 3D and 2D view of Model domain.

that the bathymetry may be reasonably represented by a simplified bathymetry featuring a planar slope that would result in representative wave transformation leading up to the structure (Figure 9). A 1/10 gradient transition slope connected the flume bed (bed elevation at -19.8 m LAT prototype elevation) to the model domain bathymetry. The main model domain bathymetry was constructed with a 1/60 gradient slope between the end of the transition slope and the structure.

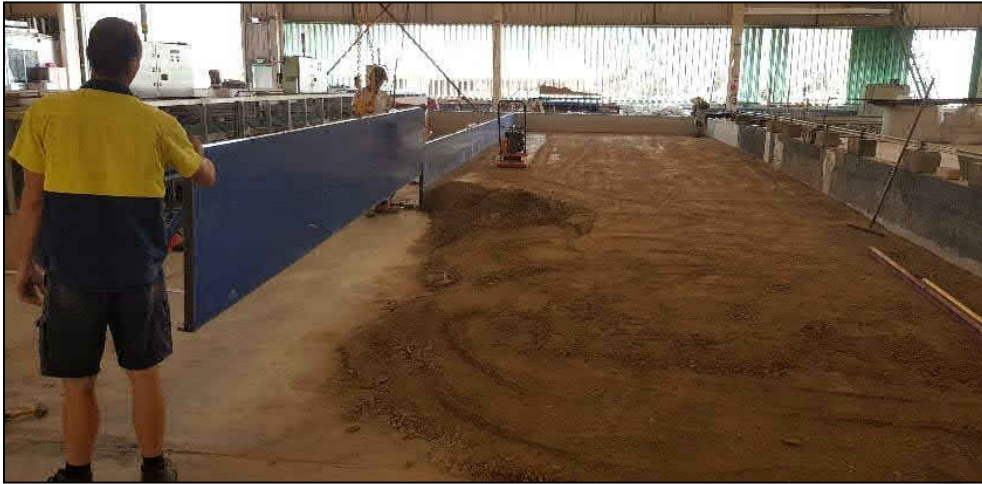
Figure 10: Flume bathymetry construction - supporting walls installation, road base fill and compaction progressing.

The construction of the basin model was a multi-stage process. A supporting wall was installed first to contain the model bathymetry and support the breakwater. After the wall was installed, road base fill was introduced and compacted to ensure a stable base for the 50 mm concrete cap (Figure 10 to Figure 12). Prior to the concrete pour and screeding, wooden templates were installed on the side walls relative to a benchmark located in the centre of the flume on the flume floor. This benchmark (prototype elevation = -19.8 m LAT) defined the offshore water depth  $h_0$ , and was used to ensure consistency in design profile elevations through the templates and model construction.

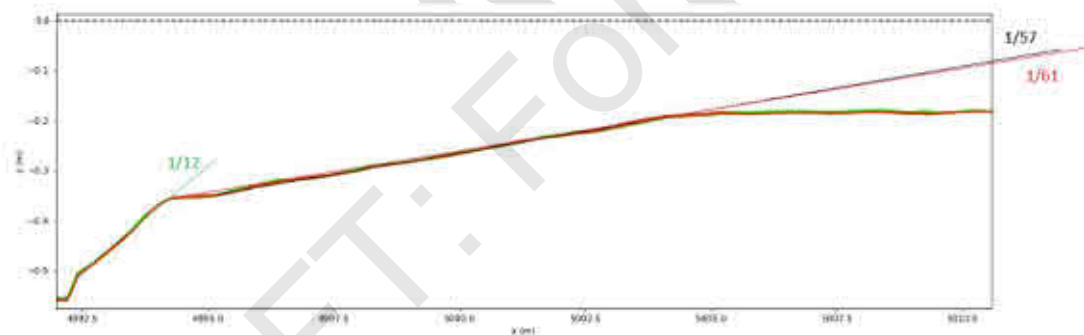
Figure 13: Surveyed flume bathymetry at 0.5m increments over the middle 4m of the basin.

Figure 13 shows the surveyed model bathymetry, including the 1/10 transition slope (measured as 1/12). The 2D profile plot has 8 profiles plotted at 0.5m increments over the middle 4 m of the basin to give an indication of the uniformity in the longshore. The profile slope over the model domain is between 1/58 and 1/61, which is in good agreement with the design (i.e. 1/60) and the horizontal section towards the right is approximately at the bedrock elevation and where the breakwater will be constructed before filling around the structure with a weak grout mix of sand and cement (sand-to-cement ratio  $\approx$  9:1) to continue the representative profile (Figure 9 and Figure 14).

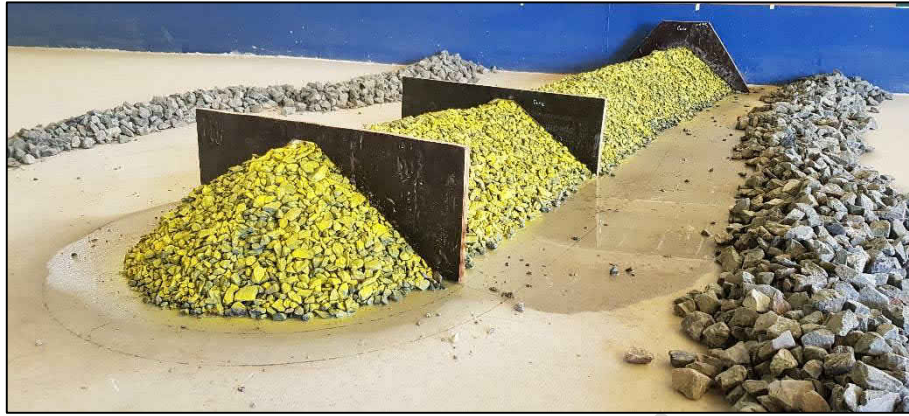
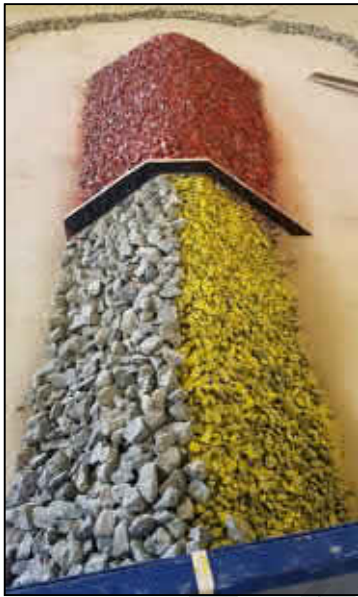
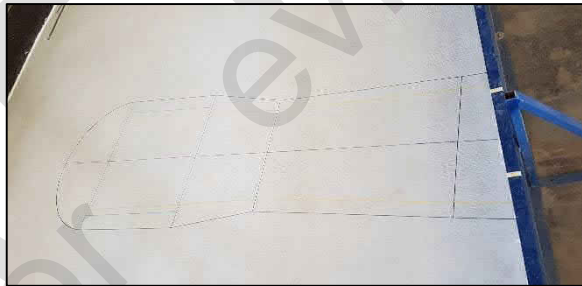
Figure 15: Photos depicting the installation of the core (top) and armour layers (bottom left) using templates. The footprint of the breakwater layers was drawn on the concrete floor as shown in the bottom right picture.

Cross-section	Design Description	Photo
<p><b>CH 60</b></p>	<p>Breakwater: crest elevation +7.8m AHD, crest width 5 m, slope 1:1.5</p>	
<p><b>CH 950</b></p>	<p>Breakwater: crest elevation +5.4m AHD, crest width 5 m, slope 1:1.25</p>	
<p><b>CH 800</b></p>	<p>Rock revetment: crest elevation +5.3 m AHD, crest width 5 m, slope 1:1.25</p>

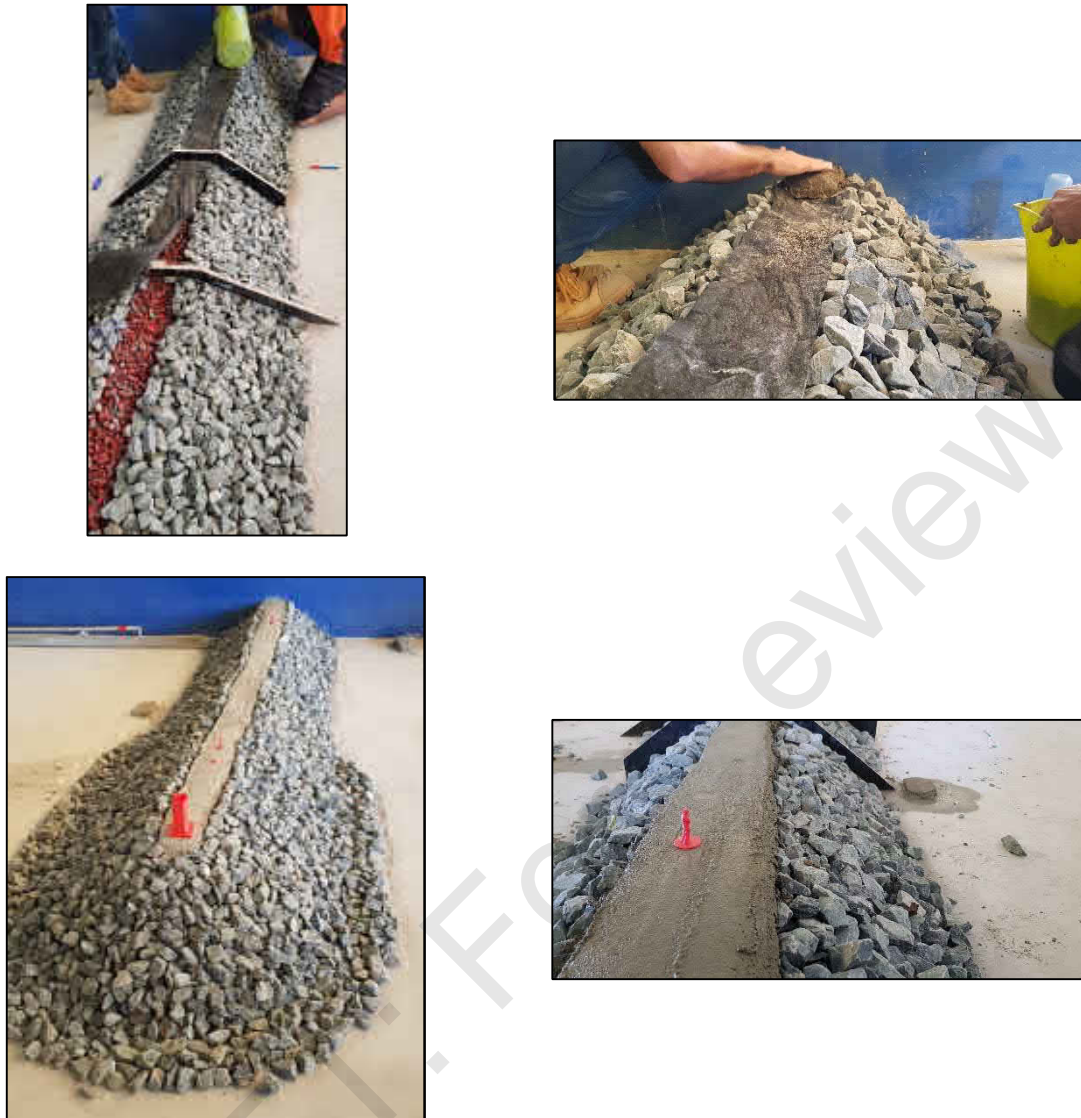
Figure 16: installation of the 5m wide walkway.

Following the installation of the armour layer, a sand and cement grout was placed along the length of the crest of the breakwater in the model to represent the 5 m-wide walkway in the prototype. To provide a similar build-approach to the prototype, geofabric was placed to contain the pour of the concrete path (Figure 16).

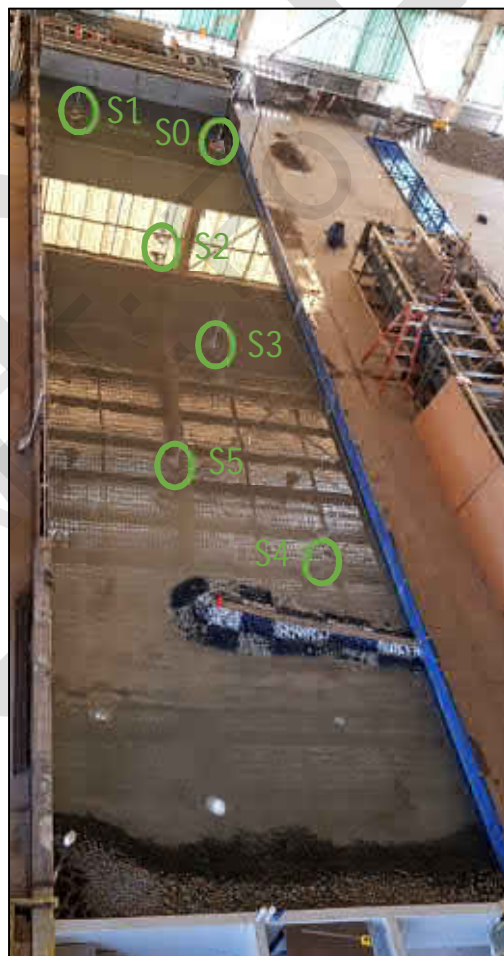
Figure 18: Flume model setup overview showing the location of the six deployed wave probes (green circles).

with probes deployed. The two offshore probes (S001 and S002) are visible in this photo, nearest the paddle

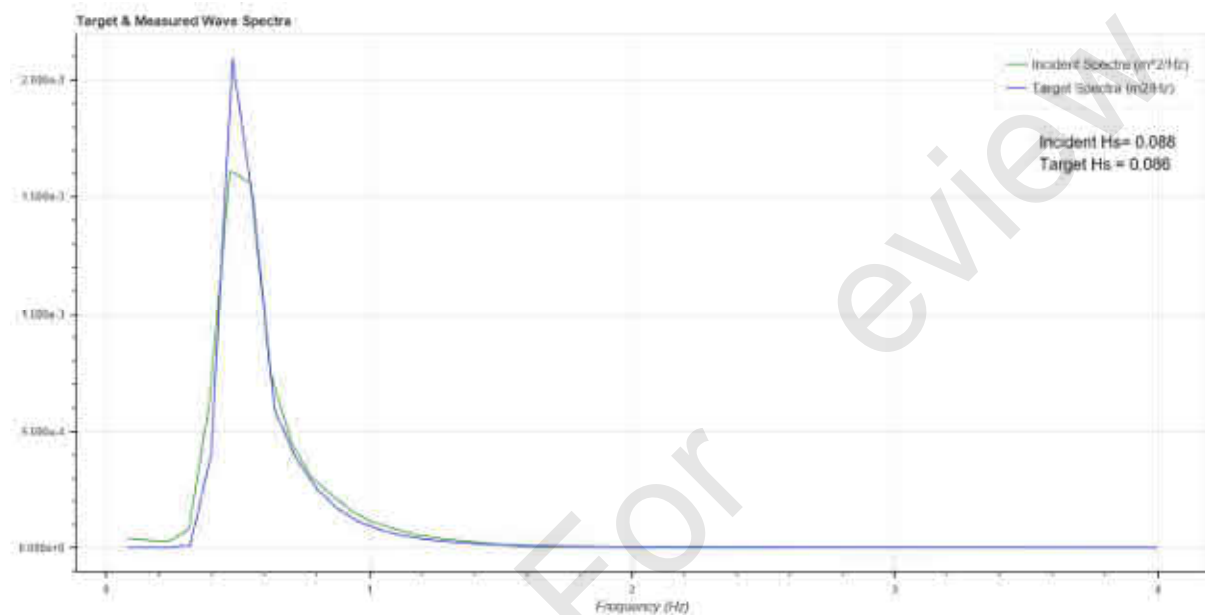
Figure 19: Example of measured and target JONSWAP spectrum for Test 001.

The wave paddle was driven by the HR Merlin software to generate random JONSWAP spectra (Gamma = 3.3, i.e., default) waves. Wave drive signals were generated to match the  $H_{m0}$  specified for the offshore wave conditions (Table 1) through adjustment of the gain factor, if necessary.

Drive signals were generated to match offshore JONSWAP wave spectra (Figure 19). resistance probes were used to monitor the incident waves and wave propagation over the model bathymetry. The wave drive signal was generated during the setup stage of the project, with the breakwater in place. The breakwater was then rebuilt before commencing official testing (Test 1).

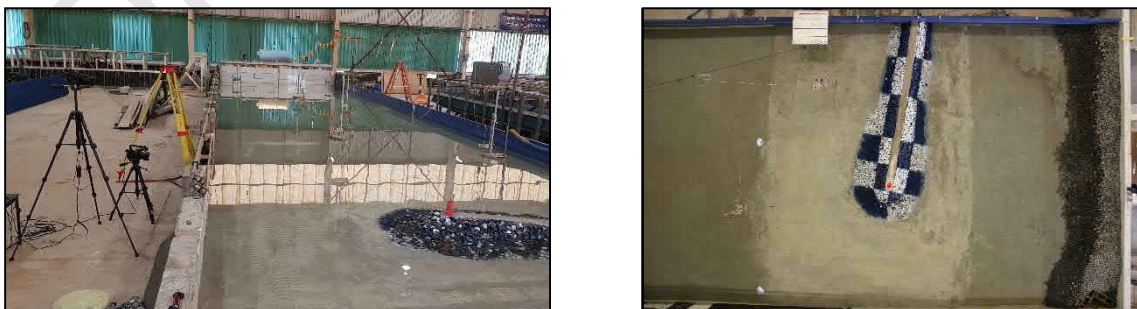
Figure 20: Side view video cameras (left). A frame from the overhead video camera is also shown (right).

Side placement and overhead view video cameras (in total three) documented each test. Photos were also taken opportunistically through testing. The overhead video camera was used to take before and after images of the structures to determine movement during testing. All before and after photos are provided in Appendix B.

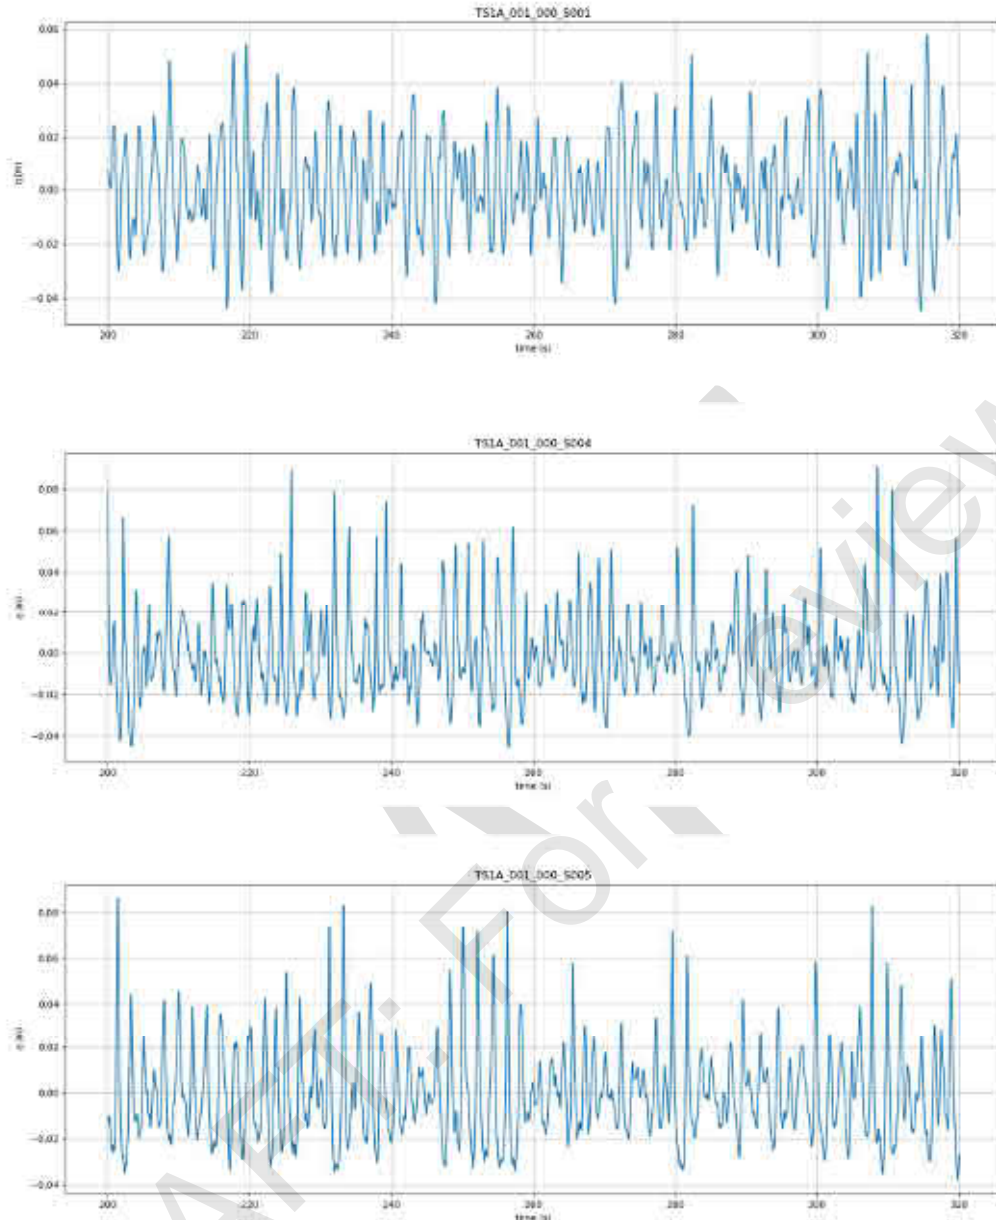
Figure 21: Surface elevation time series sample for the offshore probe S1 (top), trunk probe S4 (middle), and roundhead probe S5 (bottom).

Probe no.	S0	S1	S2	S3	S4	S5
$H_{m0}$	0.085	0.086	0.085	0.089	0.091	0.096
$T_p$	1.932	1.969	1.932	1.896	2.008	1.969
$H_s$	0.082	0.082	0.085	0.092	0.096	0.106
$H_{ave}$	0.053	0.052	0.053	0.057	0.059	0.065
$H_{max}$	0.153	0.160	0.158	0.214	0.178	0.182
$T_z$	1.585	1.553	1.627	1.691	1.466	1.677

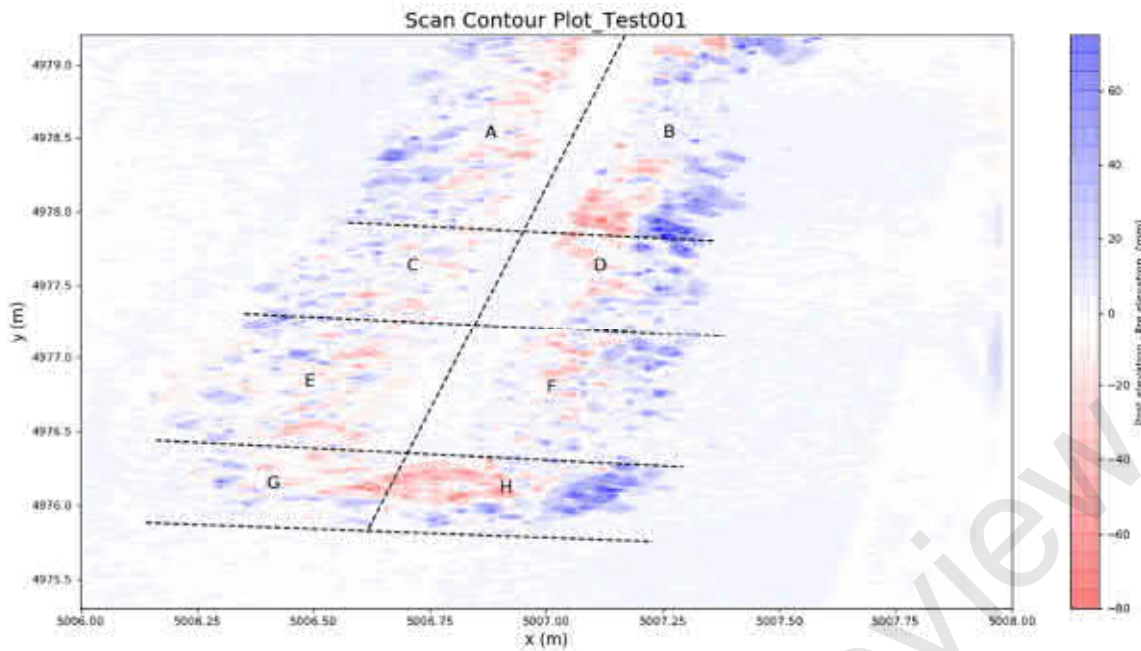
Figure 23: Difference plot of total accumulated structural changes before and after Test01, showing eroded and accumulated areas. Noticeable damage at section H and section B. (Description of the labels is provided in Table 6).

Before and after each test series a 3D laser scan was obtained. Figure 23 presents a difference plot of the total change in the breakwater after Test 01. There was a fairly uniform reduction in elevations near the crest and increase in elevations towards the toe, indicating a down-slope displacement of rocks. During testing, rocks were also occasionally observed to be displaced from the face, washing leeward onto the walkway and further, to the lee side of the breakwater.

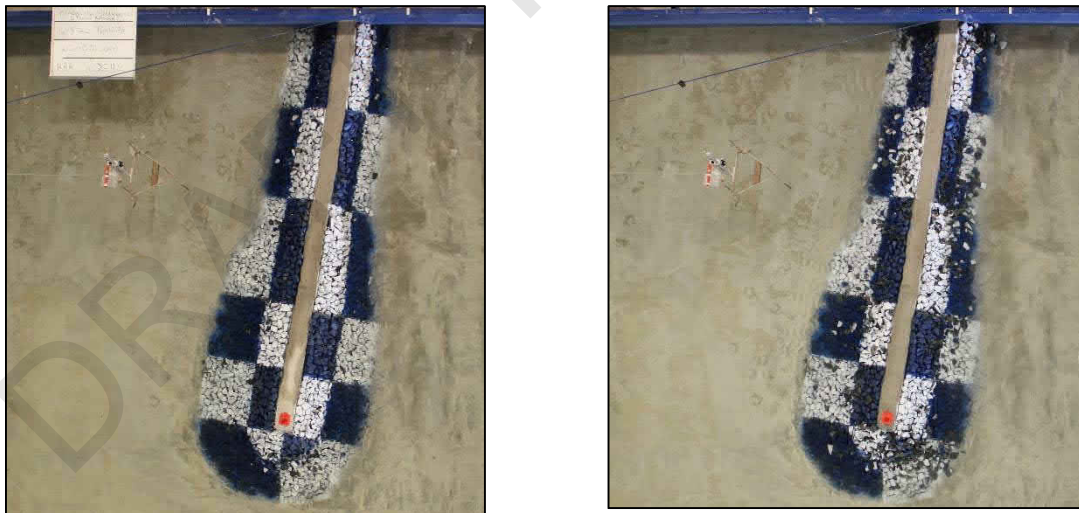
Figure 24: Overhead photo before Test01 (left) and after Test01 (right).

The overhead photo stability analysis was performed with the camera located above the structure (Figure 24) with a photo captured before and after each test. The number of rocks displaced and rocking were determined on the basis of those pictures, Table 6.

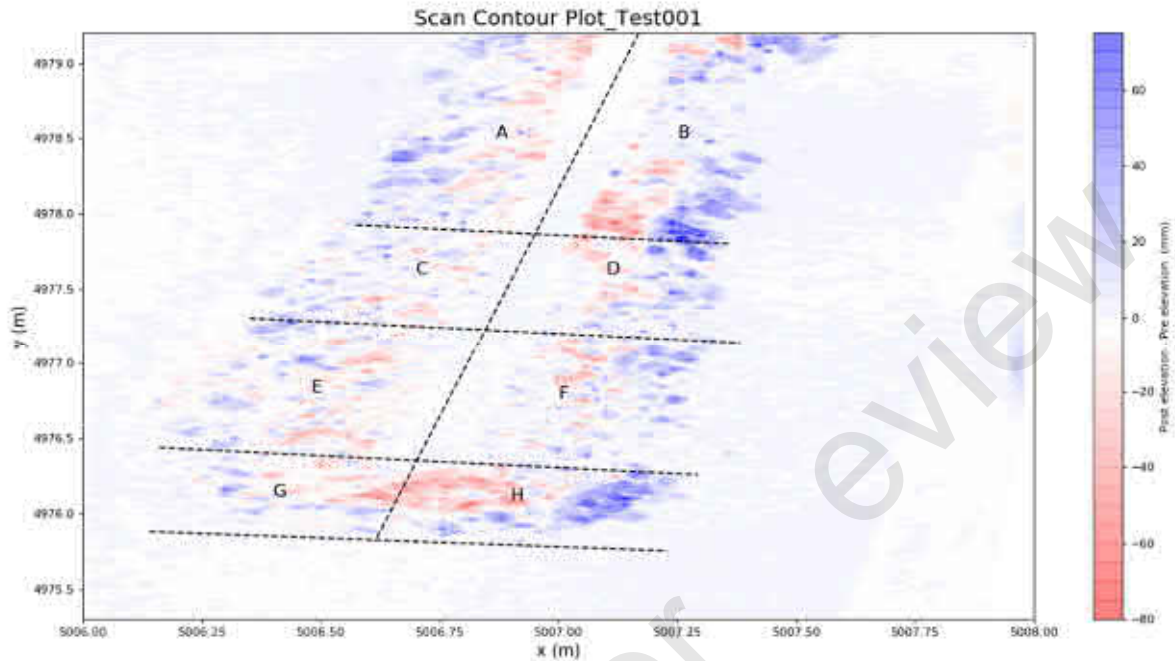
## Test0\_ Difference plot of structural changes

Test001_000_20200221						
Section	Side	Label	Area (mm <sup>2</sup> )	Rocking	Displacement	Damage(%)
Section1_CH950&800	Front	A	516971	44	22	10
	Back	B	516971	41	32	15
Section2_Transition	Front	C	288035	36	14	12
	Back	D	288035	30	17	14
Section3_CH60	Front	E	462499	64	15	8
	Back	F	462499	58	14	7
Section4_Roundhead	Front	G	295260	30	9	7
	Back	H	295260	43	21	17

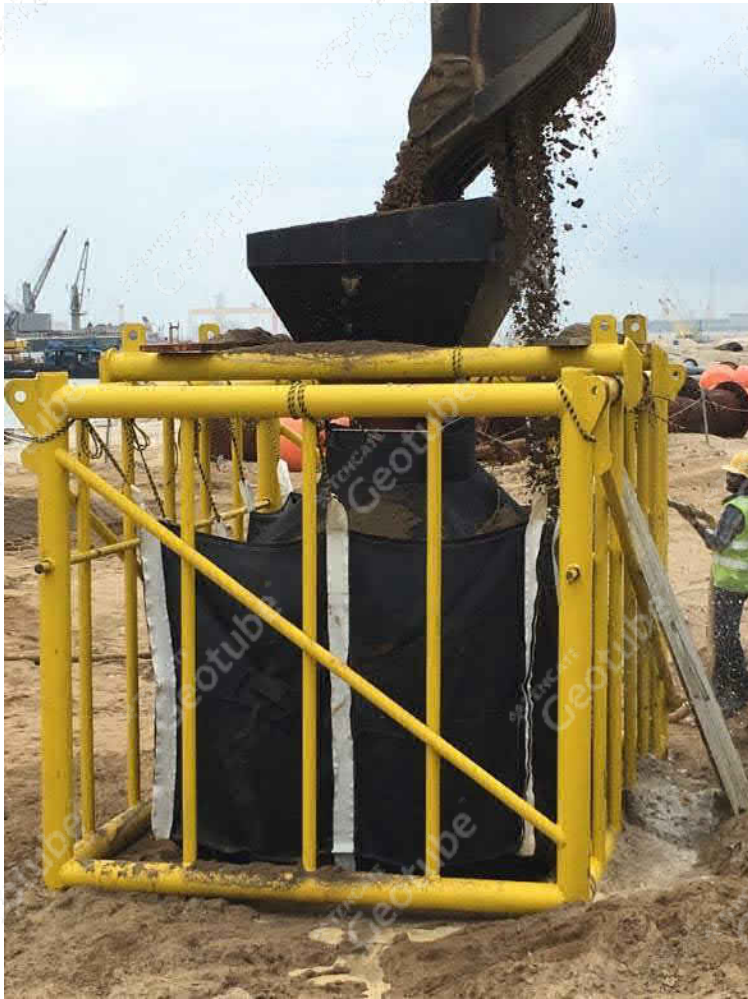
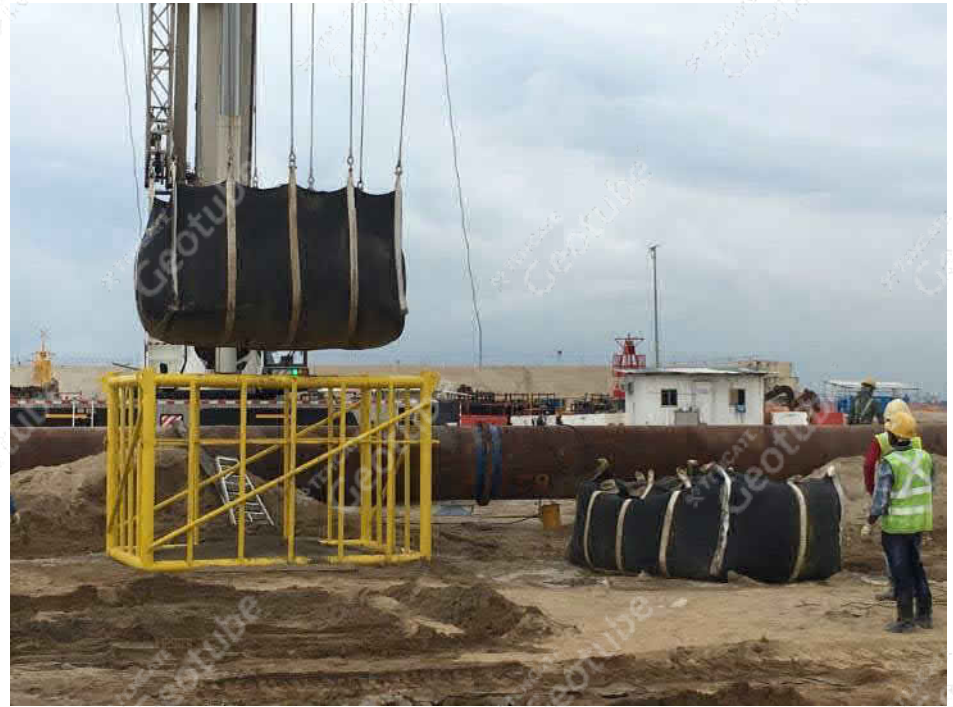
Large Geobags require fabrication of a customized filling frame.

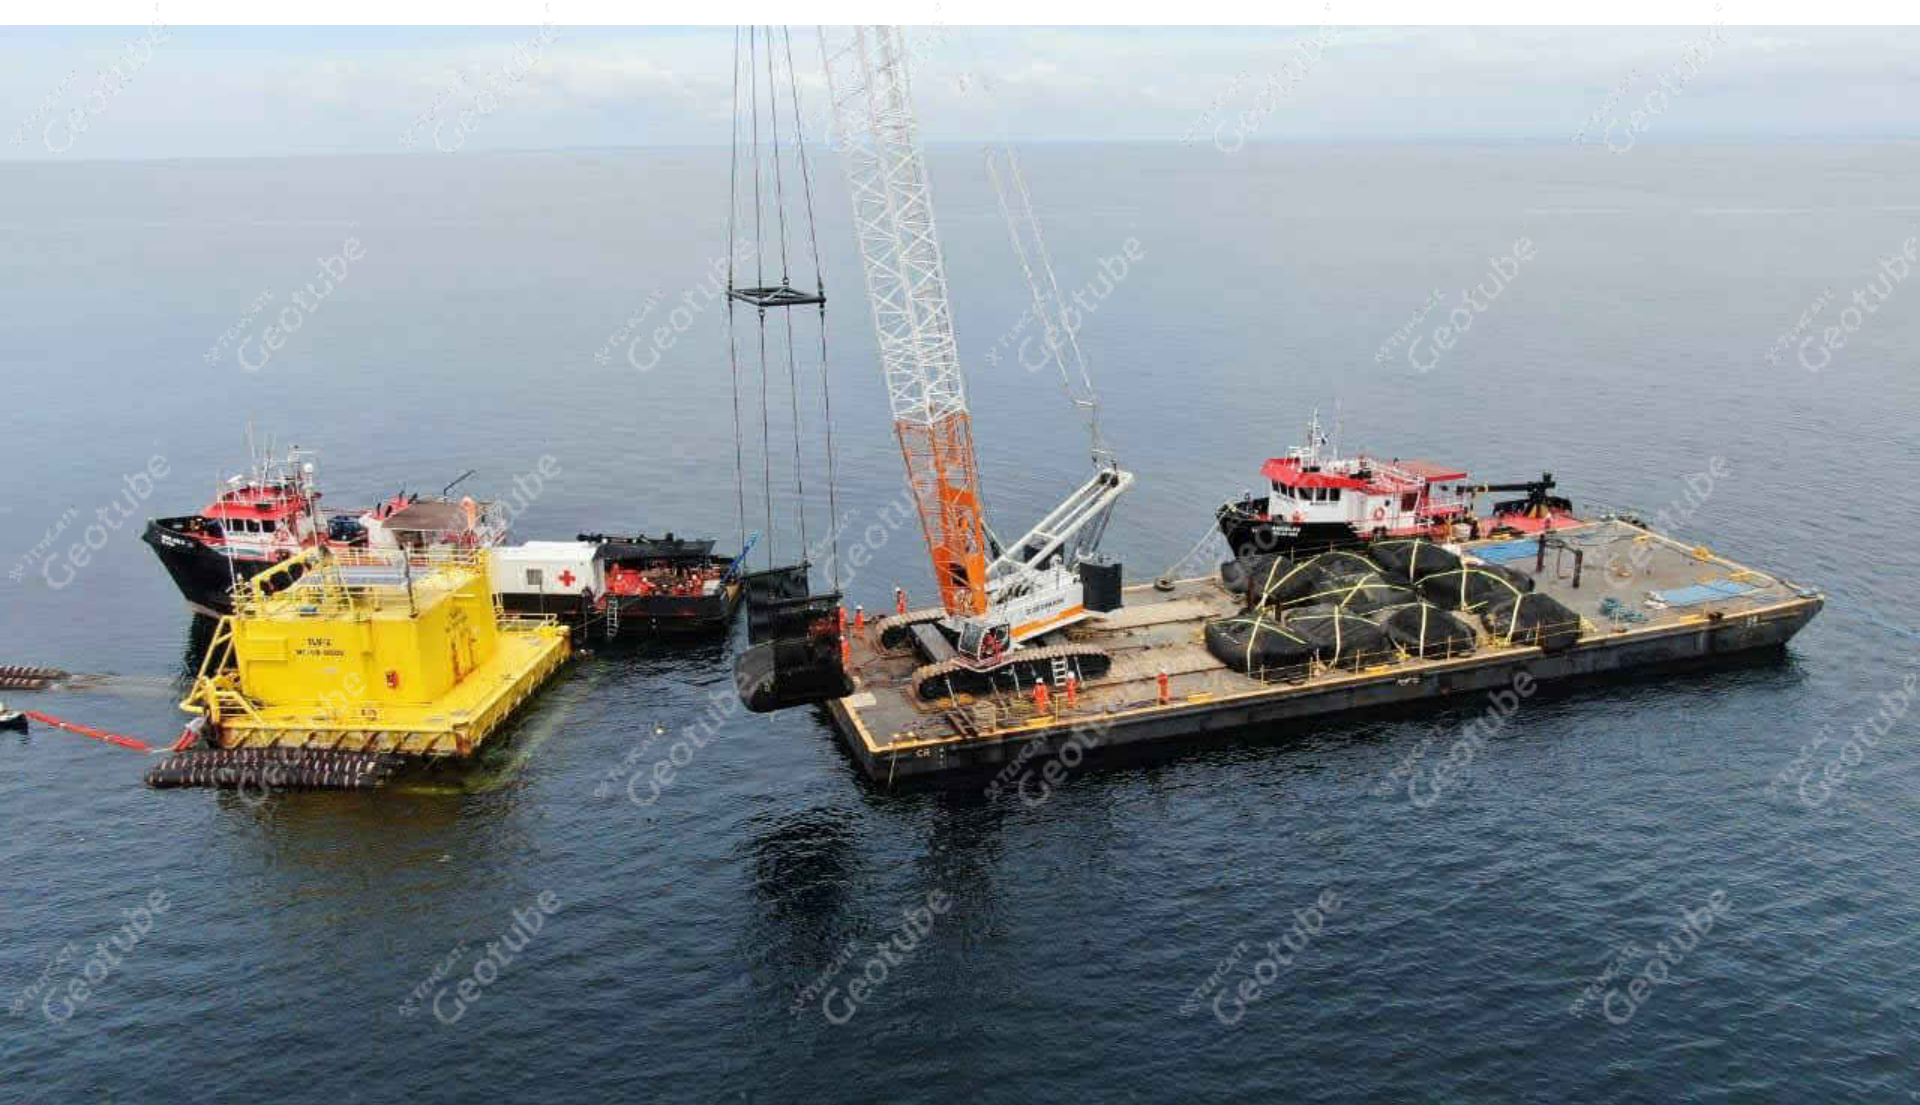
# Lifting & Placement of Large Geobag Units using Geogrid Slings

Tencate Mirafi GX Geogrid Strength Range 40kN/m – 400kN/m
