**REPORT OF THE BOARD OF INQUIRY
INTO THE MARINE INCIDENT
INVOLVING THE SHIP *WUNMA* IN THE
WATERS OF THE GULF OF
CARPENTARIA ON 6 AND 7 FEBRUARY
2007**

WUNMA BOARD OF INQUIRY

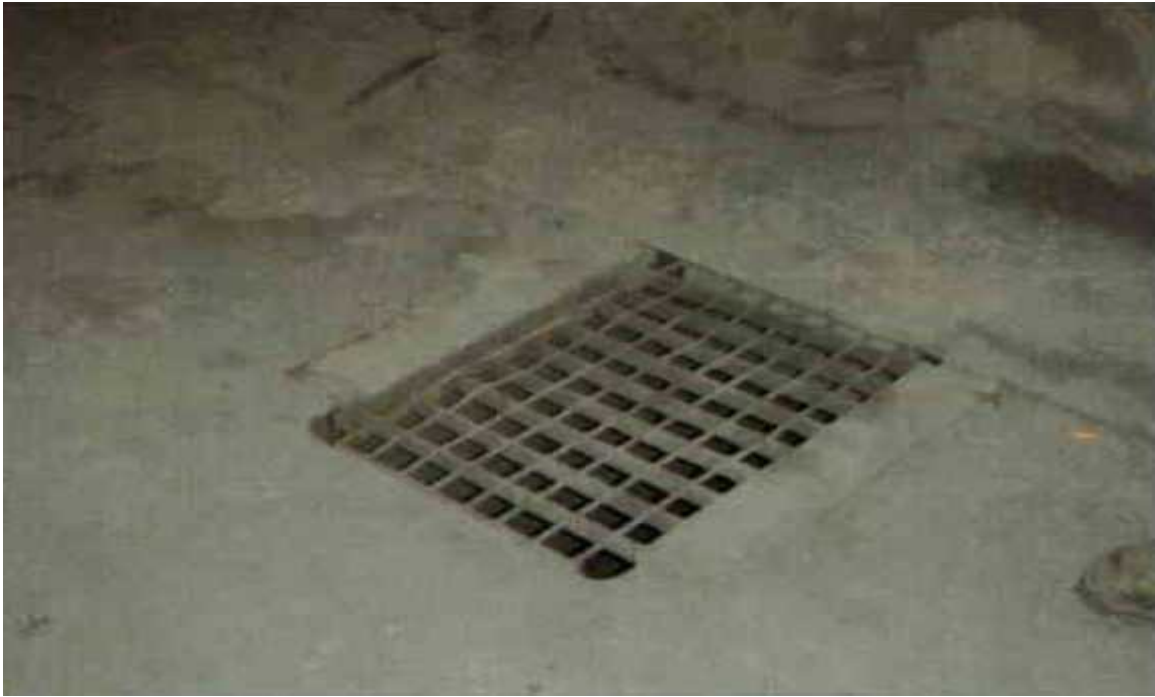
Figure 7 - Aft Well Deck Sump

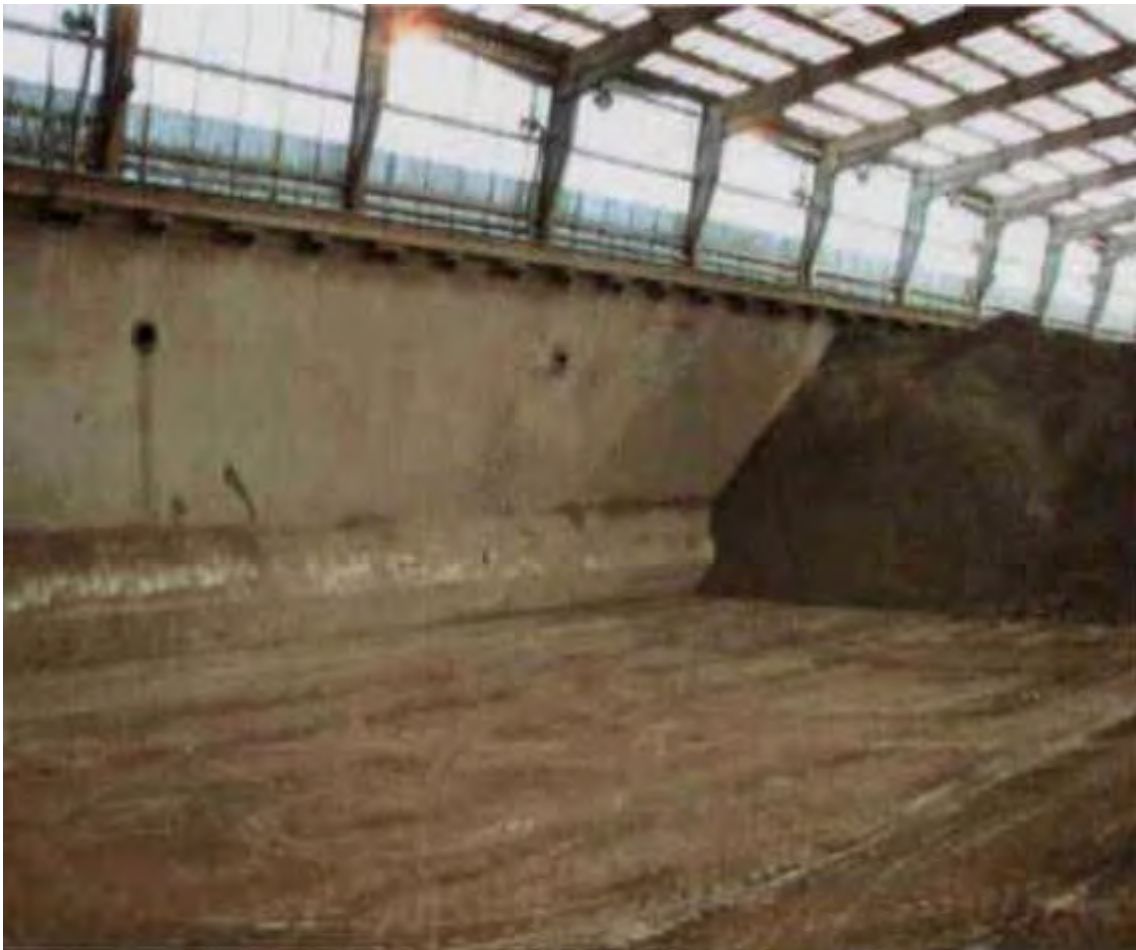
Figure 8 - Washdown Outlets from under the Conveyor

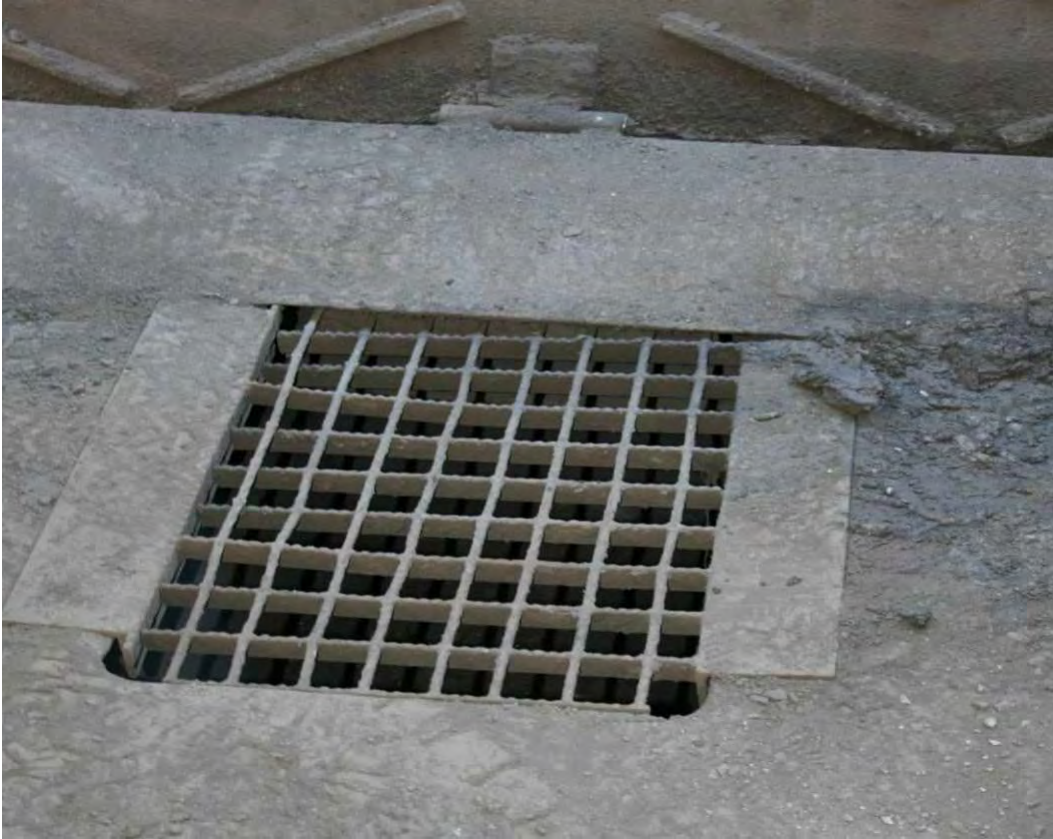
Figure 5 - The Aft Well Deck Sump

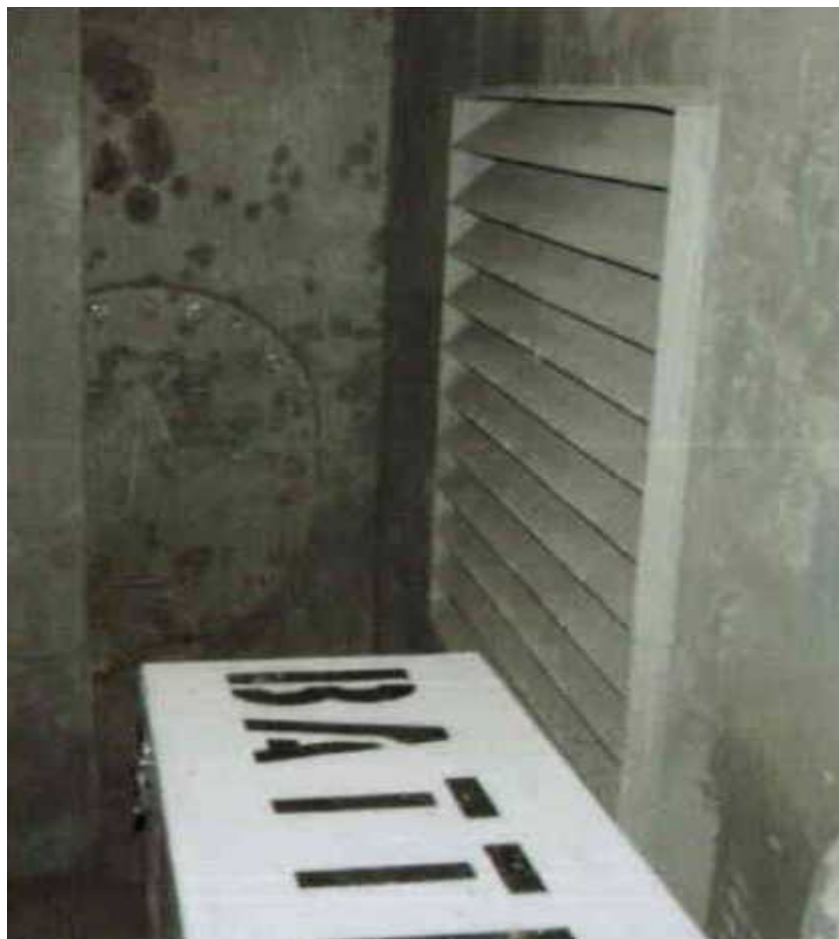
Figure 8 - Radiator Vent - Emergency Generator Room

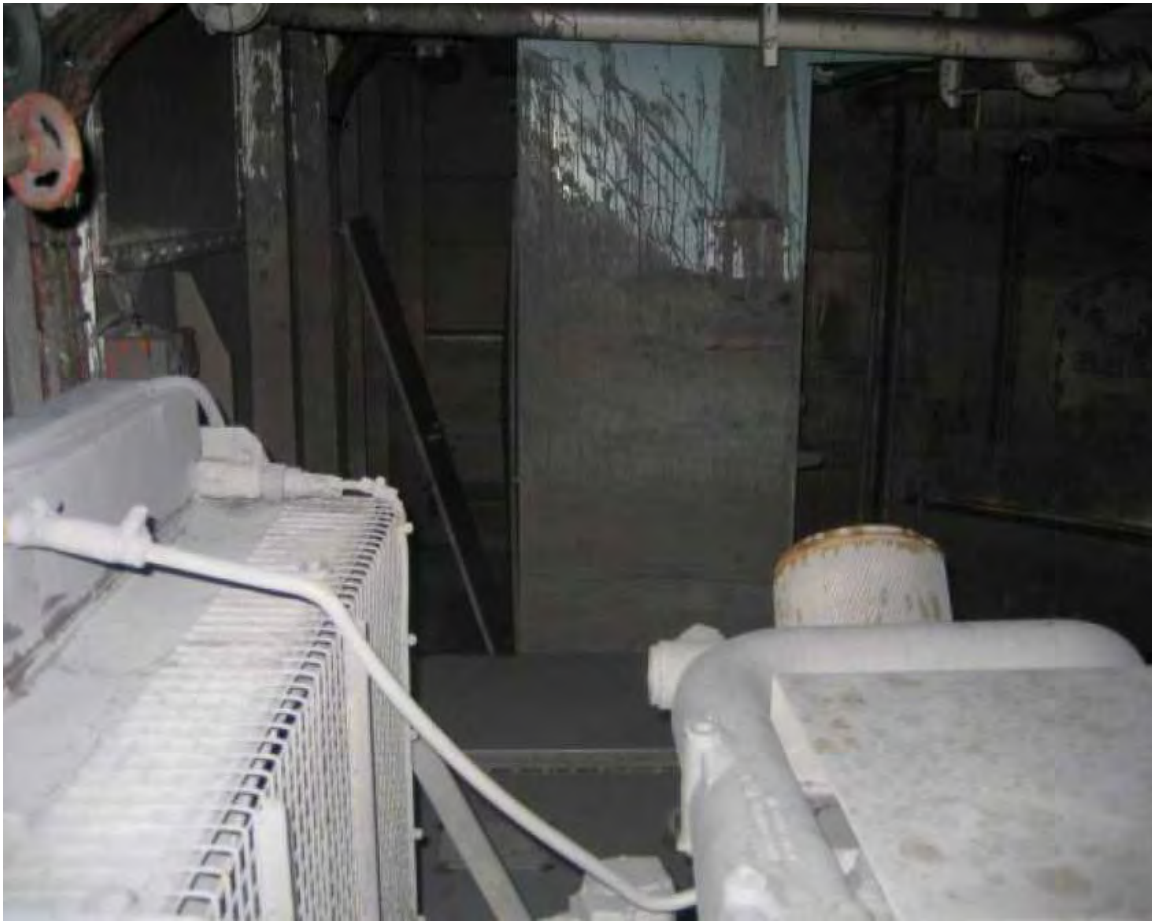
Figure 6 - Inside the Emergency Generator Room

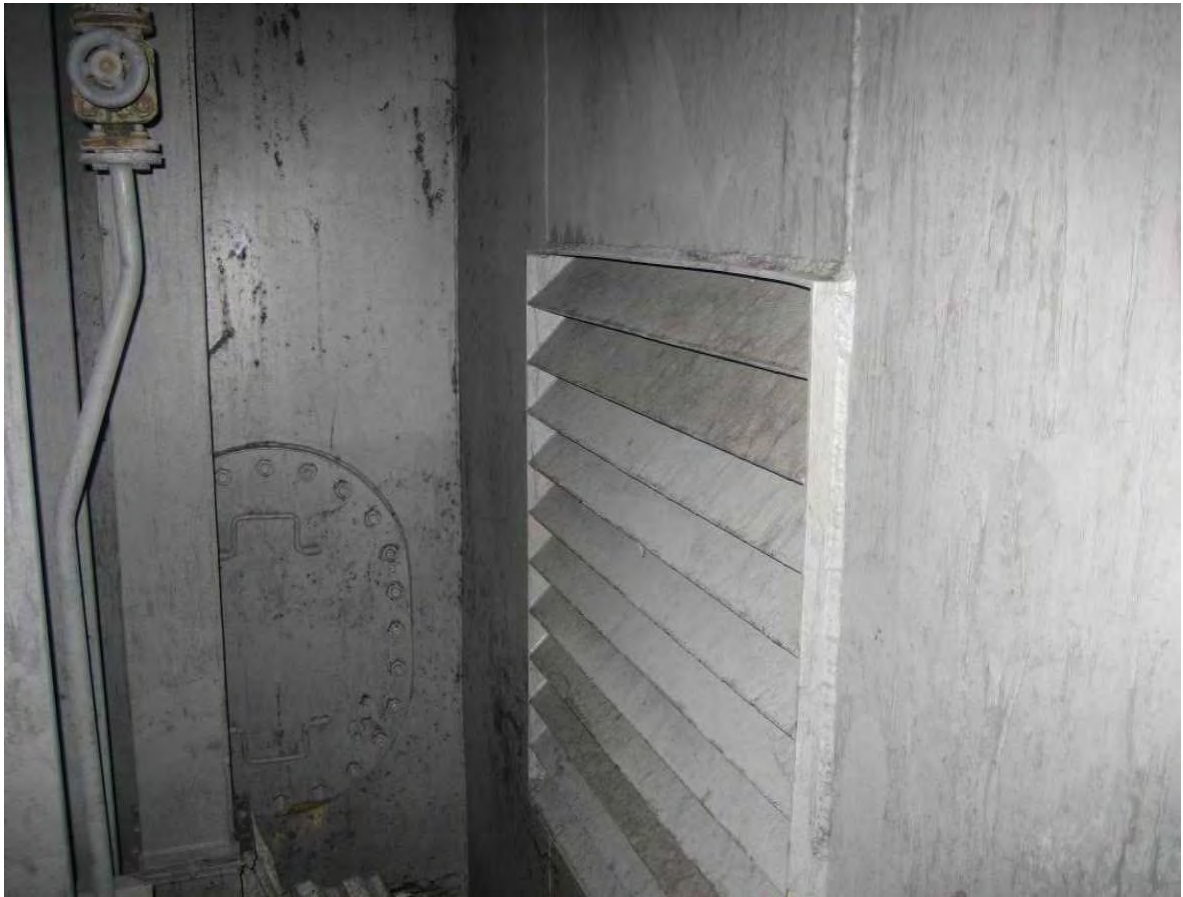
Figure 14 - Louvered Vent from the Emergency Generator Room

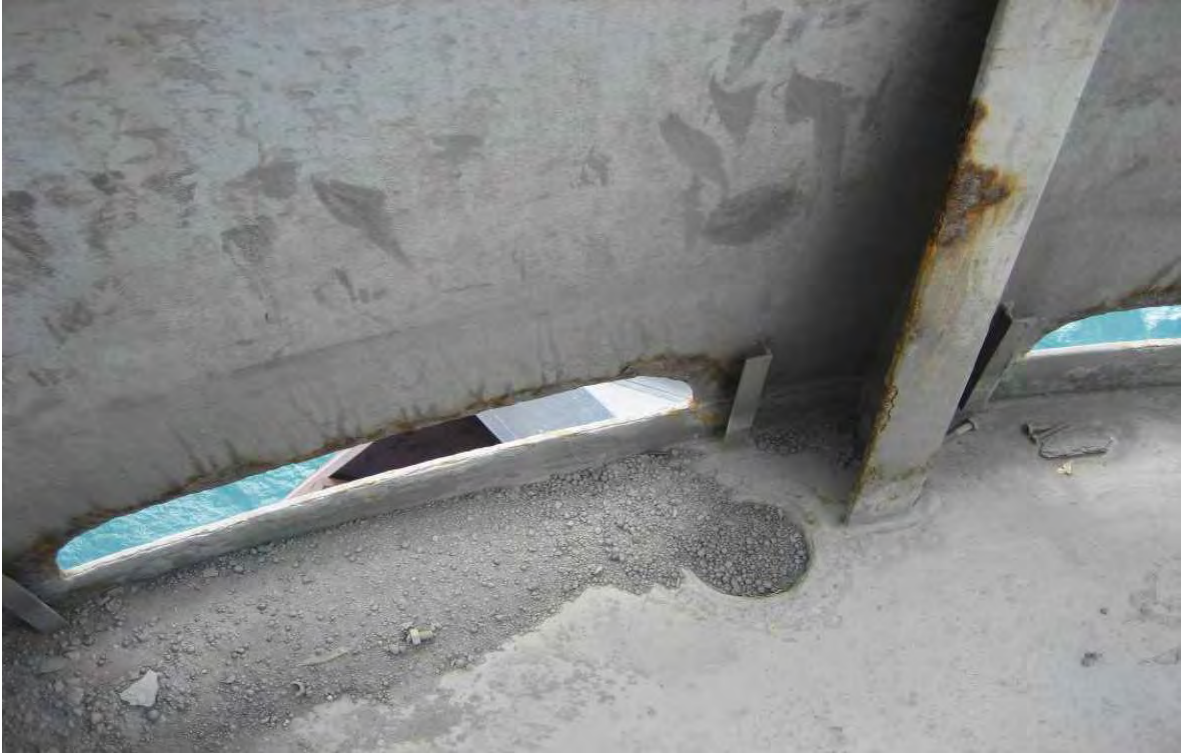
Figure 20 - Freeing Ports - Starboard Aft Quarter Deck
