# Mooloolaba Boat Harbour Eastern Breakwater Extension

Constructability Report

Prepared for:  
DEPARTMENT OF TRANSPORT AND MAIN ROADS

BEJ952-TD-ST-REP-0001 Rev 0

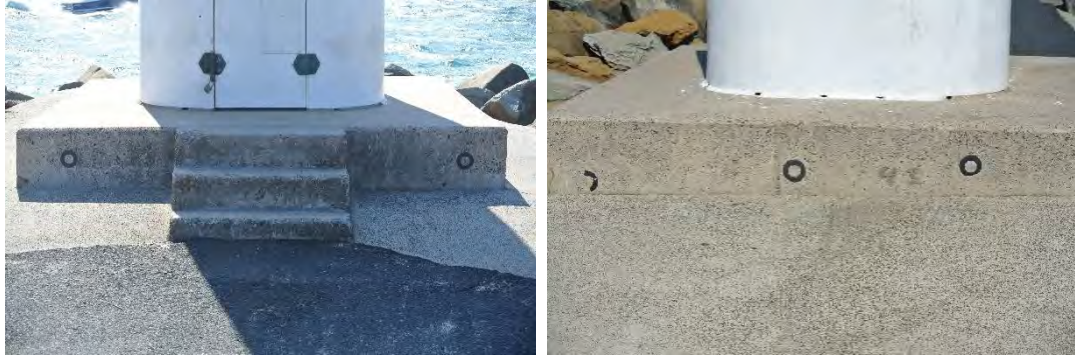
Figure 3.5 Base of existing navigation beacon and pad footing slab. Left: landward perspective towards the northwest. Right: seaward perspective looking towards the southeast.

The navigation aid footing (Figure 3.5) was measured as 3 m × 3 m as per drawings supplied. The navigation aid has a height of 4.4 m and a width of approximately 1.7 m. Drawings indicate the navigation aid is constructed from GRP (glass reinforced plastic) and with a wall thickness of 85 mm. The total mass of the beacon is currently unconfirmed. For the purposes of this investigation, the beacon is assumed to have an approximate mass of 4 tonnes, inclusive of the internal aluminium platform and lamp stand.

Without access to the door of the navigation beacon, an external inspection was conducted. No lifting lugs were noted on the structure. It appears to be structurally sound with no signs of external deterioration. Therefore it should be able to be relocated and reused (subject to internal inspection).

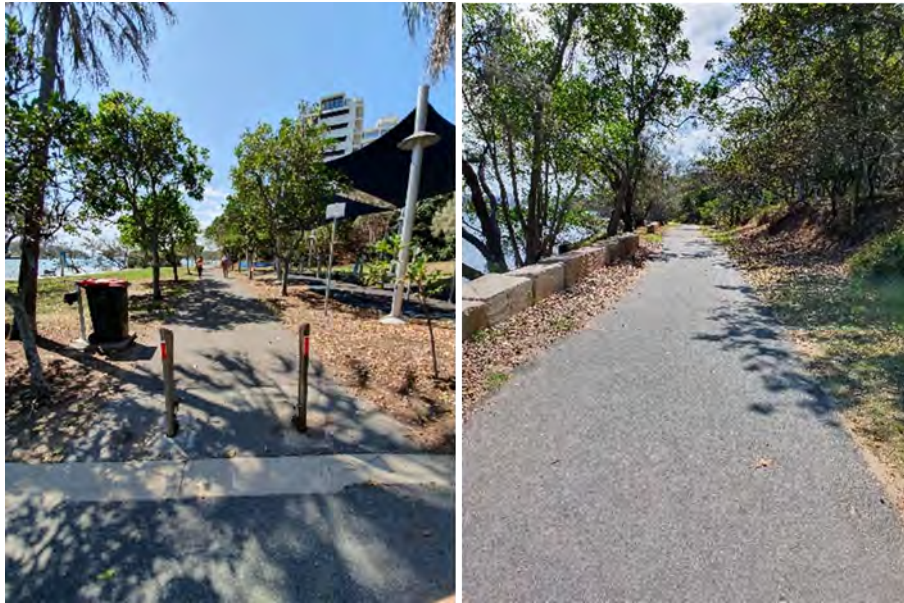
Figure 4.1 Existing footpath along the eastern bank of the Mooloolah River progressing from the car park at the northern end of Harbour Parade, Buddina towards the Mooloolah River entrance.

The path has a flat grade along its length and has adequate width for a single truck following tree trimming and in some cases, tree removal (refer to Figure 4.1Error! Reference source not found.). No guard-railing is presently in place along the Mooloolah River revetment.

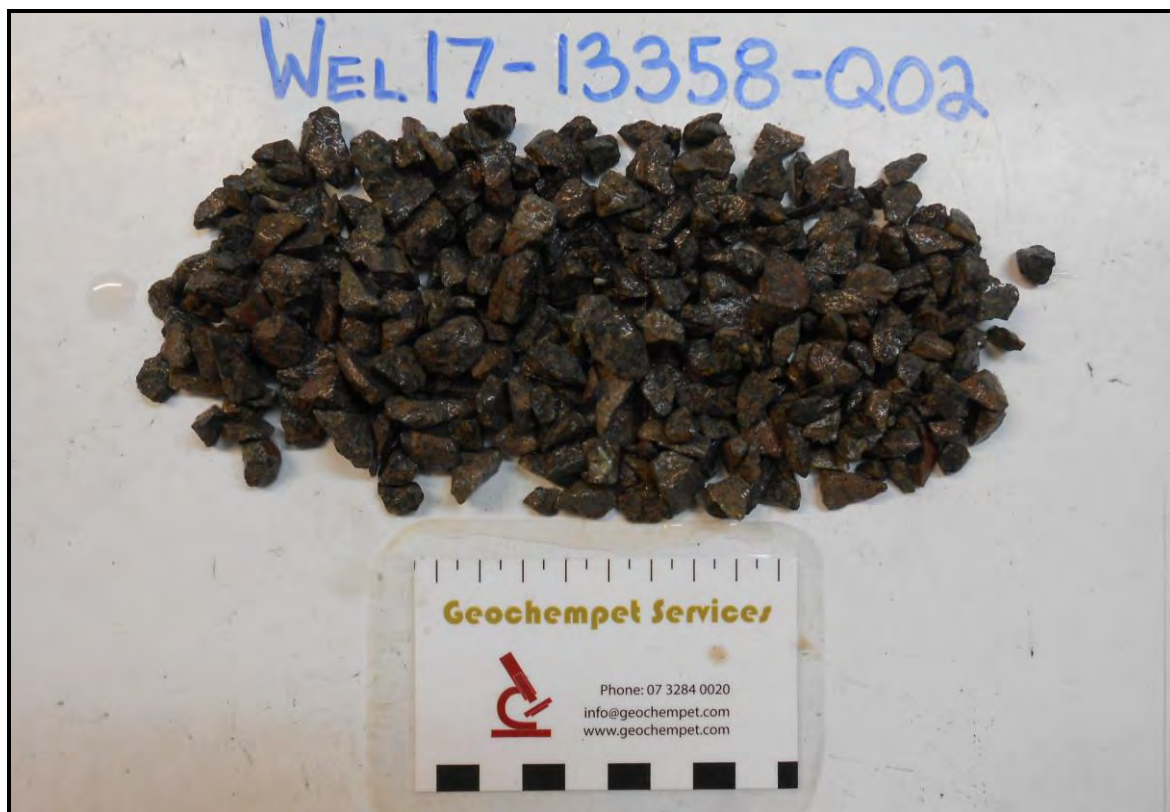
**Plate 1:** Photograph of a washed sub-sample of the supplied 10 mm aggregate.

The nominal 10 mm aggregate sample consisted of about 5 kg of crushed, angular fragments of hard, robust, now finely crystalline rock of unweathered, olive-grey to pinkish to reddish-grey appearance with pink phenocrysts of feldspar and conspicuous patches of hematitic pigmentation. It is lightly coated by an easily removed pale red dust.

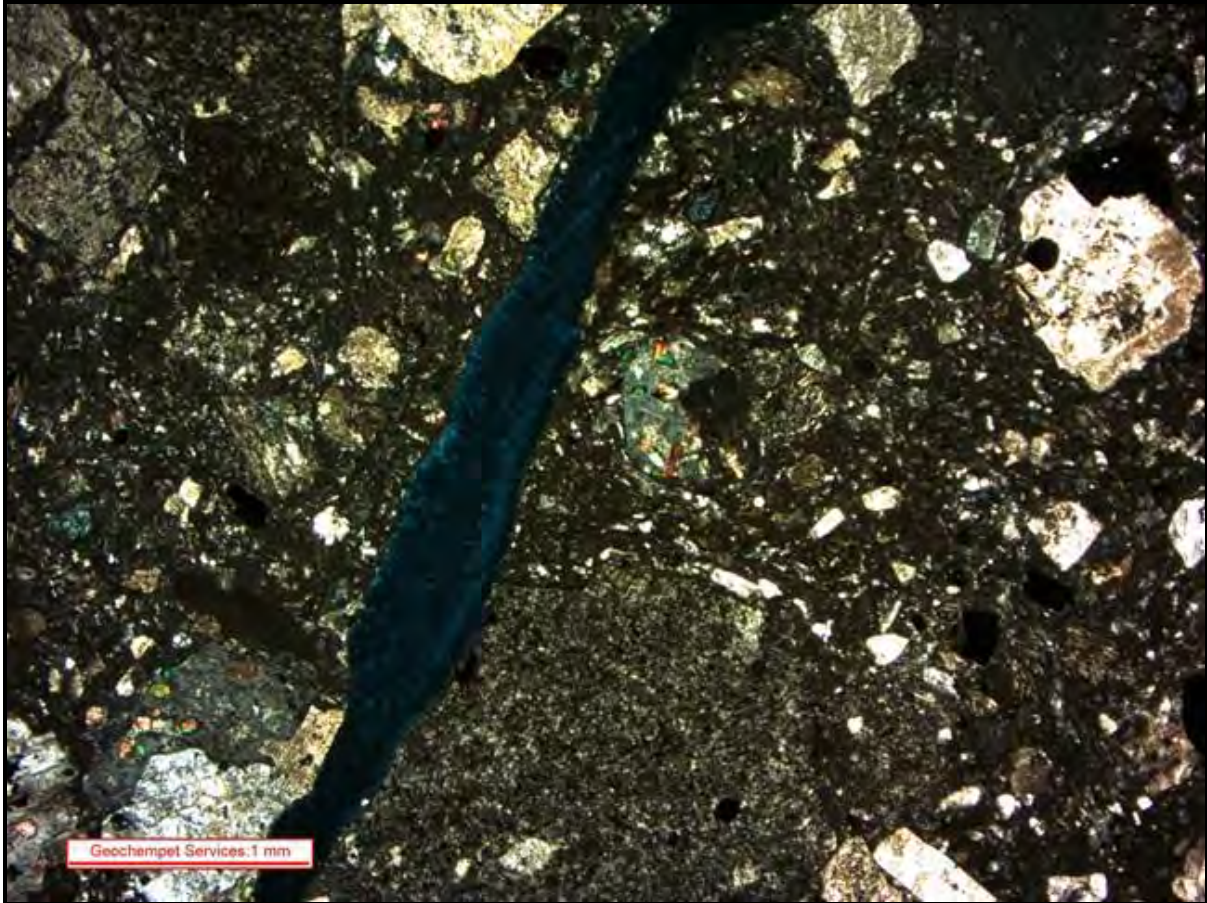
About 10% (in the form of quartz locked within a finely crystalline matrix).

**Plate 2:** Micrograph taken at low magnification, cross polarised, transmitted light image of a typical latite tuff fragment. It shows the abundantly phenoclastic rock, the phenoclasts are largely feldspar, some with alteration to epidote and sericite and smaller chloritized former mafic phenoclasts (bluish-green) in a murky feldspathic matrix.

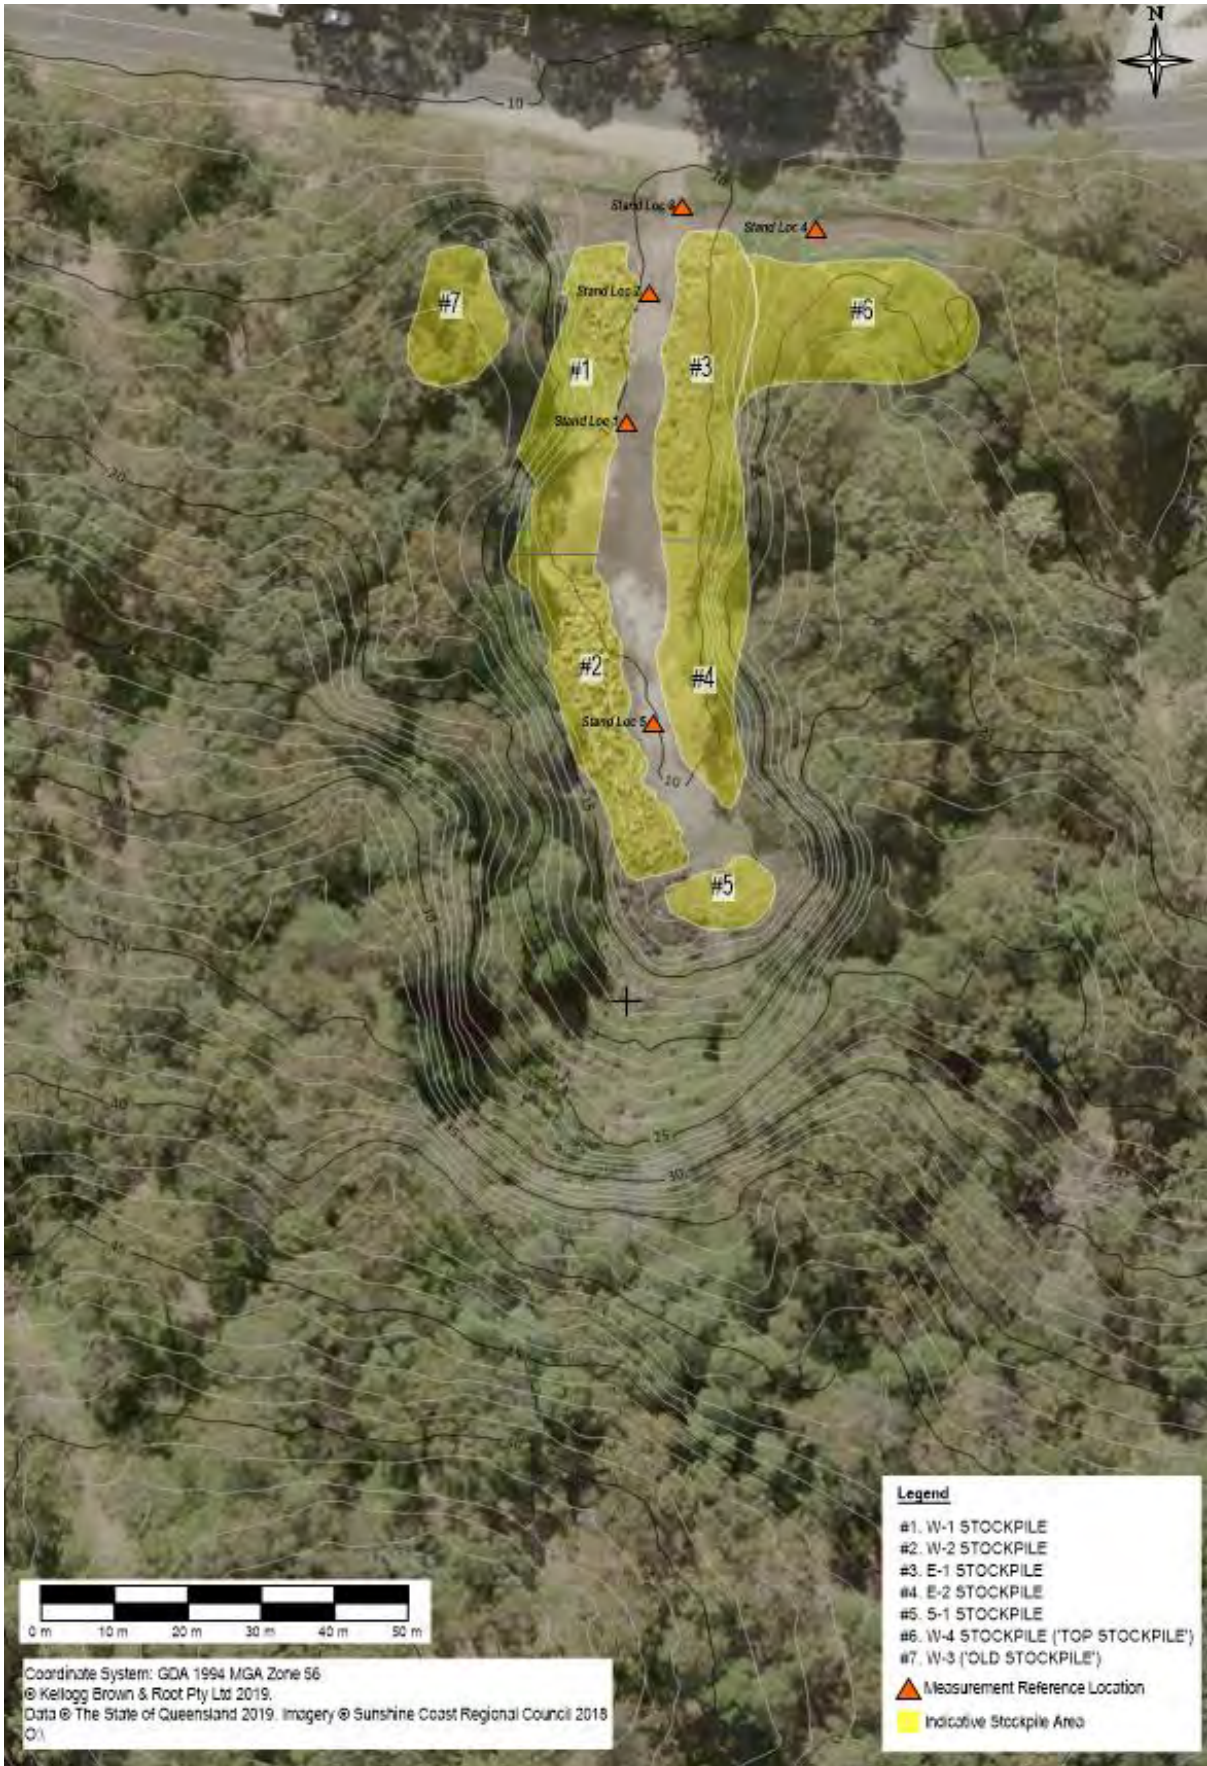
Figure 3.1 General locations and shapes of stockpile areas

Rock stockpiles were found to be widely graded, with no separation of materials into distinct grades (i.e. AS 2758.6 standard gradings). A more accurate assessment could be made if a machine fitted with a load sensor was used to sort material in the stockpiles into appropriate standard mass gradings.
