**REPORT OF THE BOARD OF INQUIRY
INTO THE MARINE INCIDENT
INVOLVING THE SHIP *WUNMA* IN THE
WATERS OF THE GULF OF
CARPENTARIA ON 6 AND 7 FEBRUARY
2007**

WUNMA BOARD OF INQUIRY

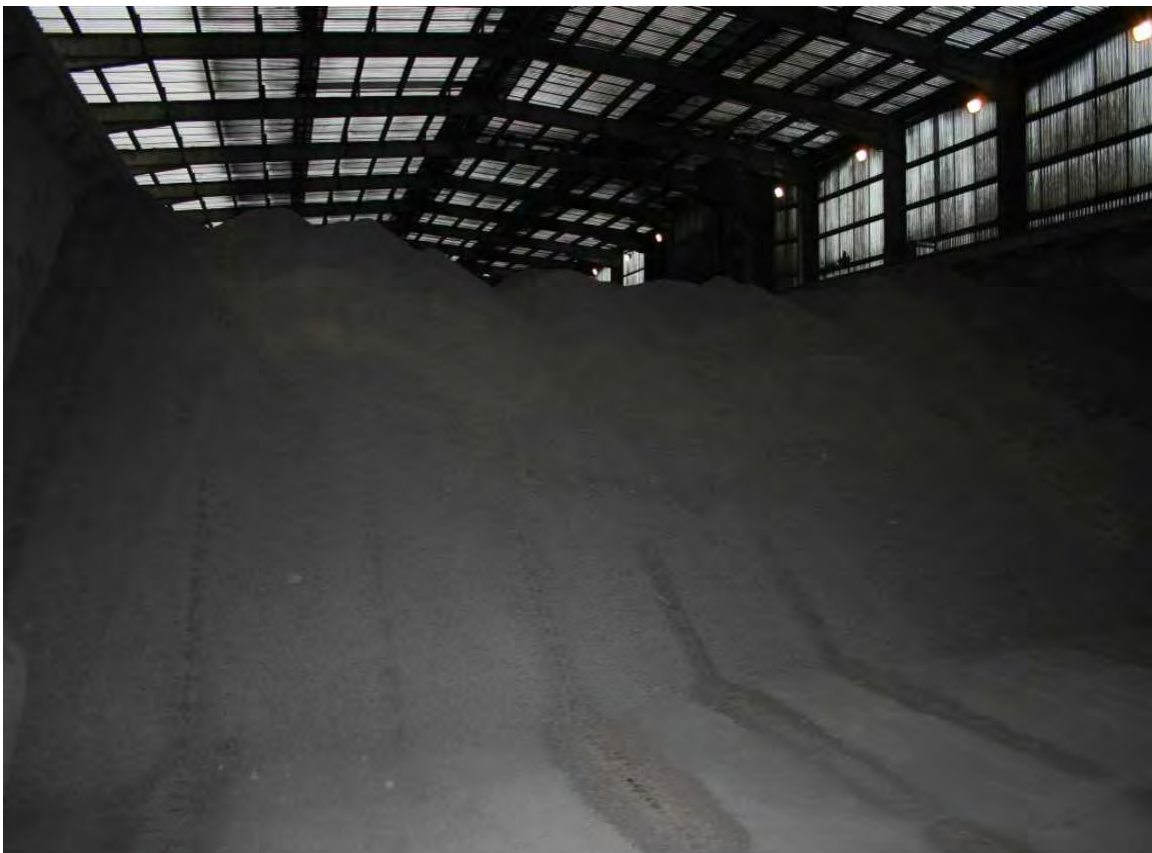
Figure 12 - Concentrate in the Cargo Hold in Typical Inclination

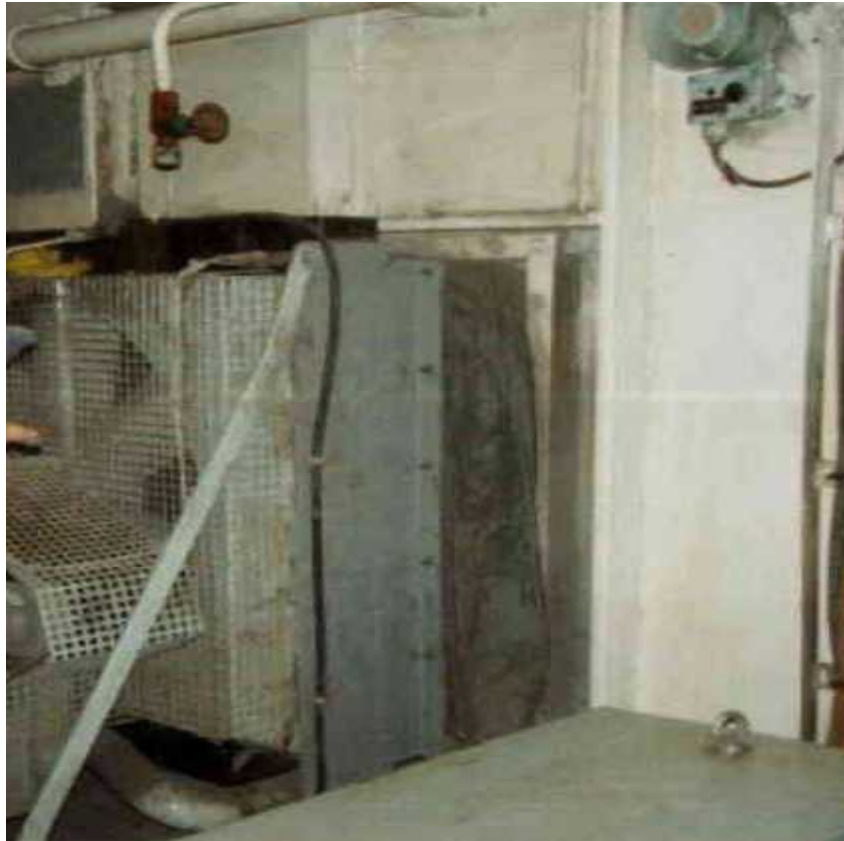
Figure 9 - Emergency Generator Radiator adjacent to Vent

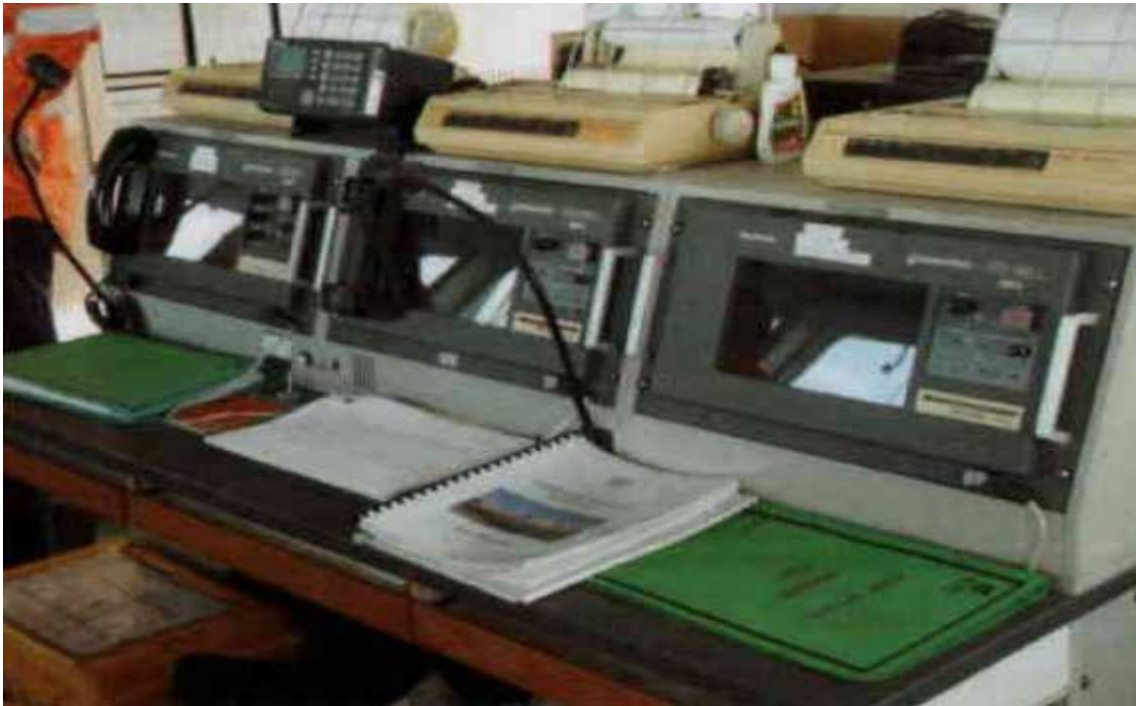
Figure 1 - MF/HF Radio, 2 x SatComm C Units and 3 x Printers

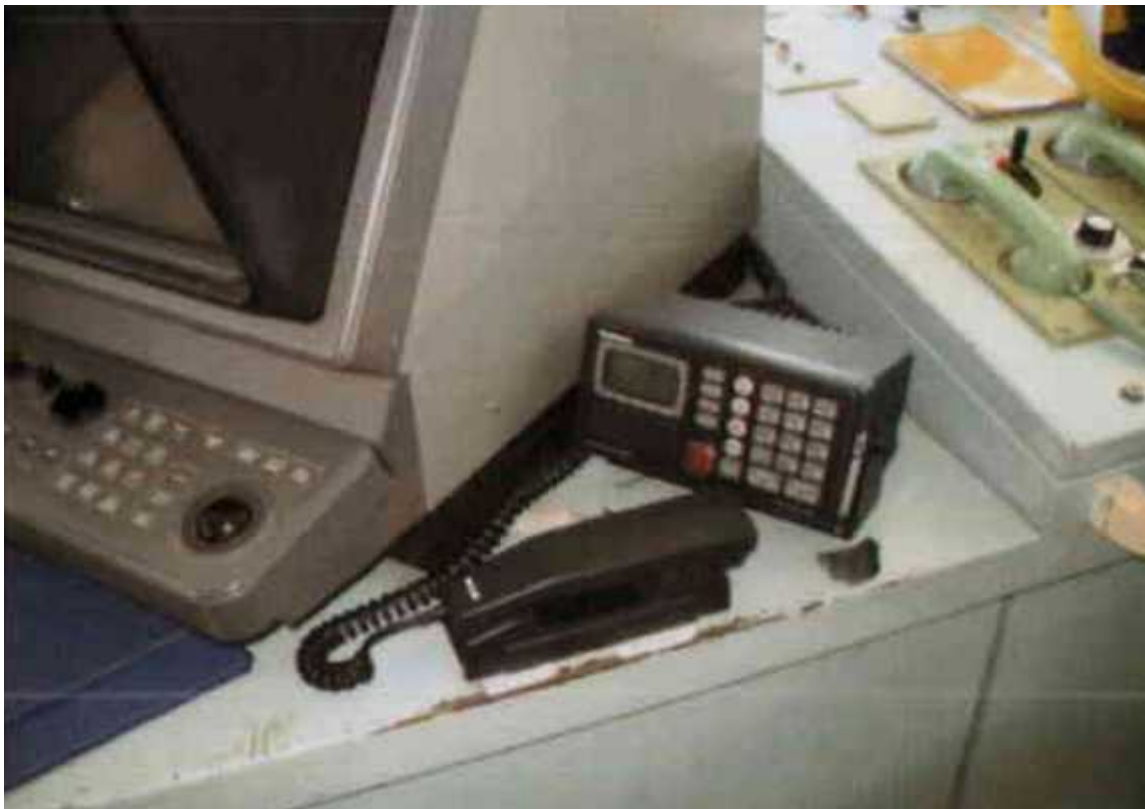
Figure 2 - The GMDSS VHF Radio

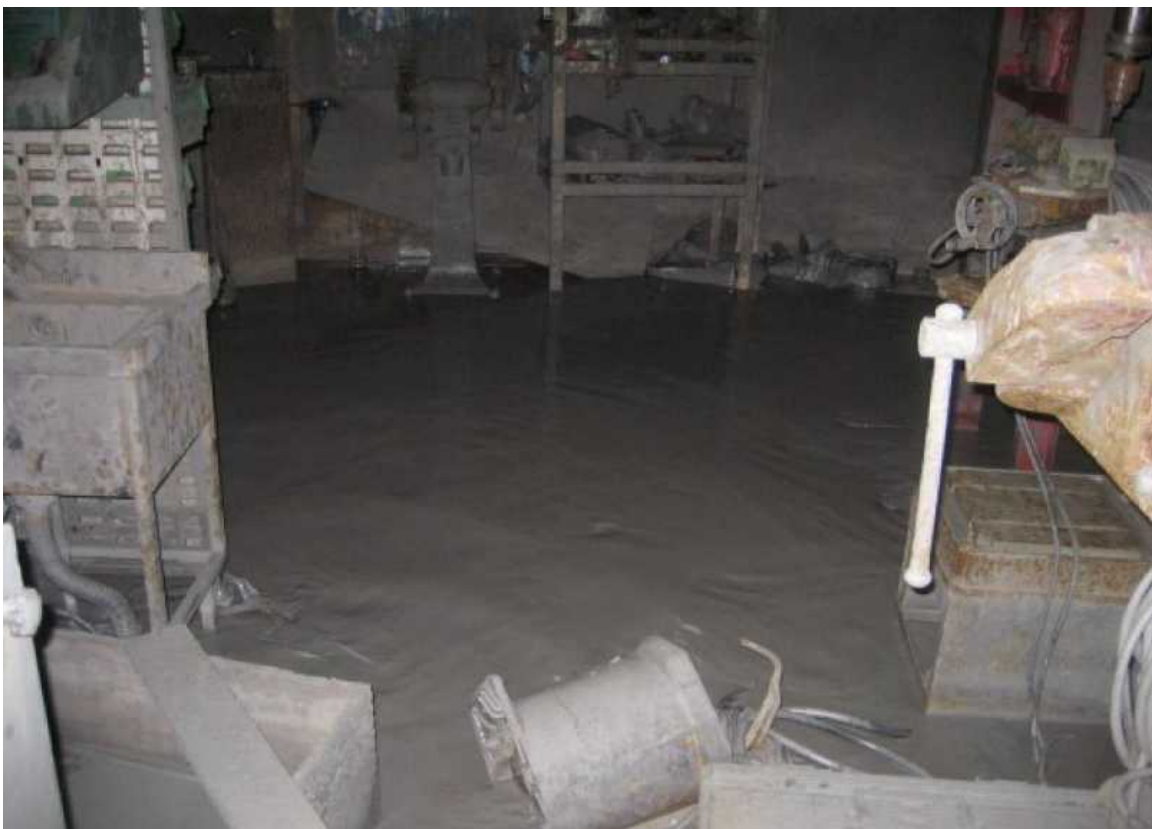
Figure 7 - Inside the Hot Workshop

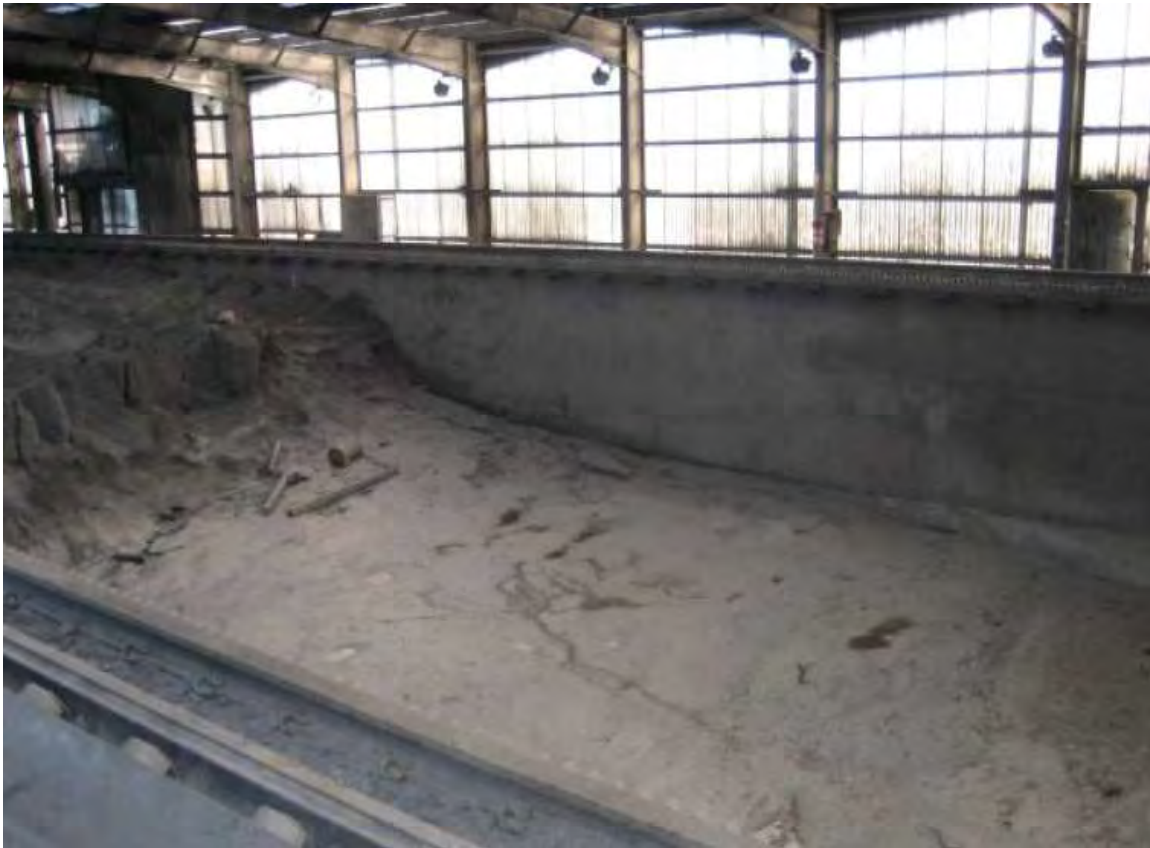
Figure 8 - The Cargo Hold

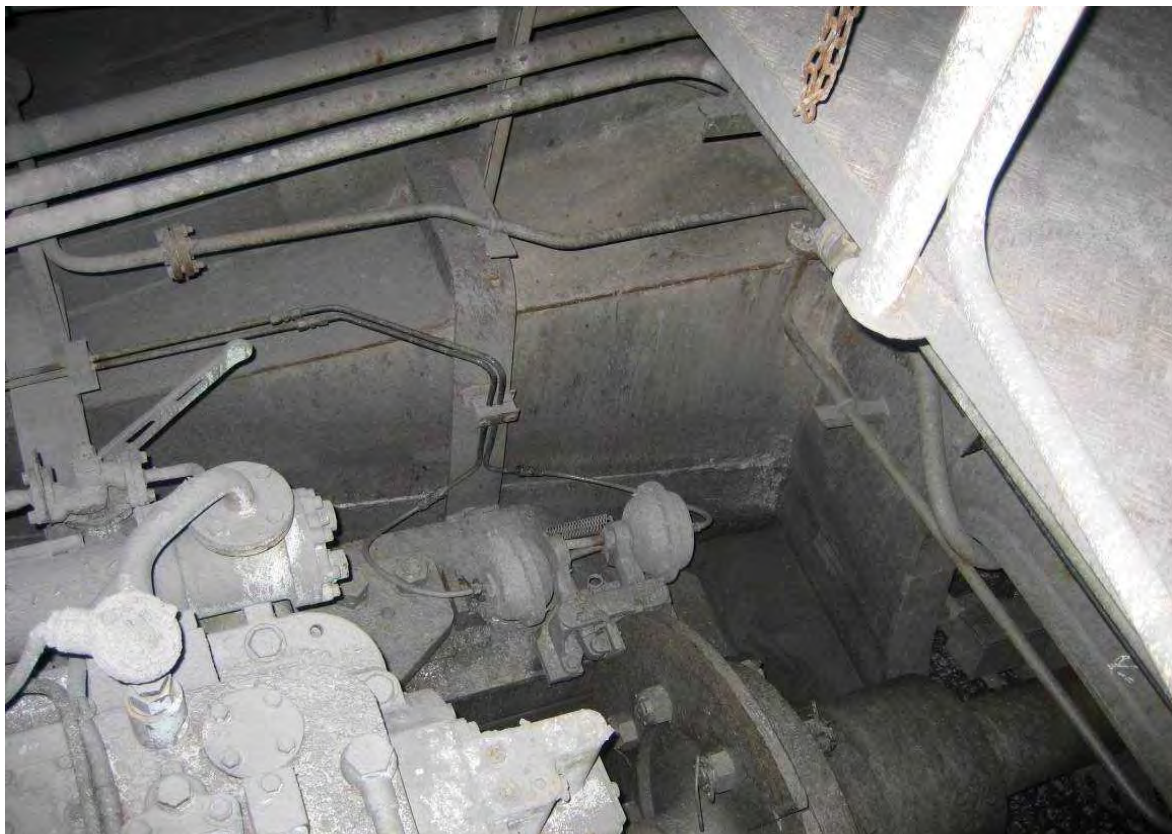
Figure 11 - Port Side Gear Box

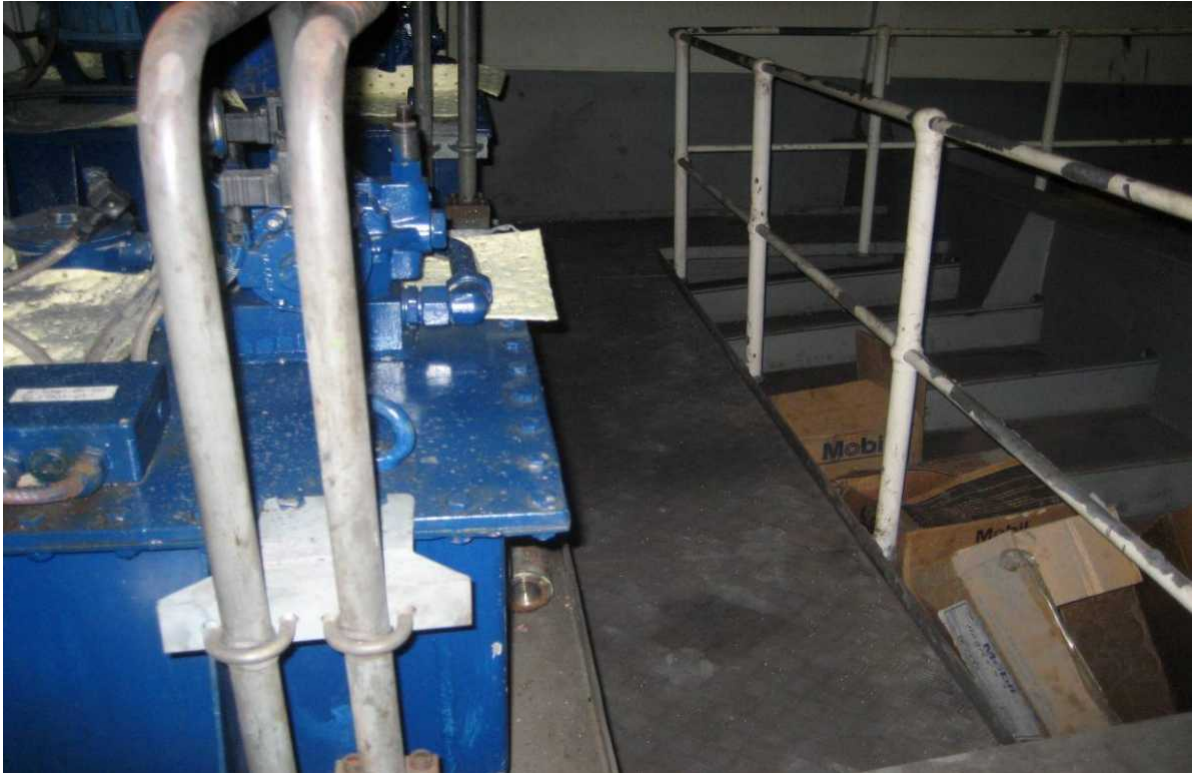
Figure 13 - Port Tiller Flat

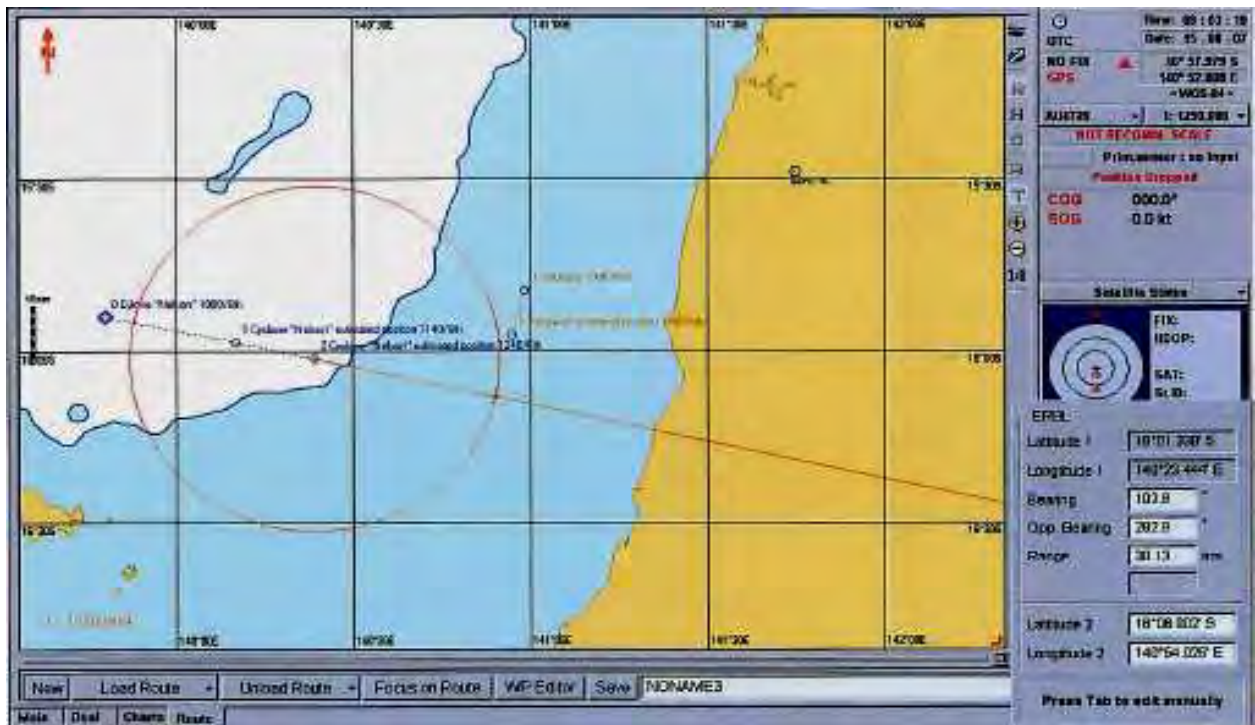
[136] The next figure reproduced at the end of this Chapter (**Figure 4**)¹⁵² depicts the estimated position of the cyclone and the ship at 1240 hours. Relevantly, it shows that after steaming South for an hour the ship was approaching the 30 nautical mile circle from the cyclone's presumed centre, and was still a significant distance to the North of its path.

Figure 4 - Showing the Predicted Positions of the *Wunma* and Tropical Cyclone Nelson at 1240 Hours on 6 February 2007
